# **Tech Tips**

Date: May 13, 2016 TT 70-16-01

2016 Passat - Center Console Installation Tips

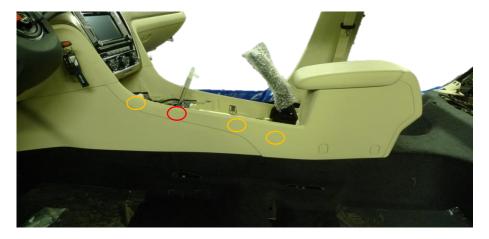
Fig. 1

MY 2016 Passat center console has S-Clips installed in 3 of the 4 available locations (see figures 1 and 2 below). Please note that the clip in the position indicated by the red circle is omitted by design in production.

The clip outlined by the red circle is omitted from the factory. An additional clip can be added to this location if necessary. Part number: WHT-004-816 (The part number provided is for reference only, please see ETKA for the latest part information).

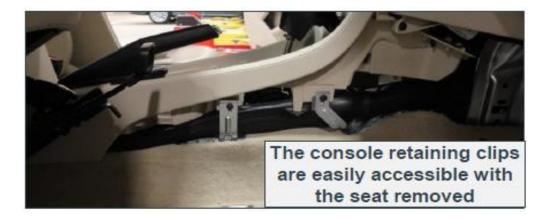
Place seat in the rear-most position. If necessary, the seat may be unbolted and carefully moved to access the retaining clip locations. Follow the proper seat removal/installation procedure in Elsa.

Fig. 3
Inspect all retaining clips for proper seating on the console in the locations shown in figure 4.

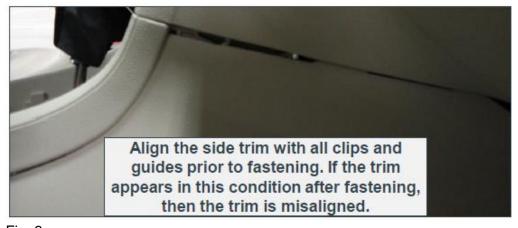
Fig. 6

Align the trim with the retaining clips, ensuring that the sound deadening does not bind on the console (figure 6).
