Tech Tips

TT 01-15-06

2015-2016 Jetta, Golf, Passat – 09G Gen 3, Erratic Shifting, P1624/P0776/P0796. Harsh Upshifts

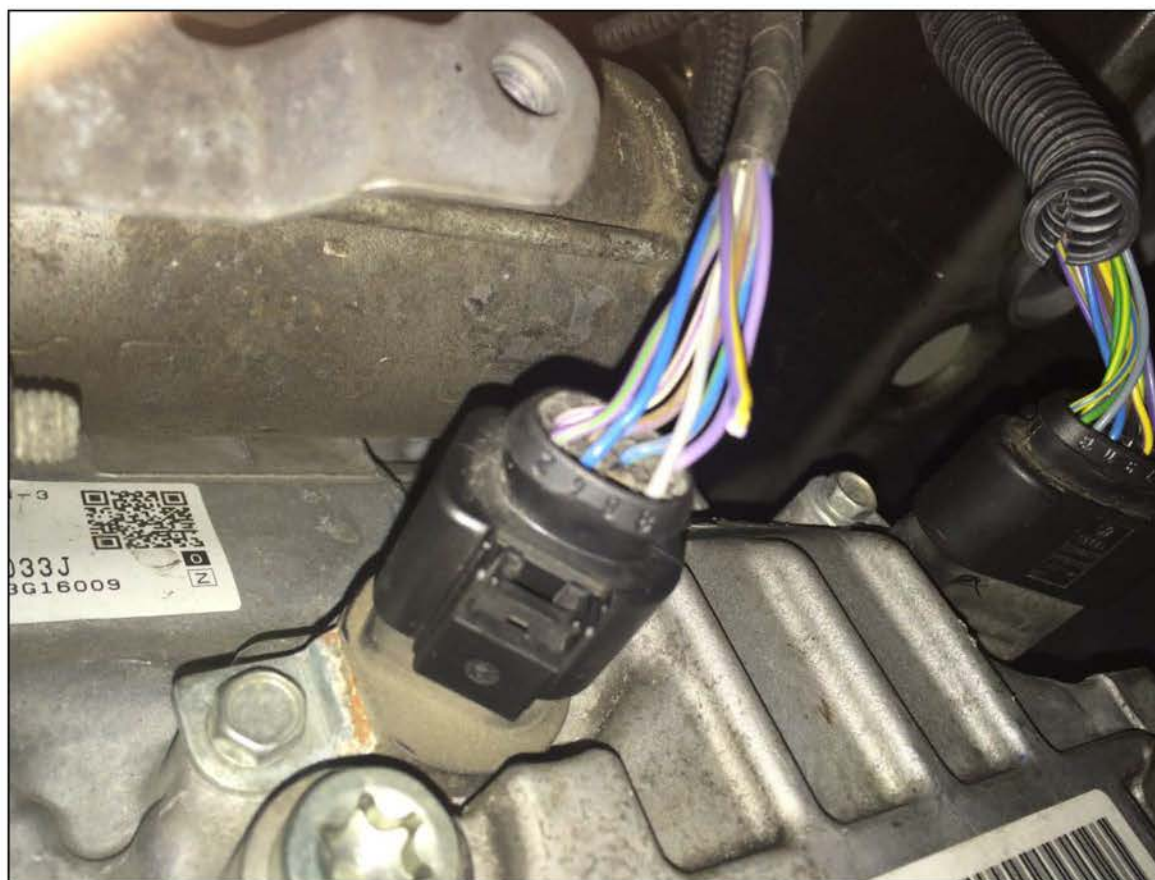
Faults may be caused by a broken wire at Pin 6 of the T8 connector located under the starter (for the N216/ N217 Solenoids.) Inspect the connector for a loose or broken Lilac/Yellow wire. Repair as needed, clear the DTC's and perform Basic settings. Perform a 25 mile drive to facilitate the complete relearn of basic settings prior to re-assessing for any additional transmission concerns.
