Technical Bulletin

66 16 02 April 6, 2016 **2027119** Supersedes T.B. V661502 dated March 11, 2015 to include additional model year applicability and include updated information.

Damage on External Chrome or Aluminum Surfaces

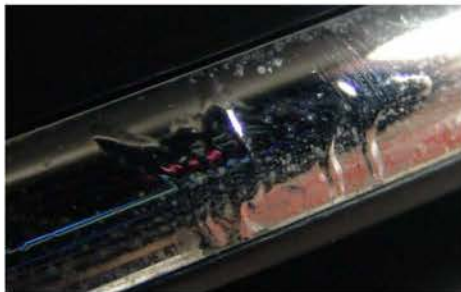
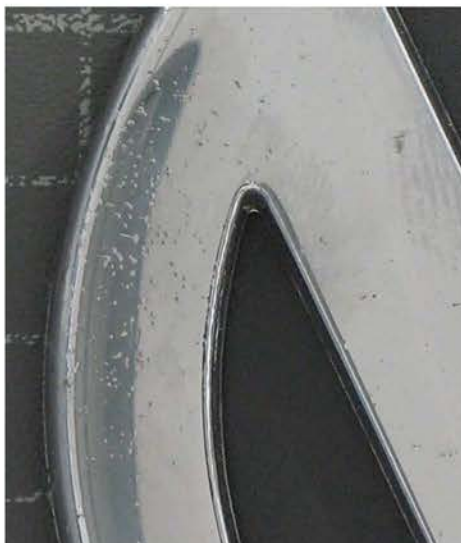
Damage type	Possible cause	Measure	Warranty
Bubbles	Surface defect in production (no external impact).	Parts replacement	Yes

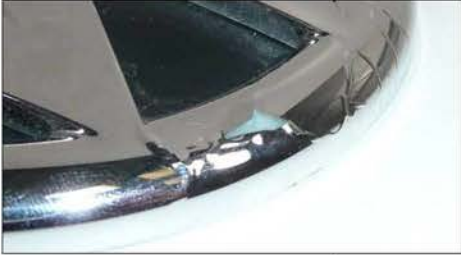
Flaking-off	Surface defect in production (no external impact).	Parts replacement	Yes

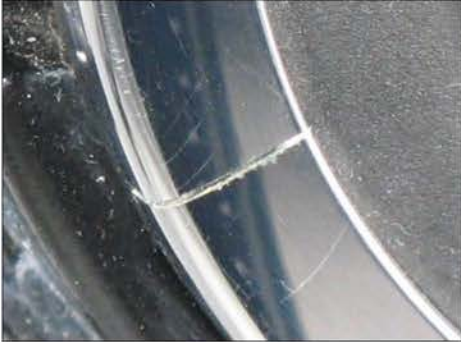
Cracks	Surface/material defect in production (no external impact).	Parts replacement	Yes

- Do not bend the components as this can lead to tiny cracks in the surface.

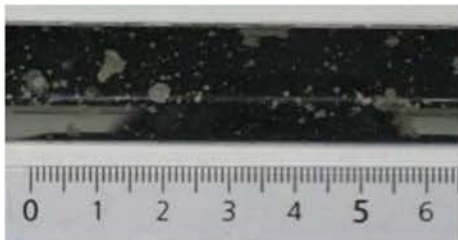
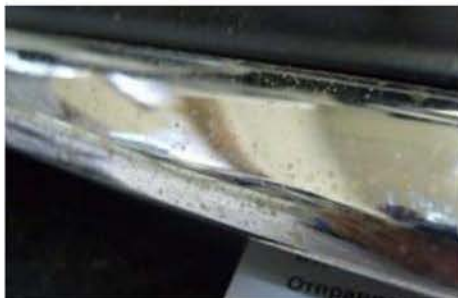
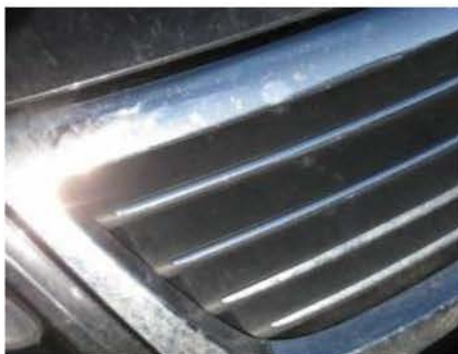
Damage type	Possible cause	Measure	Warranty
Brown marks	External impact through road salt	Polish / parts replacement	No

- Do not use any alkaline, acidic or abrasive cleaners, as they can damage the surfaces of the components (particularly anodized aluminum).
- Before the treatment the components must be clean and dry.
- Commercially available wax-containing chrome/ aluminum polish can be used.
- Observe the instructions of the cleaners.

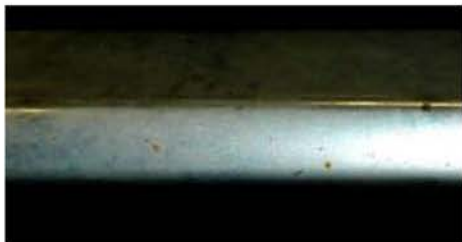
Stone chips	Damage through external impact	Parts replacement	No

Rust spots/industrial dust	External impact	Clean/polish	No

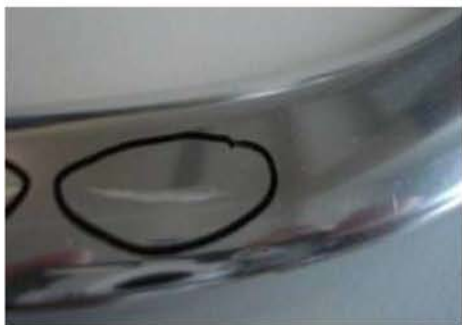
Damage type	Possible cause	Measure	Warranty
Hairline cracks in the anodized coat	External impact through possible bending of the components during the installation in service	Parts replacement	No
