**FORD:**

2017 Escape

**ISSUE**

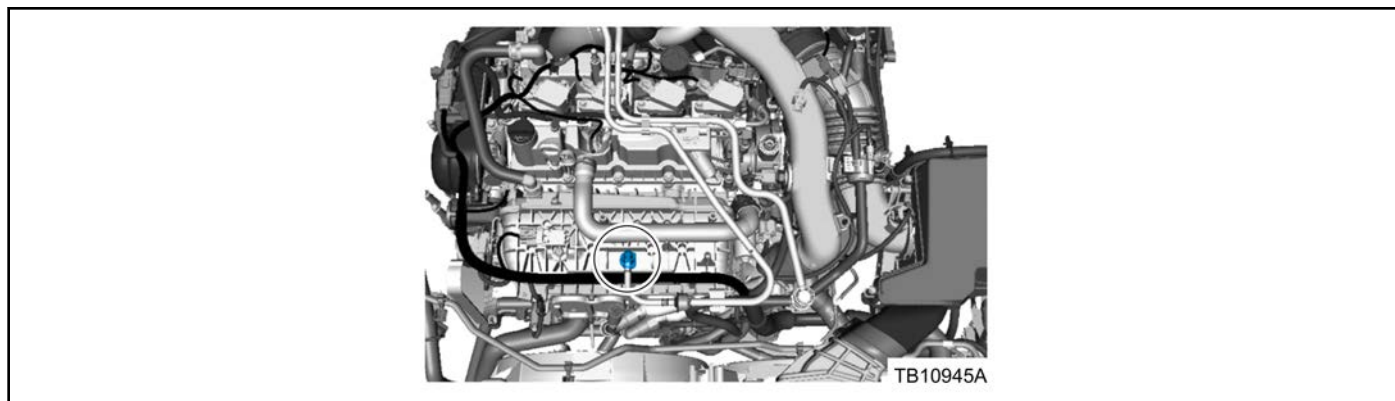
Figure 1 - Article 16-0132

Some 2017 Escape vehicles equipped with a 1.5L Gasoline Turbocharged Direct Injection (GTDI) engine built on or before 9-Jun-2016 may exhibit an illuminated MIL with diagnostic trouble code (DTC) P0455 and/or P144C stored in the powertrain control module (PCM) memory. This may be due to a disconnected or loose evaporative emission (EVAP) system underhood vapor line.

1. Connect the Ford Integrated Diagnostic System (IDS) service tool or equivalent scan tool to the data link connector (DLC). Check for DTCs. Is P0455 and/or P144C stored in the PCM memory?
  - a. Yes - proceed to Step 2.
  - b. No - this article does not apply. Refer to the Powertrain Control/Emissions Diagnosis (PC/ED) manual for normal diagnostics.
2. Lift the engine cover and inspect for a loose or disconnected underhood EVAP vapor line connection. Is the underhood EVAP vapor line loose or disconnected? (Figure 1)

- a. Yes - proceed to Step 3.
  - b. No - this article does not apply. Refer to the PC/ED manual for normal diagnostics.
3. Inspect both sides of the underhood EVAP vapor line connection for debris and clean with shop air or a clean towel if debris is present. Reconnect the underhood EVAP vapor line.
