SERVICE BULLETIN					
Classification:	Reference:	Date:			
BT16-025	NTB16-102	October 28, 2016

2016 TITAN XD; BUZZ NOISE FROM SUBWOOFER

APPLIED VEHICLE: 2016 Titan XD (A61) - Equipped with subwoofer

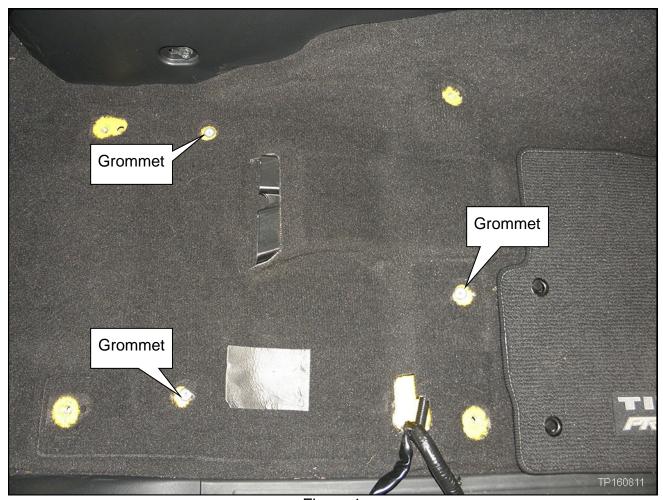
Figure 1

- 1. Remove the subwoofer.
 - Refer to the Electronic Service Manual (ESM), section AV Audio, Visual & Navigation System, for subwoofer removal.
- 2. Remove the grommets shown in Figure 1.
 - Refer to grommet removal steps on the next page.

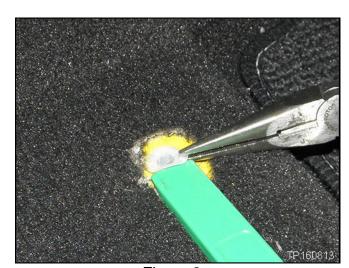
Figure 3

- b. Use a plastic trim tool to raise the edge of the grommets.
- c. Grab the edge of the grommet with needle nose pliers.
 - Be careful not to scratch the paint with the needle nose pliers.
