GROUP Eng	MODEL All w/1.6L GDI Engine
	NUMBER PS296	DATE February 2014

SUBJECT: OCV DAMAGE WHEN INSTALLING ENGINE COVER

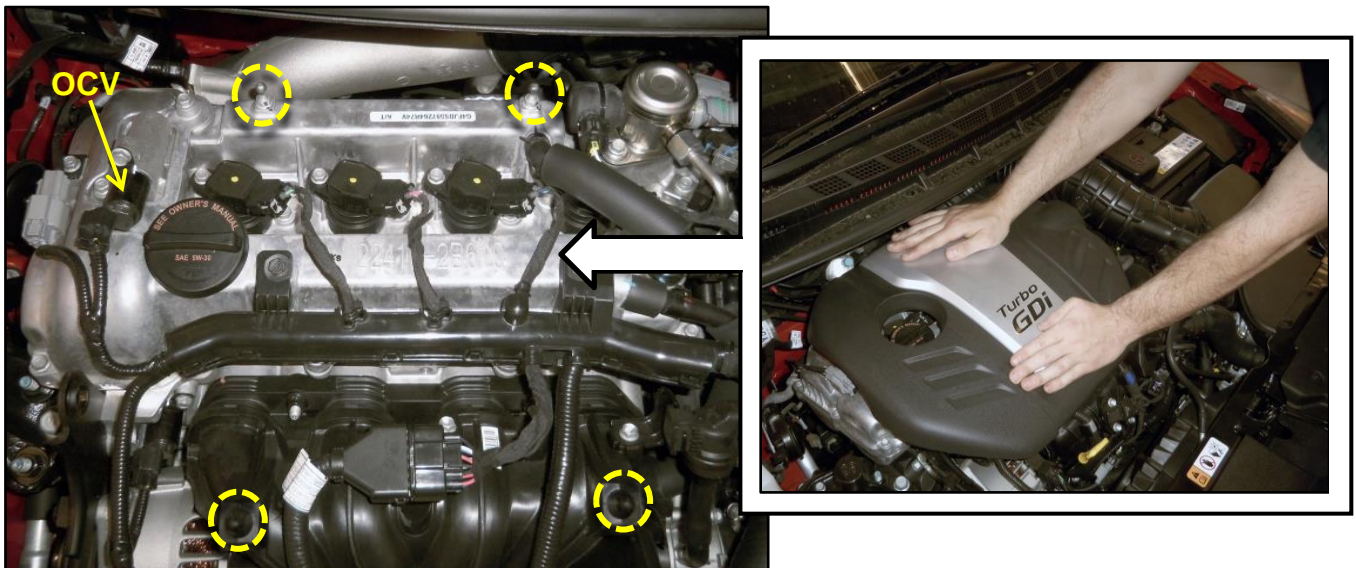
When re-installing the engine cover on vehicles equipped with a 1.6L GDI engine, make sure not to apply any downward pressure in the area around the Oil Control Valve (OCV) to prevent causing damage to the valve. Clearance between the OCV and the bottom of the engine cover is minimal; therefore, dealer personnel should refrain from using excessive force when trying to ensure the engine cover is fully seated. Before installing the engine cover, make a mental note of the approximate location of the pins and apply downward pressure ONLY to the areas immediately above the pins, as shown below.
