P5- S/V90- Front license plate installation

REF NO: TJ 31816.1.1	ISSUING DEPARTMENT: Technical Service	CAR MARKET: United States and Canada	
PARTNER: 3 US 7510 Volvo Car USA		ISSUE DATE: 2016-07-19	STATUS DATE: 2016-07-22
FUNC GROUP: 8611	FUNC DESC: Bumper, front	Page 1 of 3

Installation of front license plate H-frame.

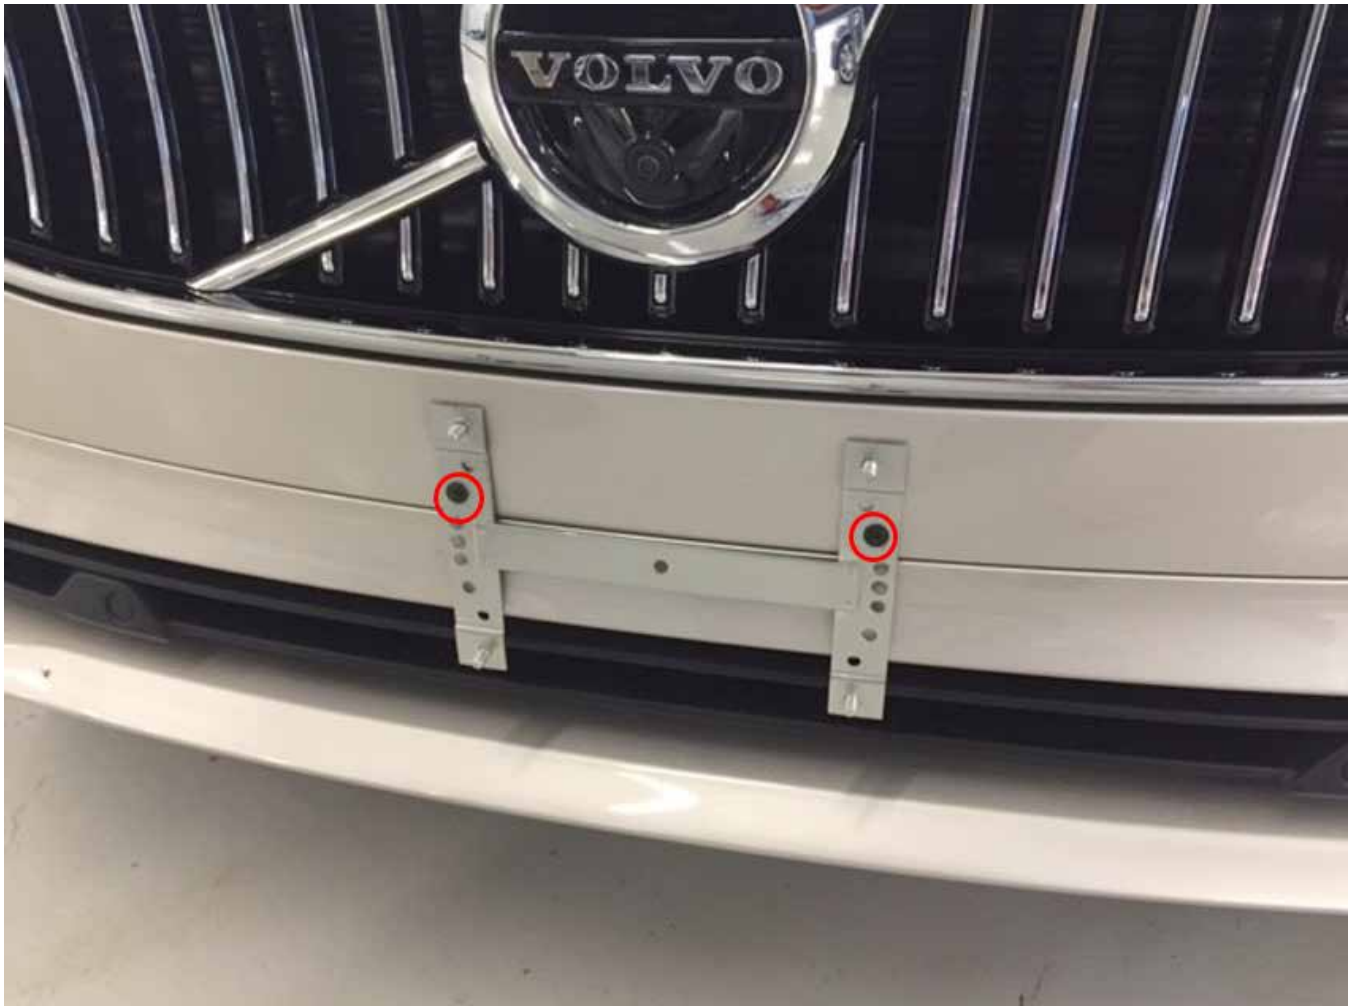
File Name	File Size
S90 License plate.PNG	0.7559 MB

Attach H-frame to the front bumper (see attached picture for reference) using Screw kit: 30632653.

Note: Insert the screws in the same location as shown, to prevent contact with the grill.
