# Technical Journal

Outer rear view mirror, play in mirror

REF NO:  
TJ 30619.1.2

TJ 30619

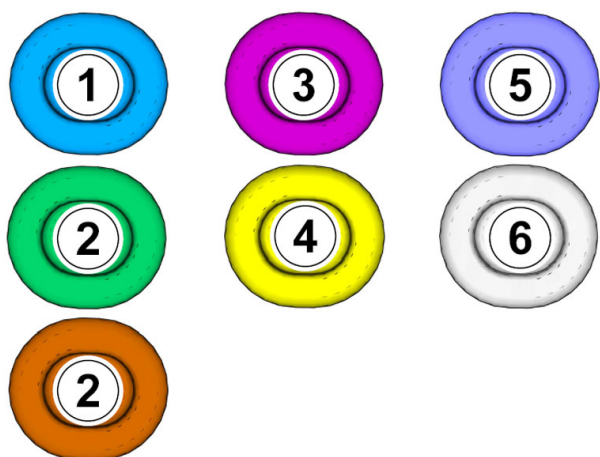
### Image philosophy

- 1 . Used for focused component, the component with which you will do something.
- 2 . Used as extra colors when you need to show or differentiate additional parts.
- 3 . Used for attachments that are to be removed/installed. May be screws, clips, connectors, etc.
- 4 . Used when the component is not fully removed from the vehicle but only hung to the side.
- 5 . Used for standard tools and special tools.
- 6 . Used as background color for vehicle components.

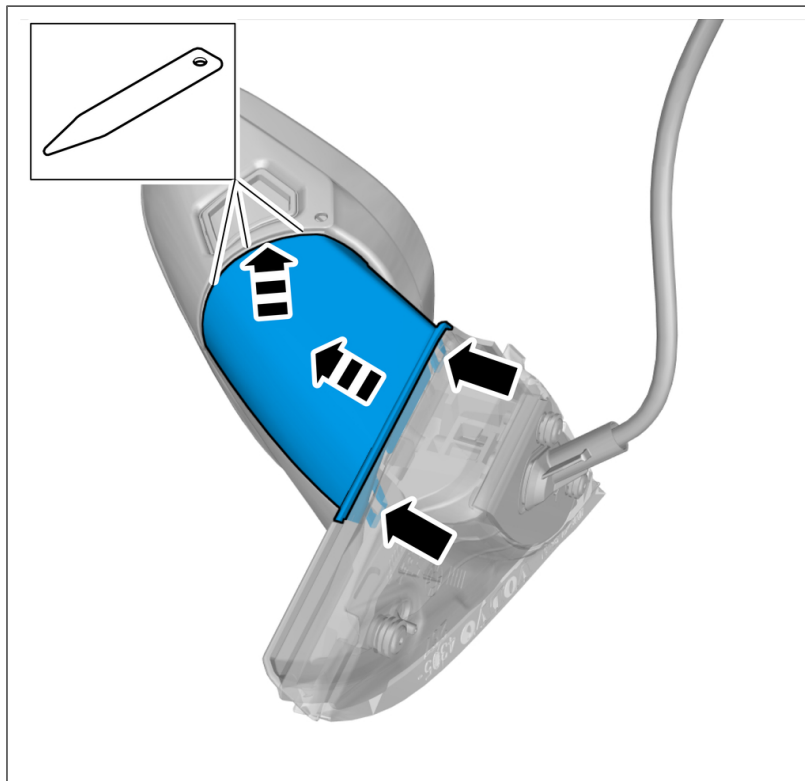
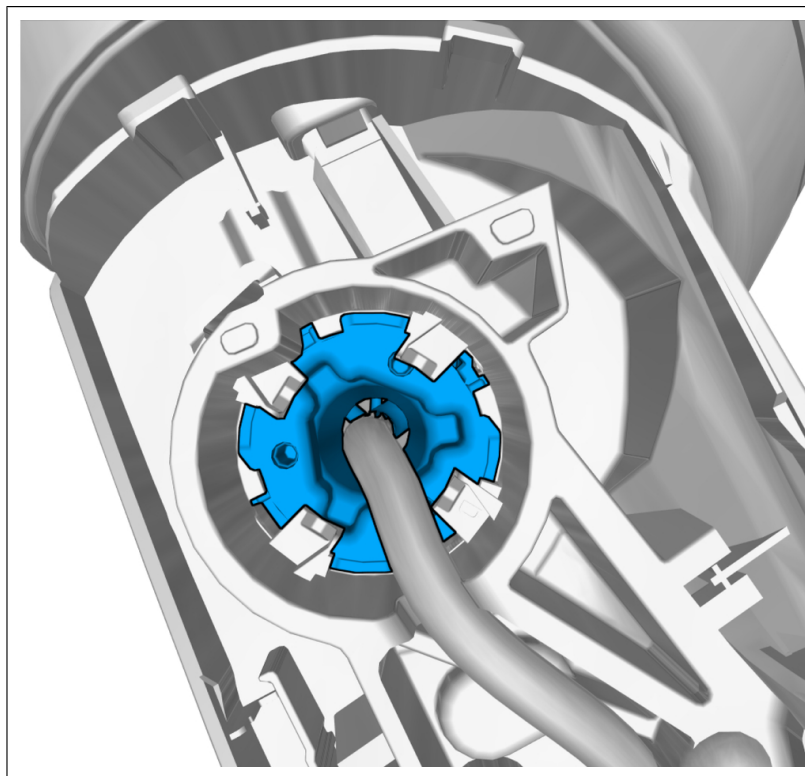
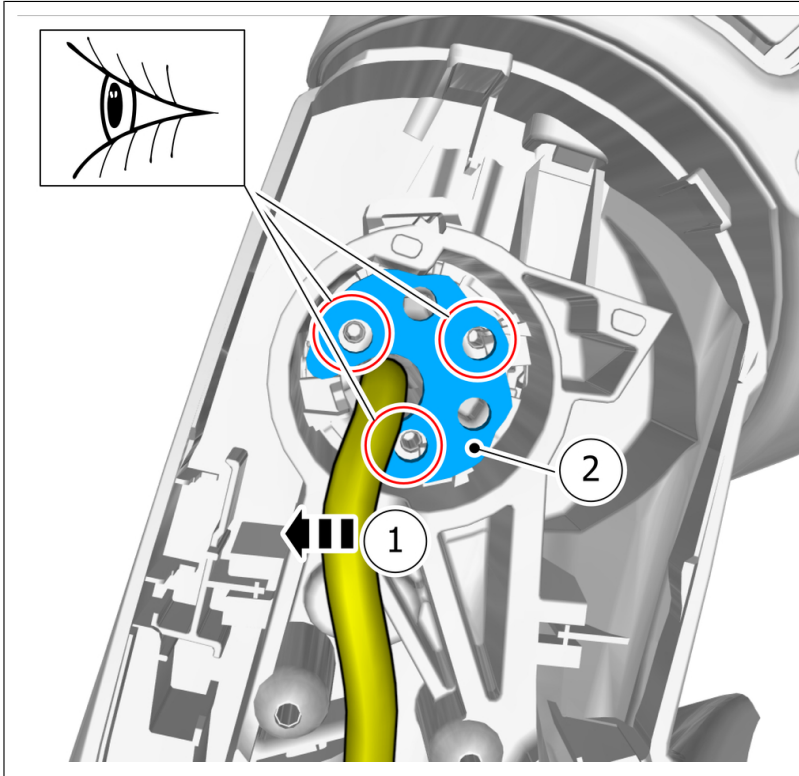
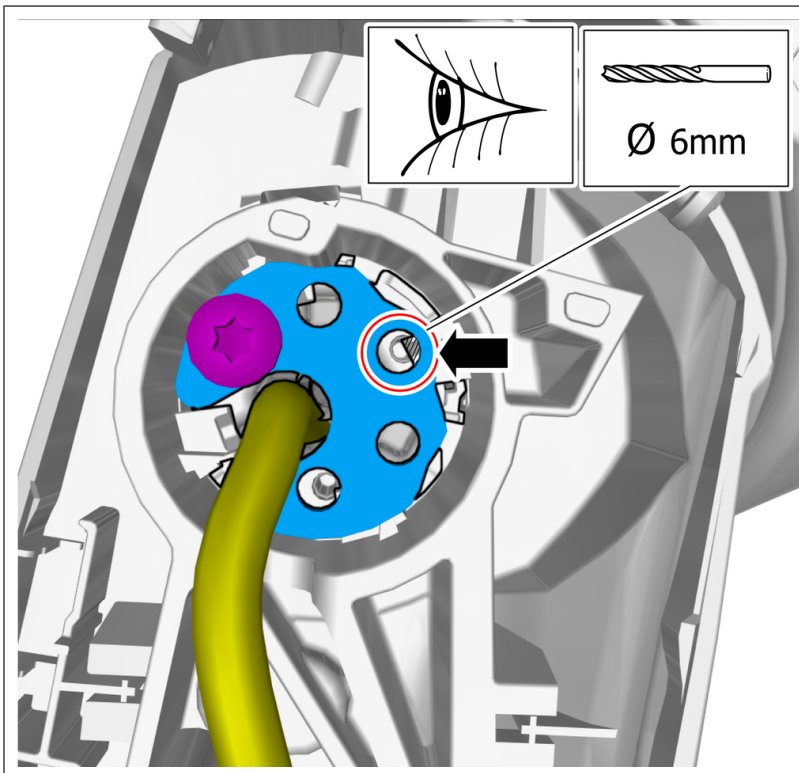
Remove rear-view mirror external , refer to:  
Removal, replacement and installation  
8 - Body and interior  
84 - Exterior trim, glass, weatherstrips  
846 - outside mirrors

Add washer if screw reaches bottom of the hole when tightening.  
Tighten the screw.  
Drill the holes.
