**PREVOST**

## WARRANTY BULLETIN

**WB16-02C**

| SUBJECT : | <b>CHARGING SYSTEM IMPROVEMENT</b> | | |

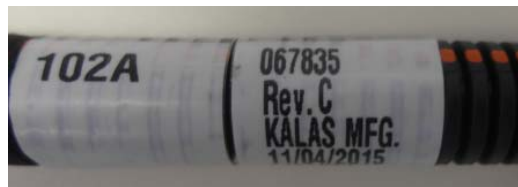
FIGURE 5

Rev.C lug terminal through hole dia.= 5/16" CORRECT

Rev.B lug terminal through hole dia.= 13/32" INCORRECT

6. Reinstall the jumper cable **#067835 revision C** included in kit #7770176 (FIGURE 5, FIGURE 6).

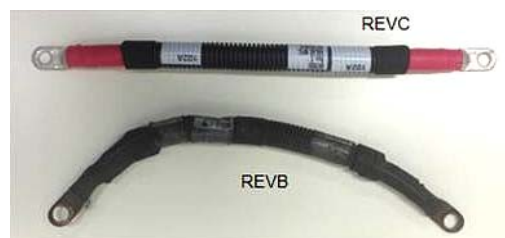
FIGURE 7

*Rev.B diameter of the through hole is too large, reducing contact surface with the stud and the nut thus reducing electrical conductivity between the lug and the alternator stud (FIGURE 7).*

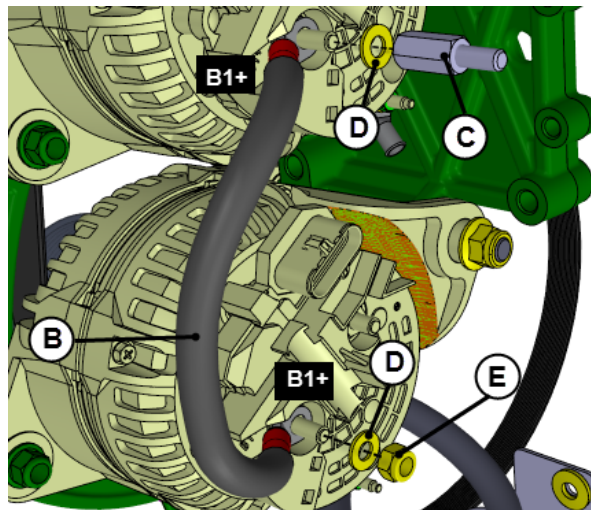
FIGURE 8

**B : JUMPER CABLE #067835 revision C**

**C : STUD ADAPTER #564590 torque: 10 lbf-ft**

**D: FLAT WASHER #5001341**

**E: NUT M8 #5001787 torque: 10 lbf-ft**

7. Reinstall appropriate jumper cable **B** (i.e. rev.C) with appropriate stud adapter. Refer to FIGURE 8.

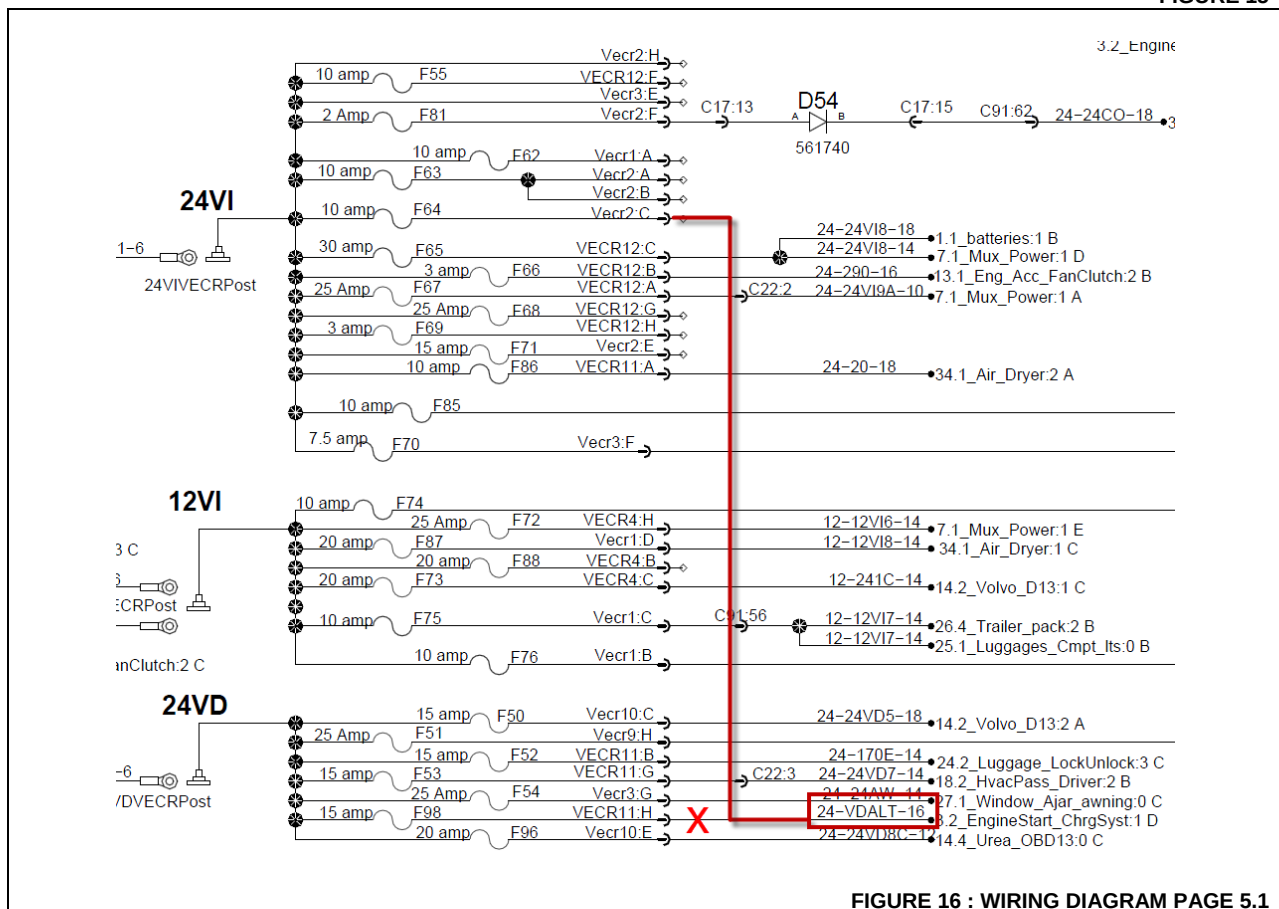
FIGURE 16 : WIRING DIAGRAM PAGE 5.1

Cavity **C** of connector no.2 should be available. This branch of the circuit will be protected by 10A fuse F64 (see FIGURE 16 below).

**Should cavity C not be available, refer to your vehicle wiring diagram page 5.1 to select another free cavity protected by a 10A or 15A fuse** (see FIGURE 16 for reference).

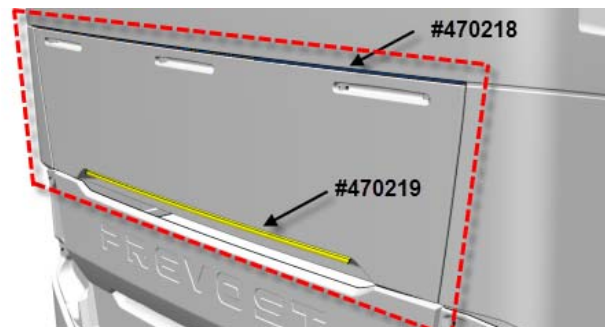
**NOTE:** FIGURE 20 shows where the drip edges will be installed.

2. Clean dirt on the lower part of the **exhaust aftertreatment system ATS** access hatch as well as the area located right above the ATS access hatch (FIGURE 20). It is very important to install the drip edge on a clean surface to assure water tightness.

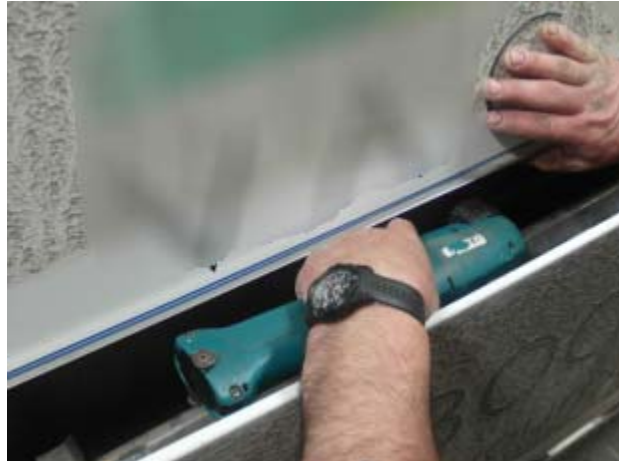
**FIGURE 34**

*Drill using a 9/64 bit. FIGURE 34 shows how to drill holes with the access hatch in place using a right angle drill.*

12. Preinstall the drip edge using five (5) screws #6x1/2 (#500583) as shown on **FIGURE 33**.

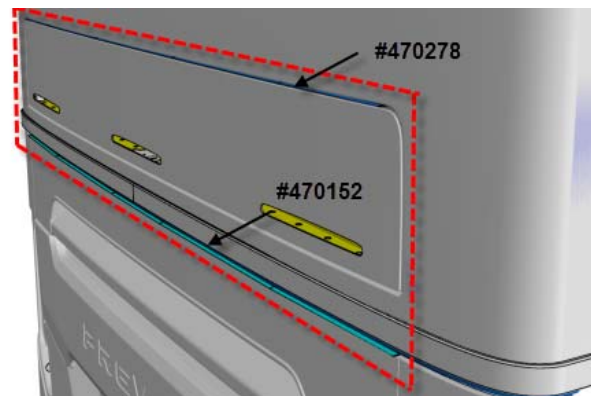
2. See on FIGURE 40 where each drip edge will be positioned. The drip edges will be fastened on the vehicle body, **not on** the ATS access hatch.

5. Clean dirt on the area located right above the ATS access hatch and the area where the lower drip edge will be installed (FIGURE 40). It is very important to install the drip edges on a clean surface to ensure water tightness.
