Field campaign

Topic	Front suspension - air spring leaking (SC16/28)
Market area	Hongkong-Macau (5HK),Russische Föderation (5RU),Australia E04 Bentley rest Asia and Australia (6E04),China 796 VW Import Comp. Ltd (Vico), Beijing (6796),Germany E02 Bentley rest Europe (6E02),Russian Federation 935 Volkswagen Group RUS (6935),United Arab Emirates E06 Bentley Middle East and Africa (6E06),United Kingdom E01 Bentley UK (6E01),United States E05 Bentley USA and rest America (6E05)
Brand	Bentley
Transaction No.	2045606/1
Campaign number	EA66
Note	
Type	Workshop Campaign
US code

Mulsanne

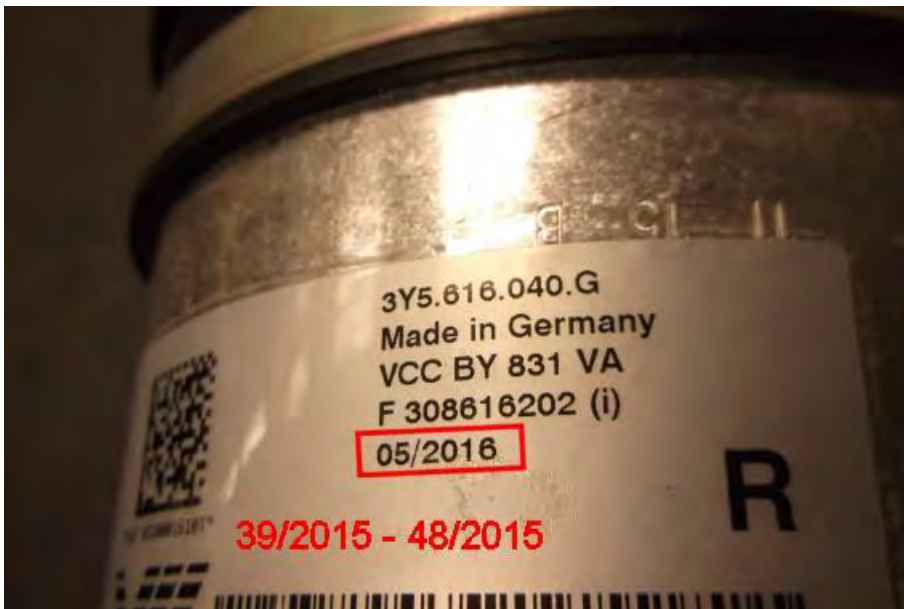
Figure 1

Affected dampers were produced between week 39 and 48 2015

If a front air spring damper is found to display a build week 39/2015 to 48/2015 (see Figure 1) then replace that front air spring damper.

All cars in the applicable VIN range require the front air spring damper date code checking.

Note: If, on inspection, only one front air spring damper is found to be displaying the affected build date then for this specific issue only (early life cars) the front dampers can be replaced individually

Reference workshop manual Rep.Gr. 40 Front air suspension strut – To remove and fit

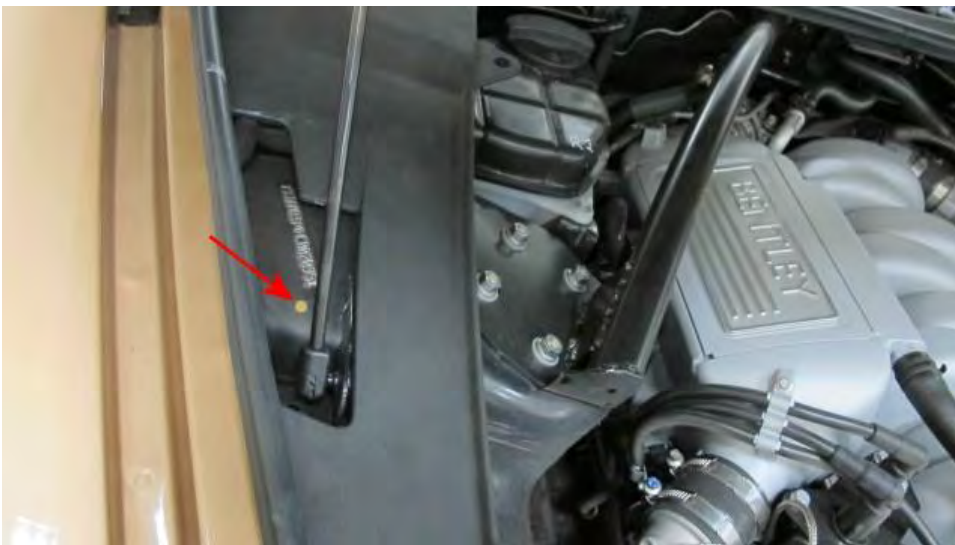
Figure 2

Engine bay, yellow campaign completion mark to the right hand front strut tower adjacent to the VIN etching

If the vehicle is not already listed as repaired in the "Repair history" (in Elsa pro), check for the presence of yellow campaign completion mark top of the right hand front strut tower adjacent to the VIN etching (see Figure 2), should neither be evident carry out the required work in accordance with these instructions.
