HDD Navigation Gracenote Database Update Process (EMV-N)

The information contained in this bulletin supersedes SB No. L-SB-0002-13.

Lexus models equipped with the HDD Navigation (EMV-N) System will periodically require an update to the Gracenote® Database. Gracenote® includes detailed information for songs (e.g., Genre, Artist, Song Title, Album Name, etc.). The Gracenote® update will be included on the Map Update SST. A Gracenote® update must be performed before a Navigation Map Update. A Navigation Map Update is not required to complete the Gracenote® update. Use the process described in this bulletin to perform the update.

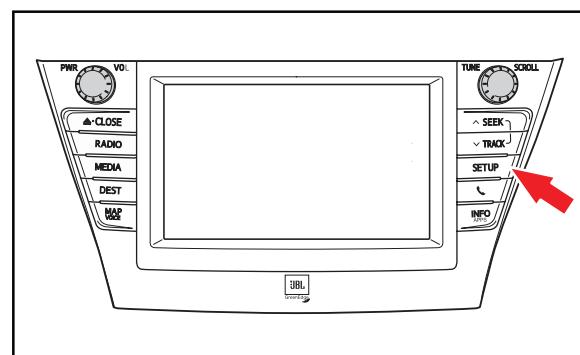
Figure 1.

1. Press the "ENGINE START STOP" switch two times to cycle the ignition to the ON mode (Engine/Hybrid system OFF).
2. Insert the USB Drive SST into the USB port of the vehicle (usually located under the navigation head unit, center console/armrest, or glove box).
3. Note the head unit style to determine how to get to the Map Data screen.
 - A. Press the *SETUP* button on the navigation head unit.

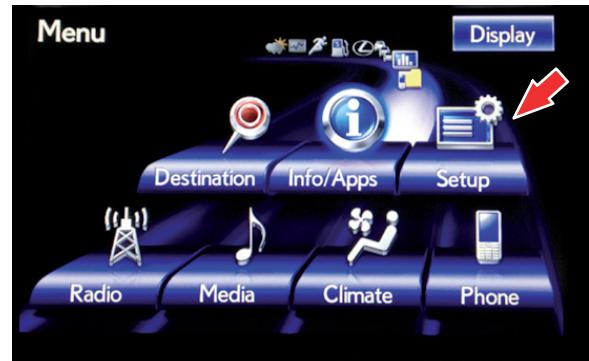
Figure 2.

B. Press *Menu* on the Remote Touch Pad, then select *Setup*.

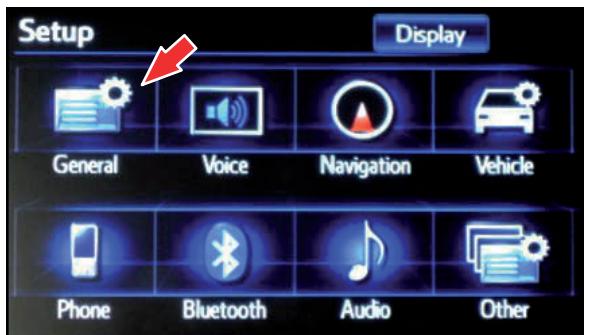
Figure 3.

4. Select *General* on the navigation screen.

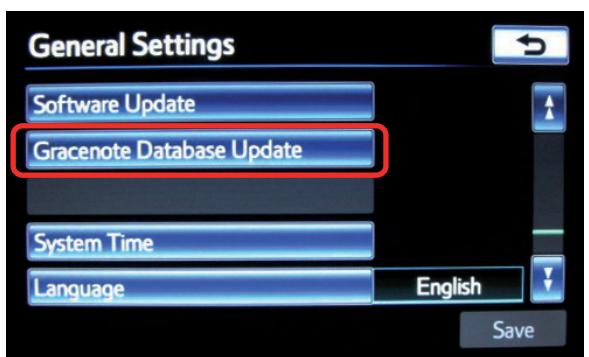
Figure 4.

5. Press the down arrow and then select *Gracenote Database Update*.

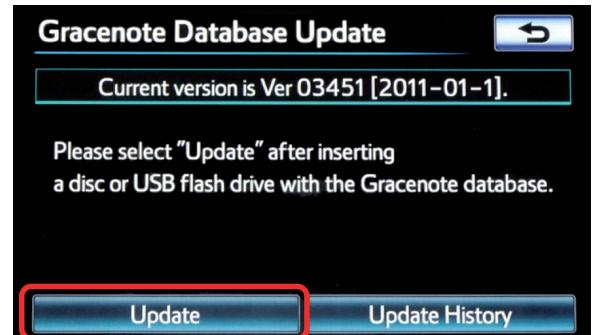
Figure 5.

6. Select *Update*.

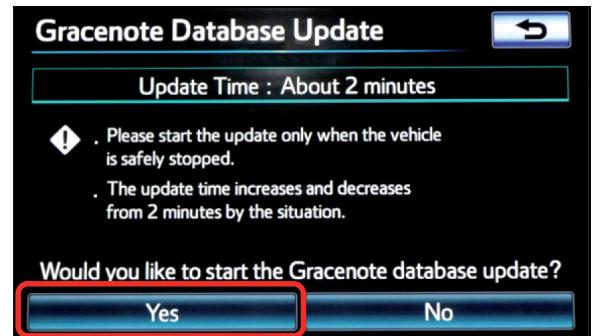
Figure 6.

7. Select *Yes*.

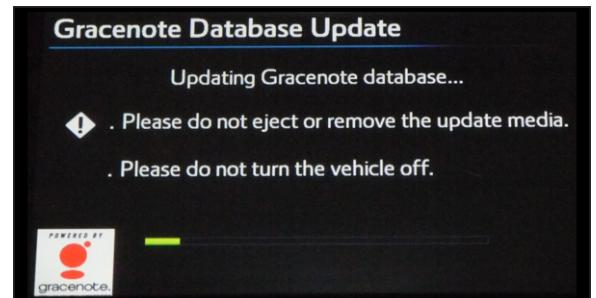
Figure 7.

8. Gracenote Database Update will begin automatically.

This process will take about 2 minutes.

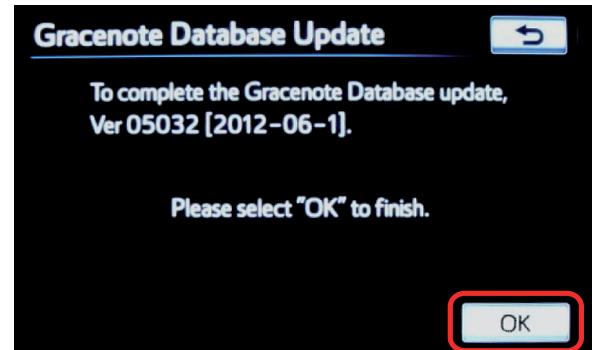
Figure 8.

9. The head unit will display the NEW Gracenote® version upon completion.

The head unit is now ready for a Navigation Map Update (if desired).
