Subject Navigation Micro SD Card Error		Market USA
Service Category Audio/Visual/Telematics	Section Navigation/Multi Info Display	
Applicability 2016 Land Cruiser

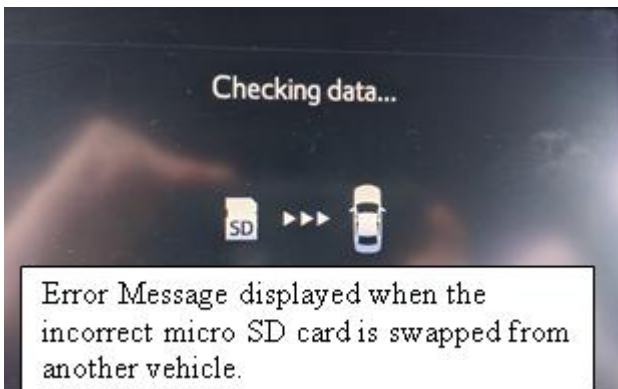
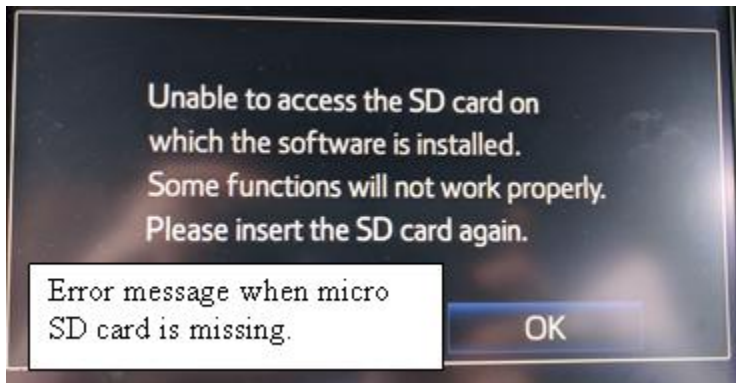
Navigation microSD (mSD) card reads an error when missing or swapped from another vehicle.

- Do not interchange mSD cards. Each mSD card is “paired” with the head unit.
- Once a mSD is “paired” with a vehicle, it may not be swapped into a different vehicle.
- A new mSD is “unpaired” and becomes “paired” when inserted into the vehicle.
- Service exchange radios come in “unpaired” service mode and accept used mSD cards.
- If a mSD card is swapped, returning it to the original vehicle will remedy the concern.
