Service Bulletin

PRELIMINARY INFORMATION

Subject: Musty Odor from HVAC Vents on Startup

Models: 2013-2015 Cadillac ATS
2014-2015 Cadillac CTS Sedan (VIN A)

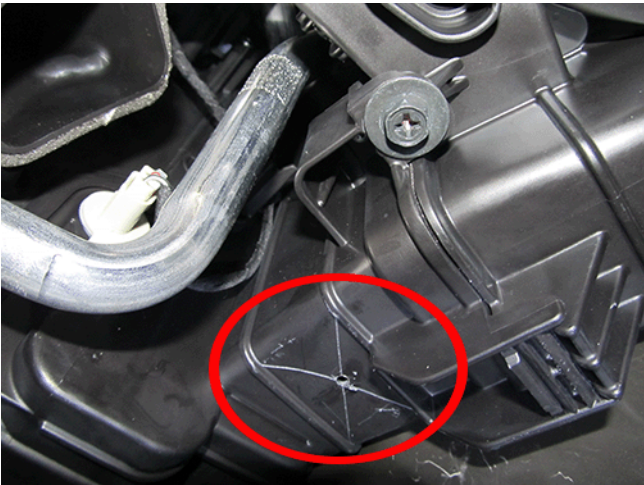
9. On the lower HVAC case, scribe an "X" in the area shown.

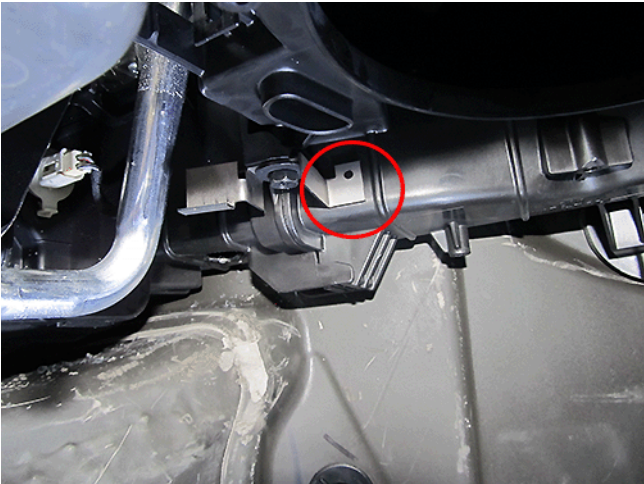
11. Drill a 19 mm (3/4") hole in the center of the air duct between the blower motor and the air distribution box. The use of a Uni-bit style bit works well. The use of a spade bit will produce excessive plastic chips and may cause the drain to get plugged.

Note: Use a vacuum to collect as many of the plastic chips inside and outside the HVAC case as possible. The blower motor removed helps gain access to the inside of the HVAC case.

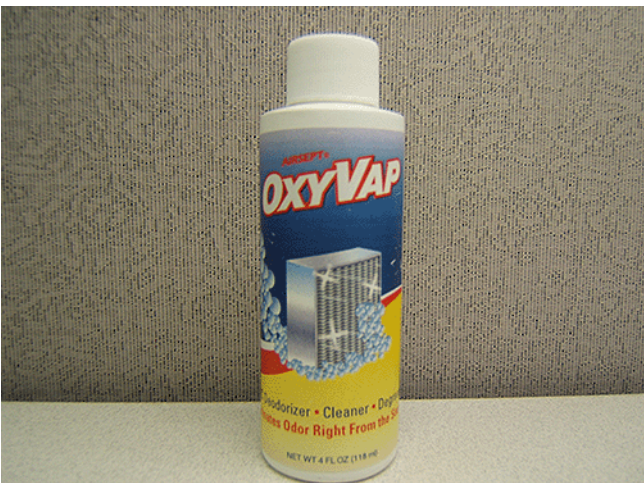
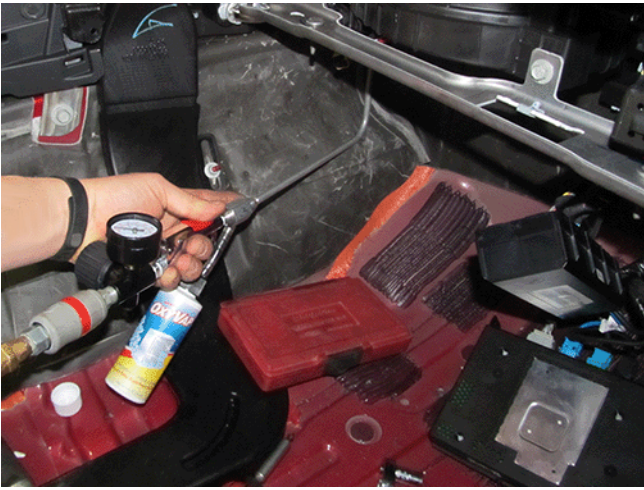
17. Insert the application tool into the drilled hole. Apply OxyVap™ at 65 psi (448 kPa).

- Apply the OxyVap to the evaporator core using applicator tool P/N 23372329. Move the wand up and down to obtain good coverage to the fin area. Turn the HVAC system to off.
- Allow the core to soak for 5 minutes.
- Rinse the empty bottle of OxyVap and fill with clean water. Rinse the evaporator core moving the applicator tool up and down with clean water until the bottle is empty with the blower turned on "High."
 - Using the applicator tool, blow compressed air on the evaporator core for one minute moving the applicator tool up and down to help remove excess water.

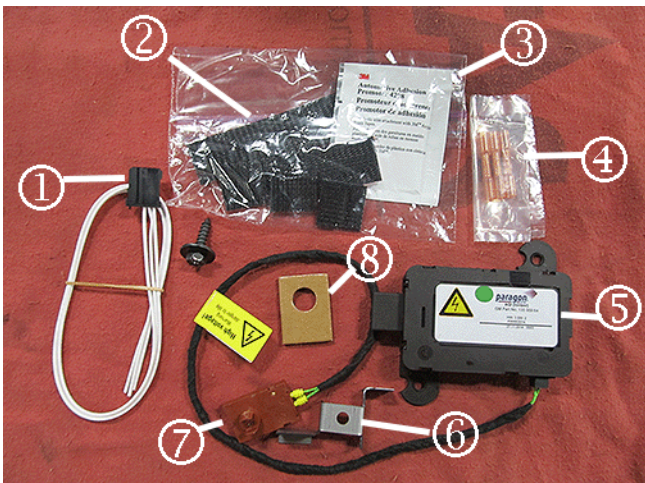
Ionizer Kit Installation

1. *Wire Harness*
2. *3M Dual Lock Mounting Strip*
3. *3M Adhesion Promoter*
4. *Splice Sleeves*
5. *Ionizer Controller*
6. *Ionizer Bracket*
7. *Ionizer Emitter*
8. *Double Sided Adhesive Gasket*

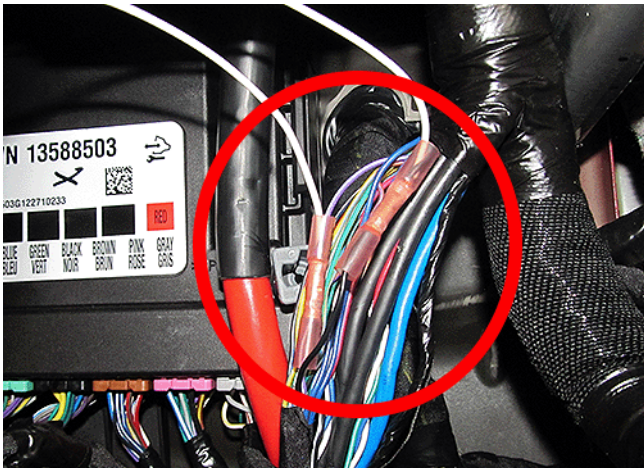
5. Using the supplied splice sleeves, crimp wire 1 from the supplied wire harness to the violet I/P harness and connect the other end of the violet wire to the connector.

Note: Stagger the crimps from the supplied wire harness to the instrument panel harness.

6. Locate the black wire (circuit 1450, K33 HVAC Control Module X2) in the instrument panel harness for ground and cut the wire.

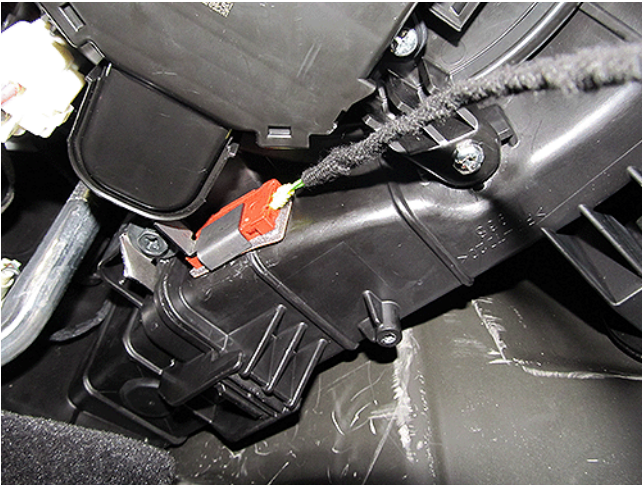
20. Using tin snips or equivalent, trim the mounting bracket as shown.

21. Install the ionizer emitter to the HVAC case. The adhesive from the gasket will hold it in place until the bracket can be installed.
