**Title:** I-6 Engine Hydro-locked

**Applies To:** MaxxForce DT, 9, 10, N9 & N10

Standard repair procedure for a hydrolocked engine.

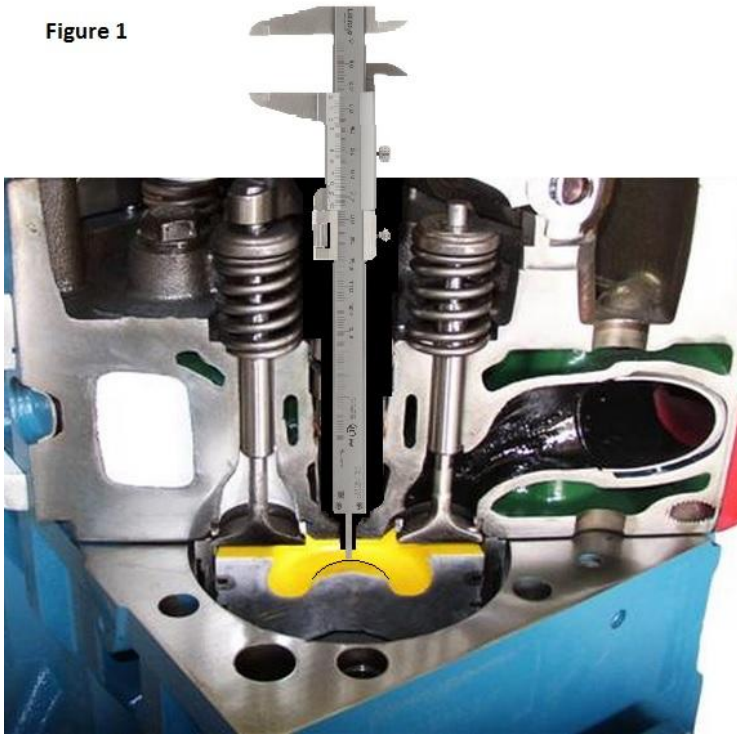
**Figure 1**

**Piston Height Measurement (Shown in figure 1 below)**

Use a Vernier Caliper depth probe to measure distance between the bottom of each injector cup to the top of the piston crown when the piston is at TDC.

1. Extend the depth probe and place it inside the injector cup so that the main scale rests against the bottom of the injector cup and the probe extends into the cylinder.
2. Hold caliper in place while someone else bars over the engine slowly by hand towards TDC.
3. Continue barring the engine slowly by hand until the piston moves past TDC; the piston will push the depth probe to the shortest possible measurement.
4. Record the value in the table below.
5. Repeat 3 times for each cylinder.
6. Use the 3 readings to determine the average measurement of the cylinder.
7. Compare the readings to the other cylinders. A difference of .007" in (0.1778 mm) or more indicates a possible bent connecting rod.

If a bent connecting rod is found remove the cylinder head & replace the connecting rod & cylinder kit (piston, rings, liner, bearings) then road test to verify repair.
