## Cab Mounted Exhaust Bracket, Replacement GU

### FSB 261-038, Cab Mounted Exhaust Bracket, Replacement

(May 2016)

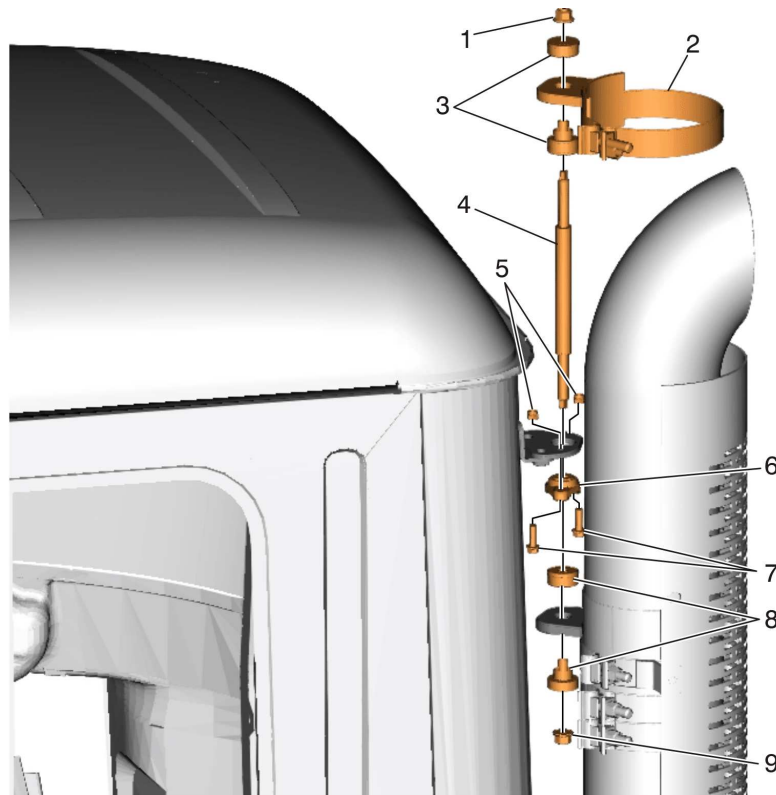
W2037578

GU MACK models equipped with cab mounted exhaust may experience excessive engine noise or vibration in the cab. In most cases, this is caused by a worn bushing in the cab mounted exhaust bracket. The bushing size has been increased to extend the life of the bushing.

- 3. EPDM Isolator
- 6. Spherical Slider Bushing
- 8. Bushings

- 1 Secure the vehicle for service by parking it on a flat level surface, applying the parking brake, chocking the rear wheels, and placing the transmission in neutral or park.
- 2 Remove the fasteners securing the rubber mount isolator rod at upper stack mount.
- 3 Remove the upper mounting strap and rubber mount. (Loosen top clamp, slide clamp up pipe and off isolator rod.)
- 4 Remove the rubber mount isolator rod from the spherical bearing.
- 5 Remove the spherical bearing from the mounting bracket.
- 6 Remove the rubber mounts from the upper and lower strap mounts.
- 7 Install the rubber mounts in the upper and lower strap mounts.
- 8 Install spherical bearing.

**Note:** Do not lubricate bearing pin. The spherical bearing is self-lubricating and does not require additional lubricant.

- 9 Install the rubber mount isolator rod and upper mounting strap.
- 10 Tighten the mounting fasteners for rubber mount isolator rod and tighten the mounting strap.
- 11 Start the engine and check for leaks.
