Service Bulletin

Subject: Spray-in Bed Liner General Information and Repair Procedures

Models: 2013-2014 Chevrolet Silverado HD 2500/3500 Series
2015-2016 Chevrolet Colorado, Silverado
2013-2014 GMC Sierra HD 2500/3500 Series
2015-2016 GMC Canyon, Sierra
Equipped with Spray-in Bed Liner (RPO CGN)

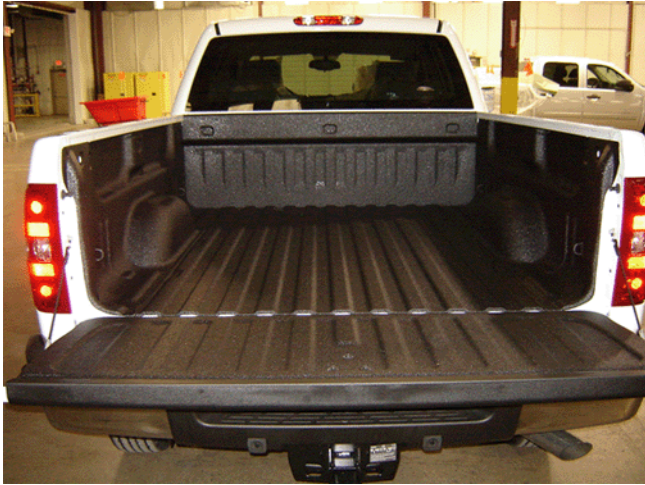
Entire bed

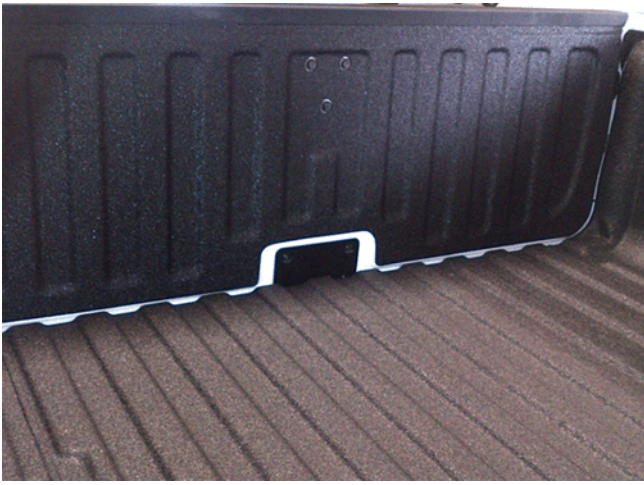
Tailgate with Rear Vision Camera (gate in closed position)

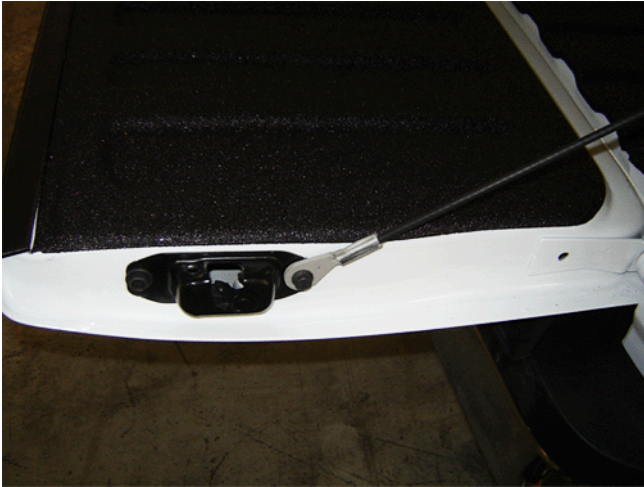
Tailgate side view

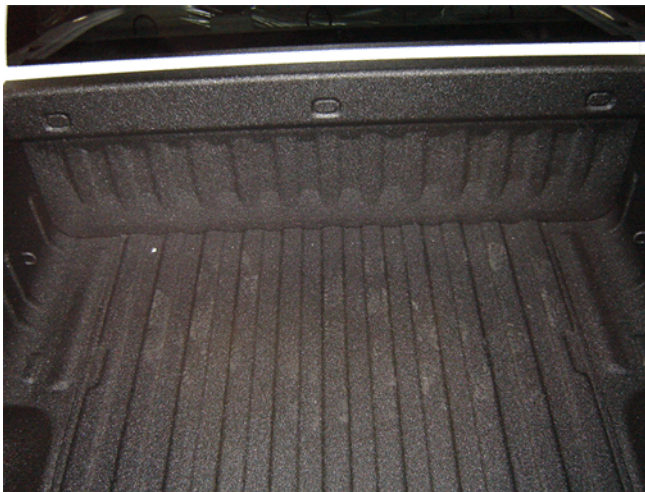
Bed header panel

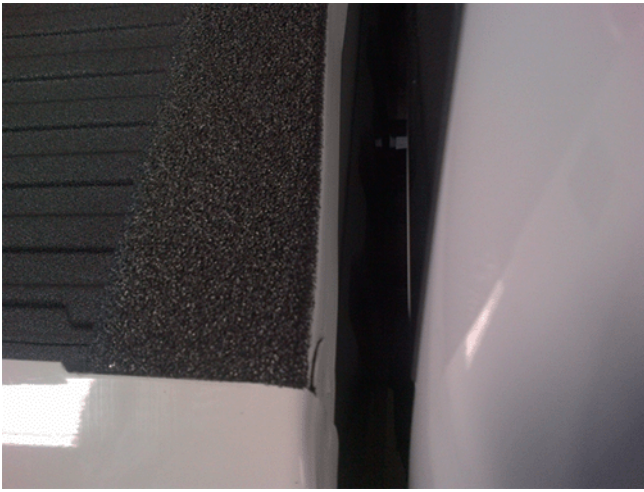
Bed header panel close up

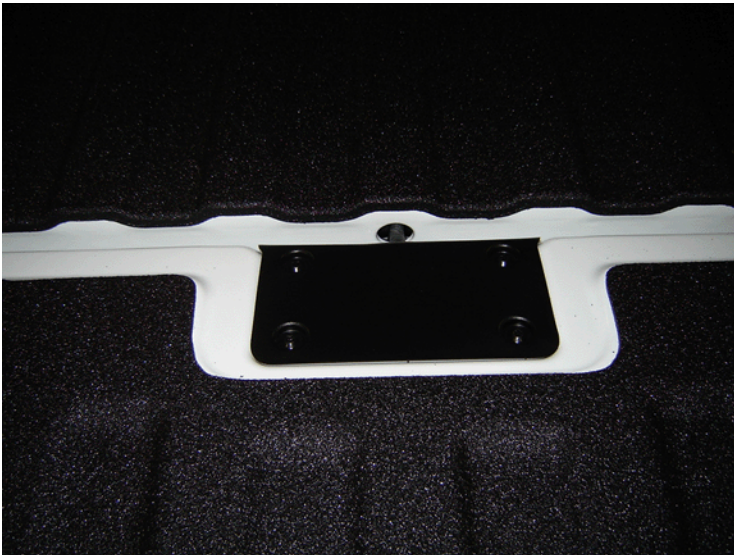
Bed floor (with rear camera access panel, gate open)
