Document ID: IK1500085

Title: ProStar Fuel Tank Unable to fill

Applies To: ProStar

The article will guide you on what to do if the customer is unable to fill the vehicle with fuel at the service station.

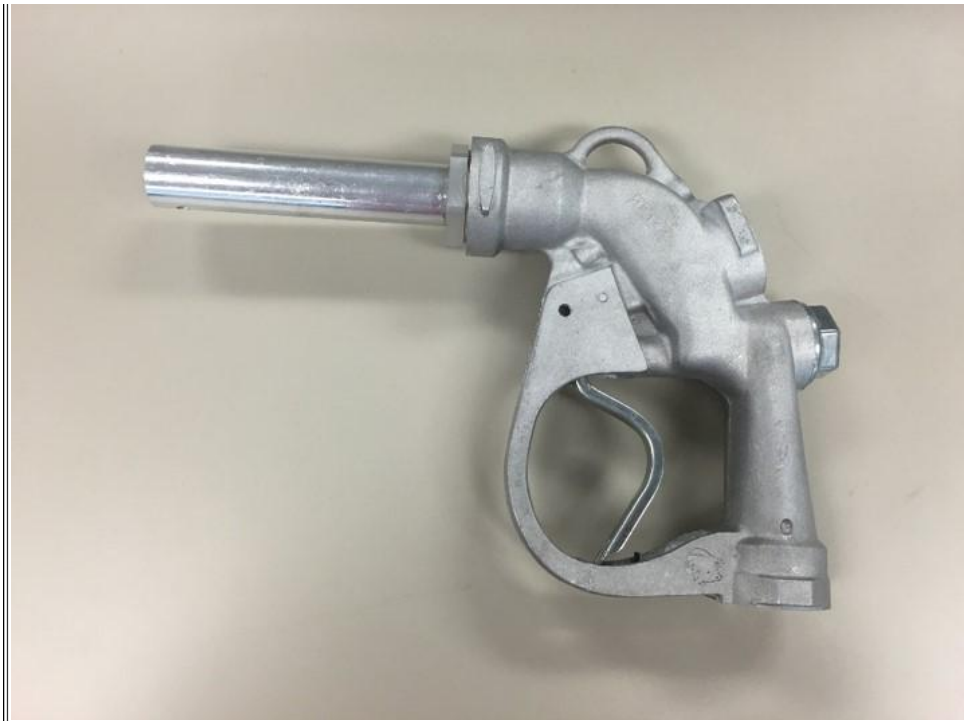
Figure 1: Off Road Type Nozzle

Step	Action	Decision
1	Understand where the customer is fueling the truck and what type of nozzle they are using.	1. Off road type nozzle: Go to step 2
	Two types of nozzles are used to dispense diesel fuel : Figure 1 refers to an off road type nozzle, and Figure 2 refers to the standard high flow fuel nozzle What type of nozzle is the customer using?	2. Standard high flow nozzle: Go to step 3

Step	Action
2	Off Road Type Nozzle If this is the type of nozzle the customer is using, rotating the fuel tanks, or any other adjustments are not covered by warranty.

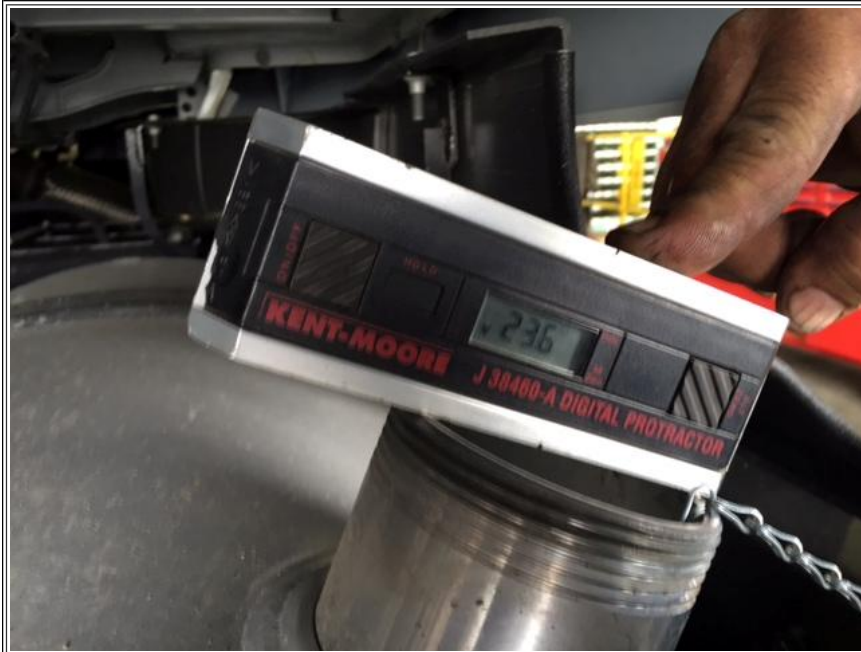
Figure 3: Measuring

5. Remove the fuel tank cap and record the initial angle of the tank at the fuel fill neck (Figure 3) and record the reading. A reading of 26 degrees +/- 1 indicates not action is need for tank rotation. If the initial reading is outside of 26 degrees +/- 1, the fuel tank will need to be adjusted.

6.To adjust the fuel tank, the tank will need to be drained the straps loosed and rotated. For detailed instruction on how the system functions, Refer to the steps outline in manual [0000859551](#) (2010–2016 ProStar Technician Manual (Service and Diagnostic) under the section for fuel tanks.

Ensure final fuel tank position clears all frame mounted items including back of cab suspension.
