| Bulletin No: | SB-16-021 |

## Subject: CORRECTION OF WORKSHOP MANUAL FOR HINO600 SERIES Correction of Electrical Wiring Diagram

**RELEVANT MODEL:** Conventional Trucks 238, 258, 268, 338, 358

Correction of the electric wiring diagram.

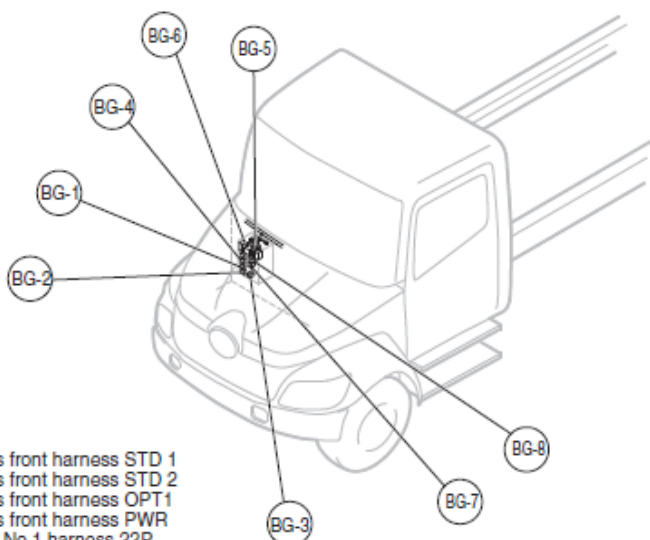
Position of connectors BG

- BG-1: Cab main harness to chassis front harness STD 1
- BG-2: Cab main harness to chassis front harness STD 2
- BG-3: Cab main harness to chassis front harness OPT1
- BG-4: Cab main harness to chassis front harness PWR
- BG-5: Cab main harness to engine No.1 harness 22P
- BG-6: Cab main harness to engine No.1 harness 38P
- BG-7: Chassis front harness to engine No.1 harness 6P (GND)
- BG-8: Chassis front harness to engine No.1 harness 26P

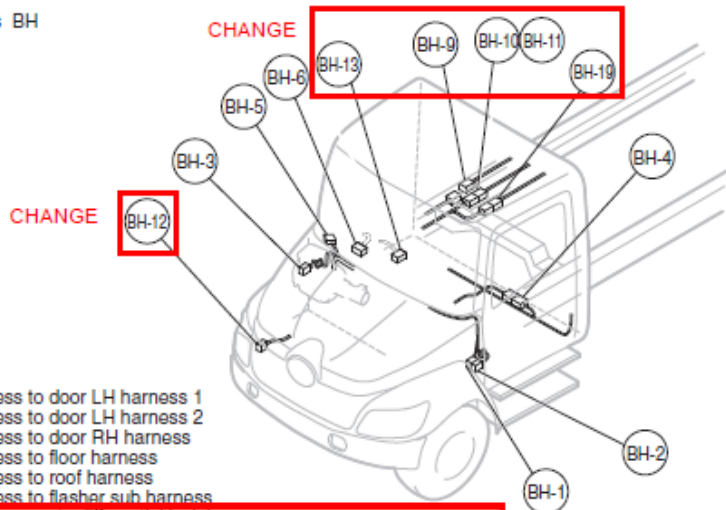
Position of connectors BH

- BH-1: Cab main harness to door LH harness 1
- BH-2: Cab main harness to door LH harness 2
- BH-3: Cab main harness to door RH harness
- BH-4: Cab main harness to floor harness
- BH-5: Cab main harness to roof harness
- BH-6: Cab main harness to flasher sub harness
- BH-9: Chassis front harness to differential lock harness
- BH-10: Chassis front harness to intermediate harness (For full air brake)
- BH-11: Chassis front harness to intermediate harness (For HYDRO MAX brake)
- BH-12: Chassis front harness to head light harness
- BH-13: Chassis front harness to engine No.2 harness
- BH-19: Chassis front harness to intermediate harness (For air suspension dump)

CHANGE
