TO: All Mazda Dealership General Managers and Service Managers
DATE: February 2016
SUBJECT: 2015-2016 Mazda3 – Spare Tire Air Pressure Concern
Special Service Program (SSP) A3

2015-2016 MAZDA3 SPARE TIRE PRESSURE CONCERN SSPA3

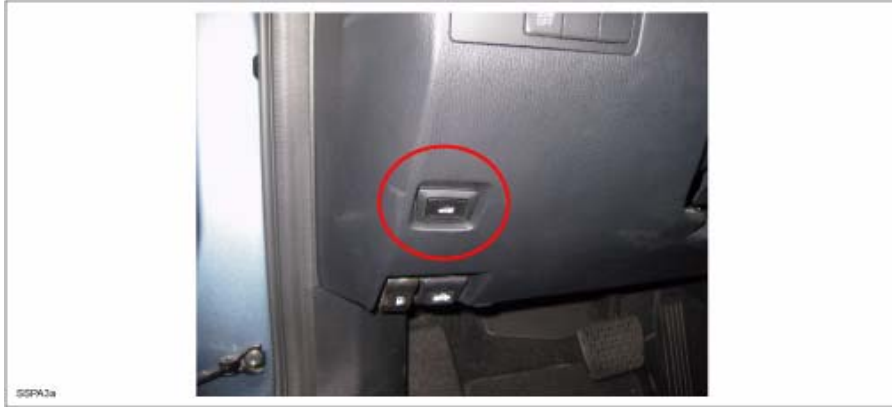
1. For the 4-door sedan, open the trunk. There are 3 ways to accomplish this.
 - a. Press the button to left of the steering wheel.

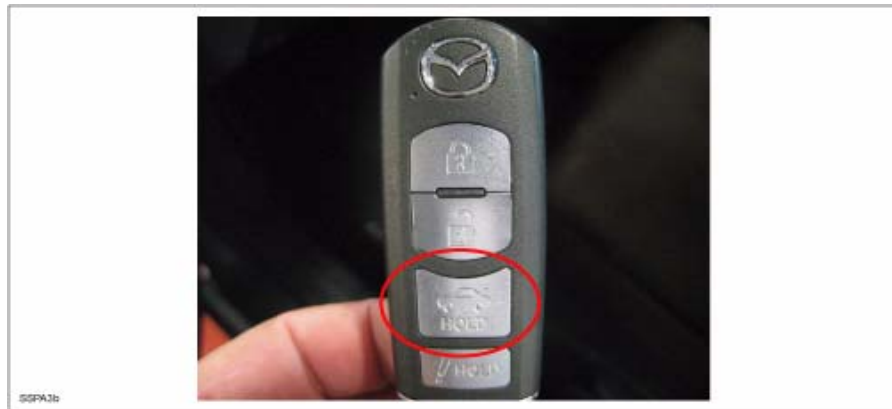
- b. Press and hold the button on the remote.

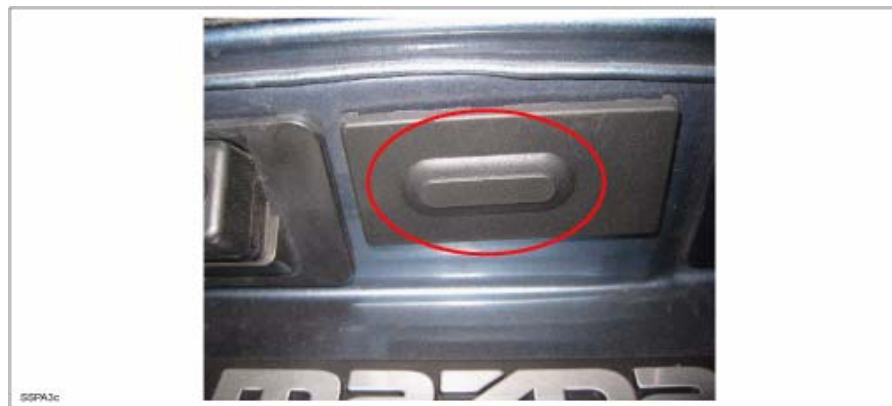
- c. Press the electric trunk lid opener button, located next to the back-up camera on the trunk lid.

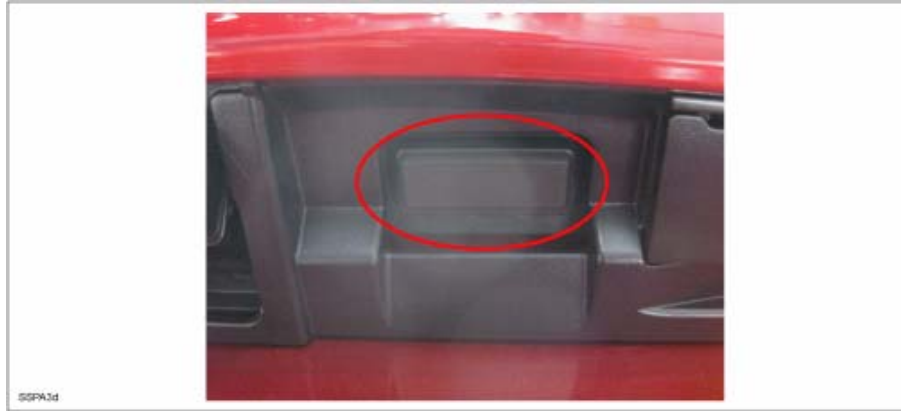
2. For the 5-door hatchback, open the liftgate by pressing the electric liftgate opener.

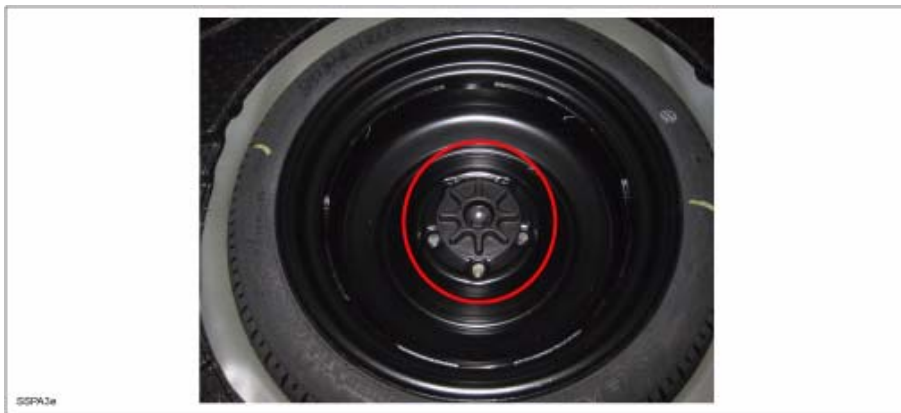
3. Lift up the trunk mat and unscrew the spare tire hold down bolt by hand and place it to the side.

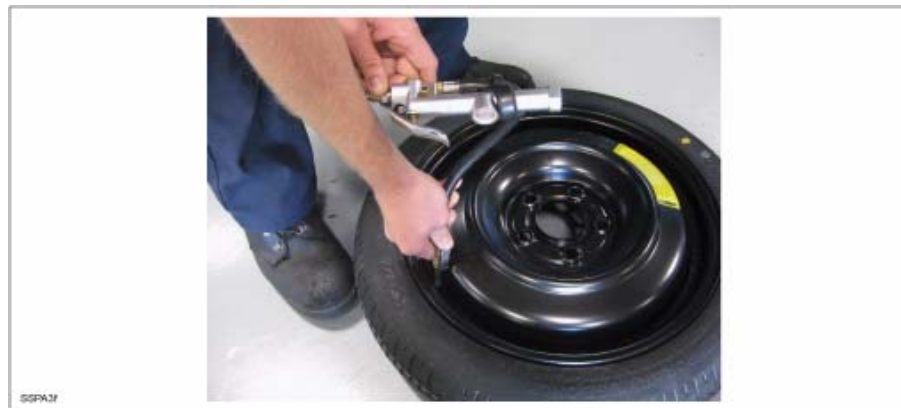
4. Remove the spare tire, turn it over, and remove the valve stem cap.
5. Use a pressure gauge to read the pressure.
 - **US tire pressure specification: 60-77psi.**

- If tire pressure is below 60 psi, fill to 60-77 psi, and go to next step.
 - If tire pressure is 60 psi or more, go to next step.
6. Put the valve stem cap back on and install tire back in the vehicle
 7. Secure spare tire with the same hold down bolt removed previously and tighten until snug.
NOTE: Be careful not to over tighten or cross thread the hold down bolt.
 8. Close trunk/liftgate and record the VIN as completed.
