# Technical Service Bulletin

## 30 Haldex coupling does not work (DTC C111204)

30 16 20 2043144/1 February 1, 2016.

Model(s)	Year	VIN Range	Vehicle-Specific Equipment
A3, Q3	2015 - 2016	All	quattro

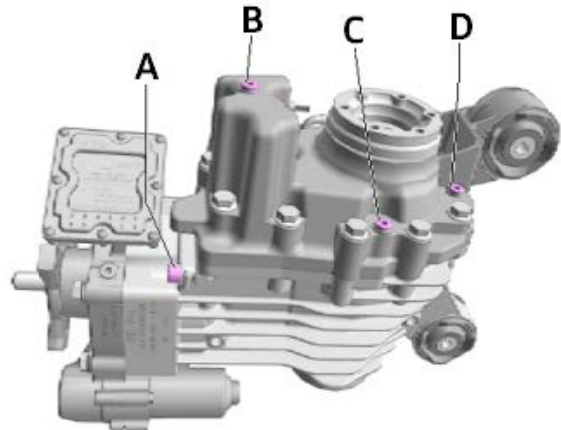
The final drive and the Haldex coupling have separate oil circuits. Refer to ETKA for information on which oil to use, and refer to the Elsa Repair Manual for draining and filling information.

- The Haldex coupling uses high performance oil for Haldex couplings, and the final drive uses gear oil.
- The image at right (Figure 1) shows the correct drain and fill plugs.

**Figure 1.** Drain plug for Haldex oil (A), oil filler plug for Haldex oil (B), gear oil drain plug (C), oil filler plug for gear oil (D).

1. Before proceeding, confirm that the issue matches the *Condition* exactly.
2. Replace the hydraulic pump according to the Elsa Repair Manual.
3. Replace the high performance oil for the Haldex coupling according to the Elsa Repair Manual.
4. Perform all-wheel drive basic settings.
