**HYUNDAI**NEW THINKING.  
NEW POSSIBILITIES.**Technical Service Bulletin**

**16-01-047**

**ACCENT (MC)****SUBJECT:**ACCENT (MC) UNDERBODY CORROSION PREVENTATIVE SERVICE  
(SERVICE CAMPAIGN 944)**\* IMPORTANT****\*\*\* Retail Vehicles Only \*\*\***

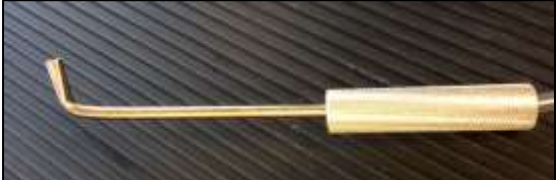
<p>This nozzle is supplied with the wax gun.</p>

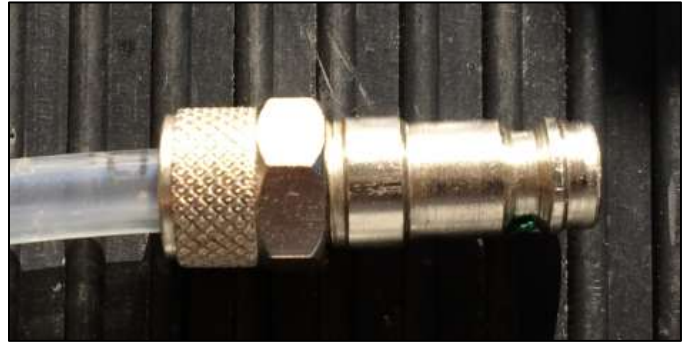
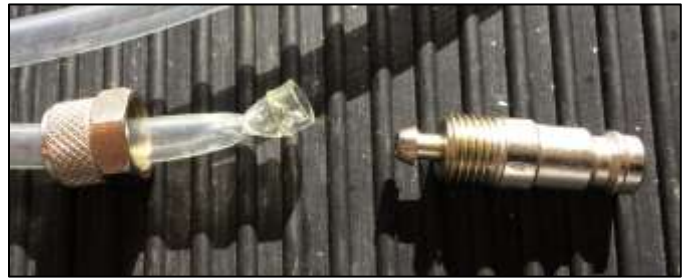
2a. Remove the compression fitting from the nozzle assembly that originally comes with the wax gun by unscrewing the nut, then removing the fitting from the tube.

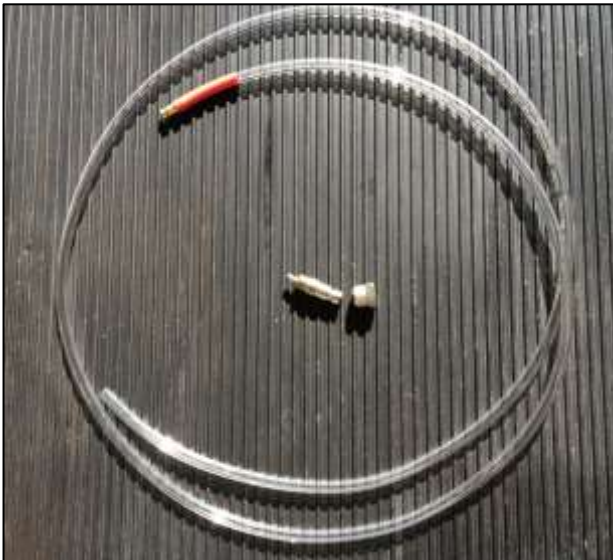
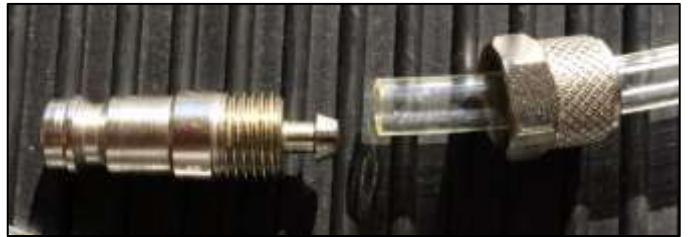
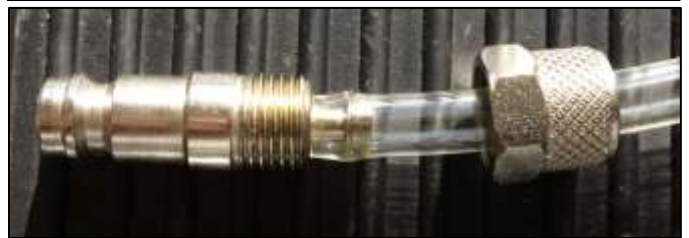
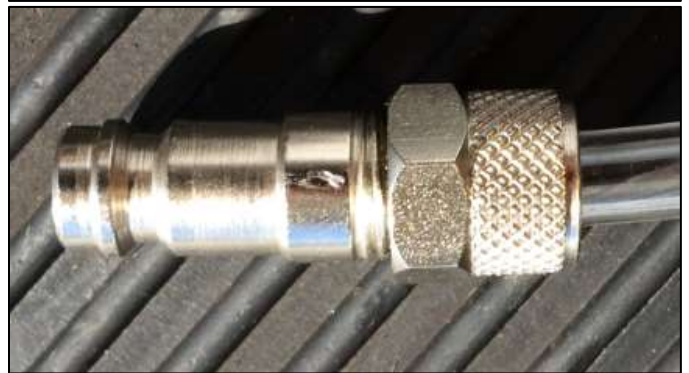
2b. Attach the compression fitting to the tubing on the new nozzle assembly.

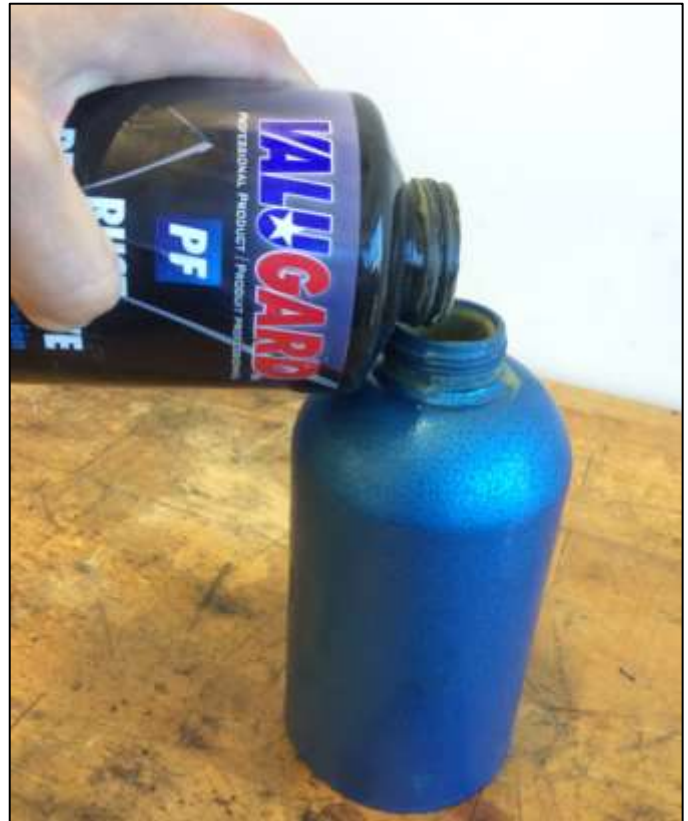
2c. Fill wax gun reservoir with cavity wax.

Prime the wax gun by spraying into a trash bag (or similar) until a light mist is visibly coming out of the nozzle.

Air supply pressure must be set to 70 psi.

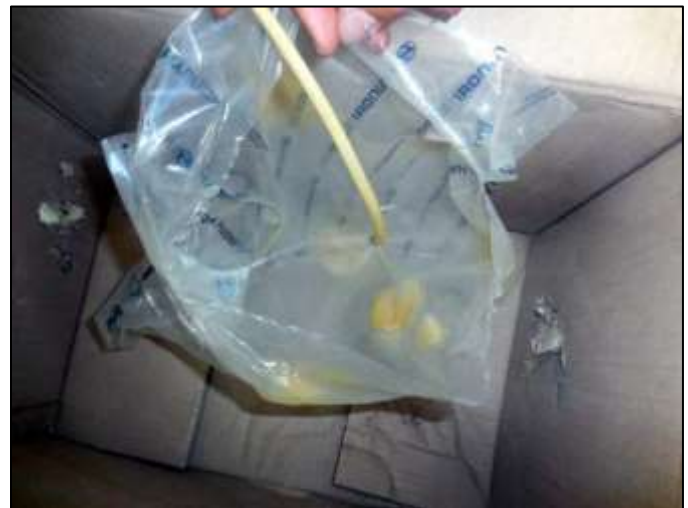
If volume of wax coming out of the nozzle slows significantly (so that a light mist is no longer visible), prime the gun again.

It may speed the priming process to block the nozzle with a rag while spraying the gun until the flow of wax increases.

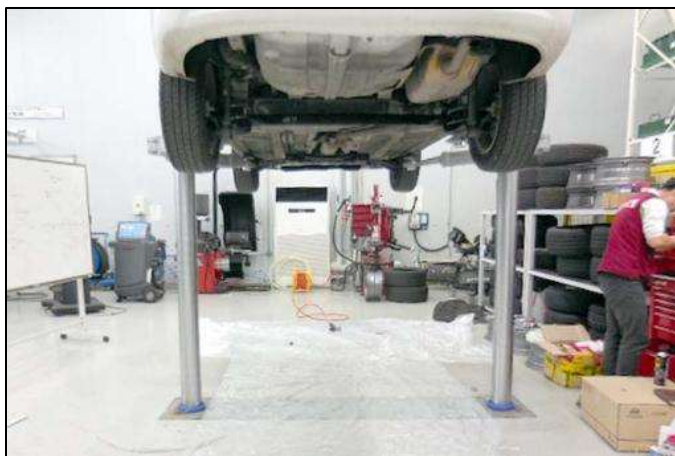
2. Remove the undercover (A).

**Tightening torque:**

7.8 ~ 11.8 Nm (0.8 ~ 1.2 kgf.m, 5.8 ~ 8.7 lb-ft)

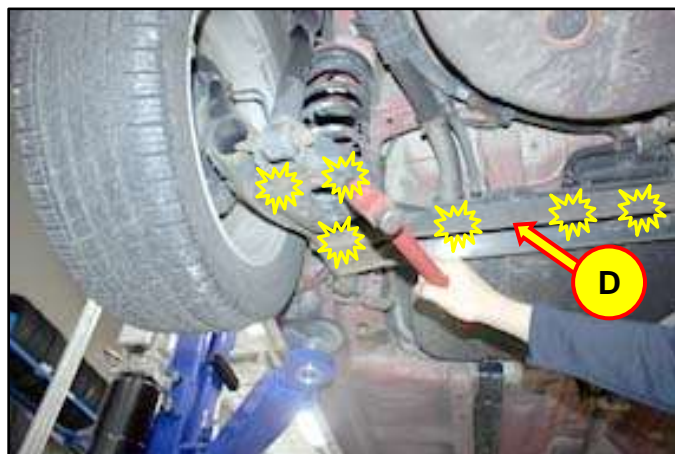
4. Remove the remaining debris by inserting an air nozzle into the locations shown, then blowing air in multiple directions.

- Left/Right Front Lower Control Arm

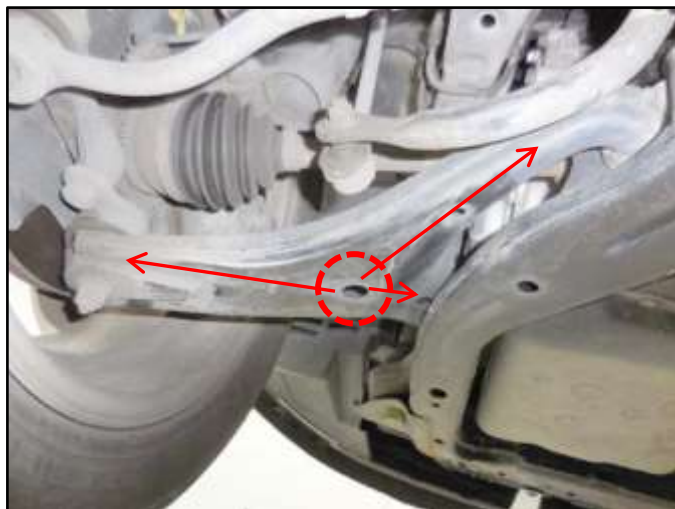
- Front Cross Member

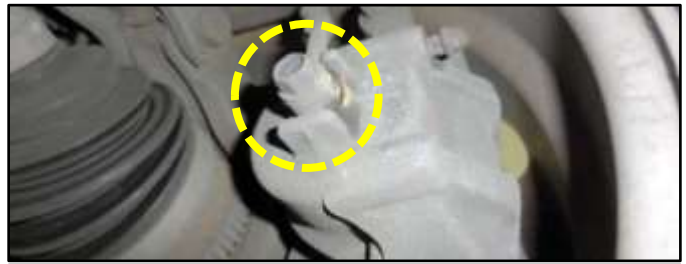
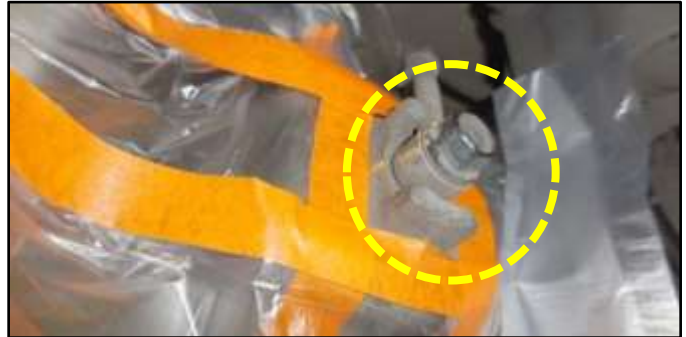
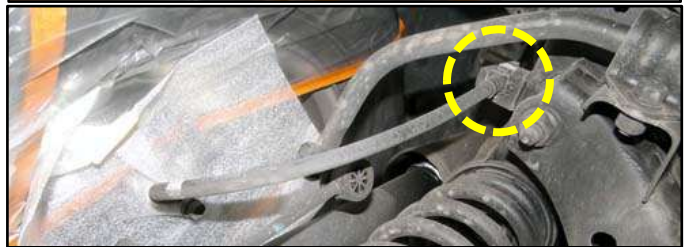
1. Clean the front and rear brake caliper banjo fittings surfaces and brake hose mounting brackets at all 4 calipers using a wire brush.

Then wrap the brake assemblies with plastic bags to protect them from overspray. Use tape to secure the plastic bags in place.

Leave the banjo fitting and brake hose bracket area exposed, as shown.

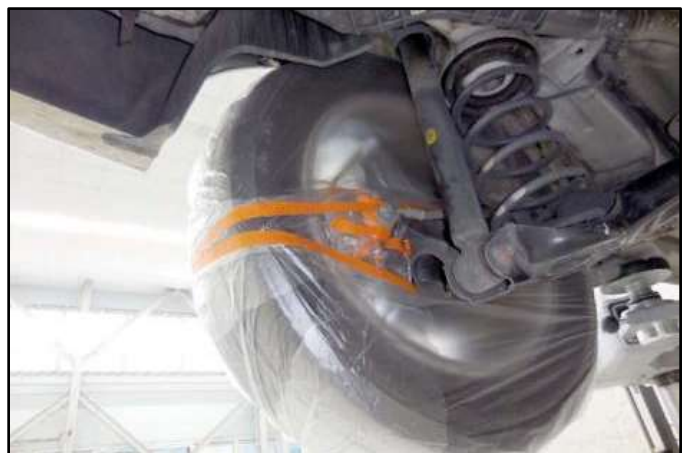
2. Wrap large plastic bags around the wheel/tire/brake assemblies to protect them from overspray. Use tape to secure the plastic bags in place.

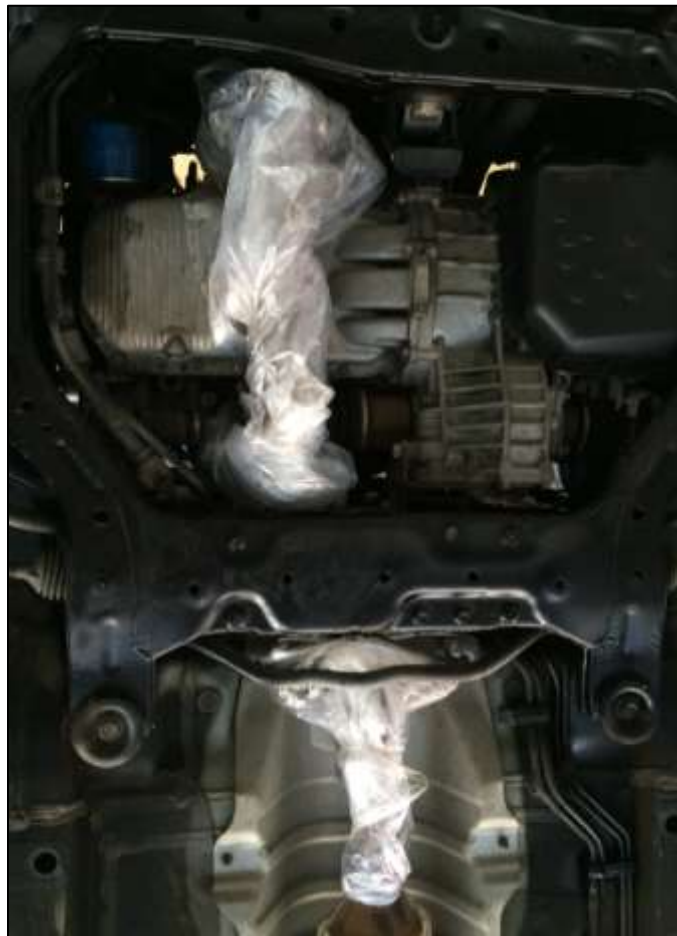
3. Wrap the exhaust areas adjacent to the Front Cross Member and Rear Beam Axle with plastic bags to protect them from overspray. Use tape to secure the plastic bags in place.

The exhaust must be sufficiently cooled before it is wrapped.

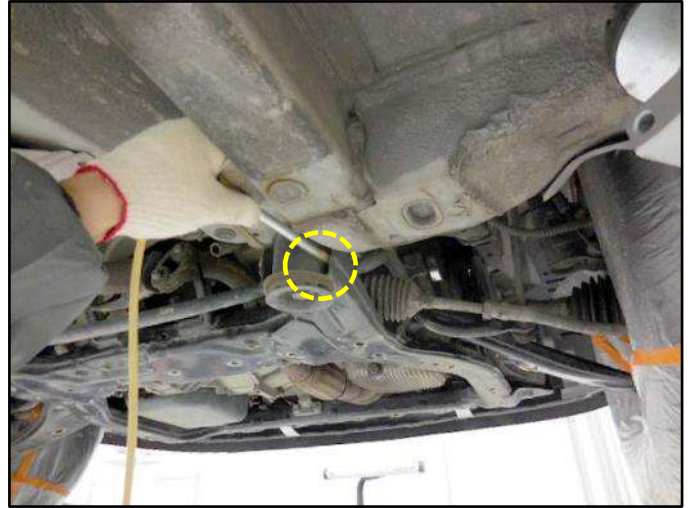
- Insert the nozzle through the opening in the rear of the Front Cross Member to spray the cavity wax.

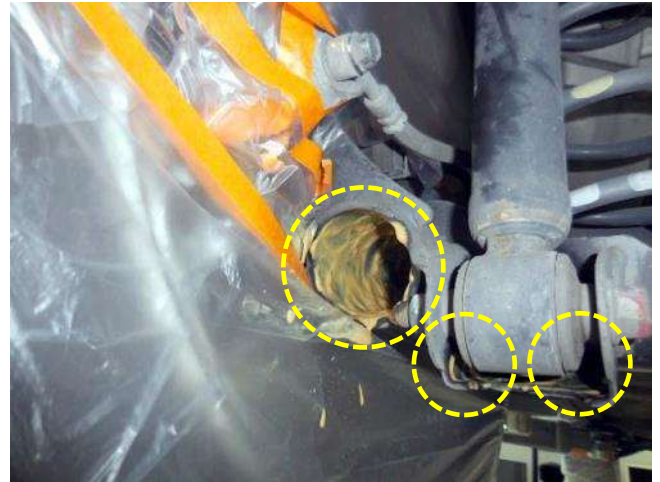
- 1c. - Inside the Rear Beam Axle

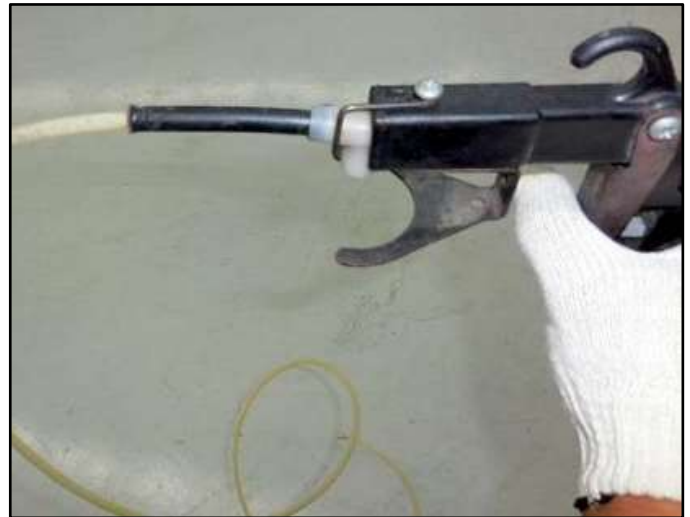
2. After applying the cavity wax, use an air nozzle to remove the remaining cavity wax in the nozzle.

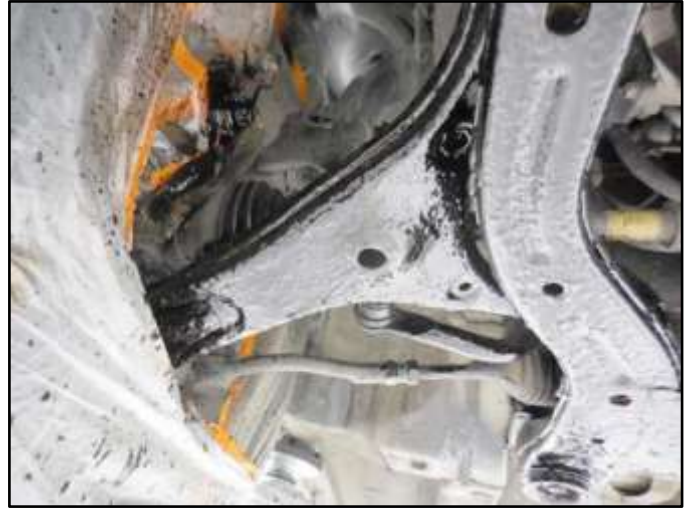
- 1c. - Left/Right Front Lower Arms

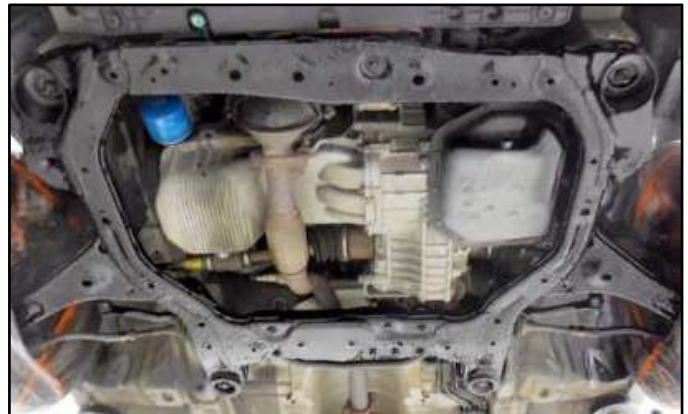
- 1d. - Front Cross Member

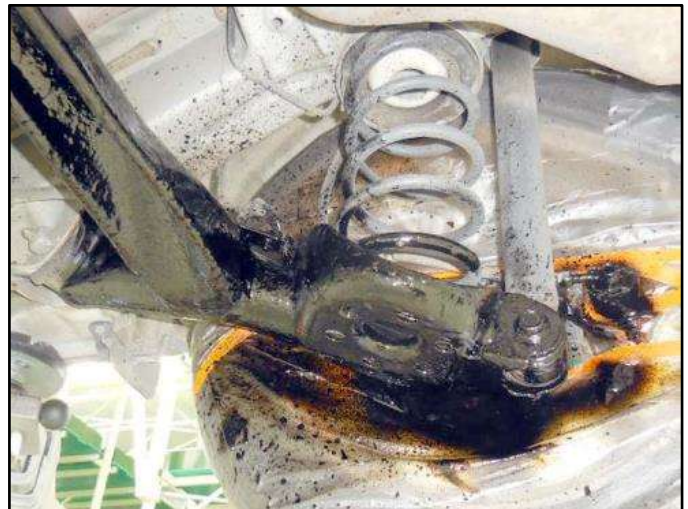
- 1e. - Rear Beam Axle
