EM16-007

## 2016-2017 Q50, 2017 Q60, AND 2017 QX30 WITH 2.0L TURBO ENGINE; CARTRIDGE-STYLE OIL FILTER

**APPLIED VEHICLES:**            2016-2017 Q50 (V37)  
                                          2017 Q60 (V37)  
                                          2017 QX30 (H15)

**APPLIED ENGINE:**            2.0L Turbo

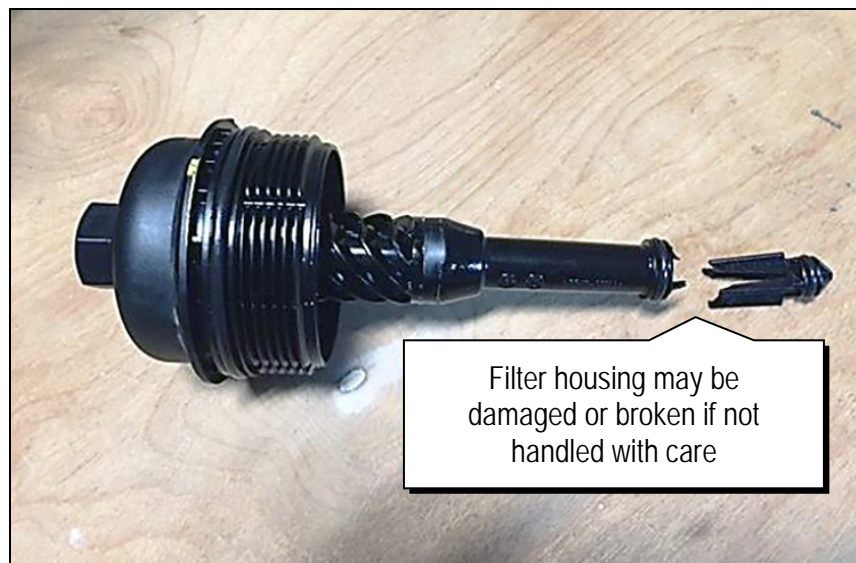
- The Applied Vehicles are equipped with a cartridge-style oil filter.
- The filter may be difficult to remove. If this should occur, pull the filter straight off with no bending (if the filter rotates with the housing).
- The filter housing may be damaged or broken if not handled with care.
- If the filter housing is damaged or broken, it must be replaced.

- If the tip of the filter housing breaks off inside the front cover of the engine, use needle-nose pliers to remove the piece(s) to prevent debris from entering the oil passages when the engine is started.
- If a replacement filter housing is needed, make sure to lubricate the o-rings and neck of the filter housing prior to installation.
