PREVOST

WARRANTY BULLETIN

WB16-02B

DATE :	MAY 2016	SECTION :	06 - Electrical
EXPIRATION:	MAY 2018		
SUBJECT :	CHARGING SYSTEM IMPROVEMENT

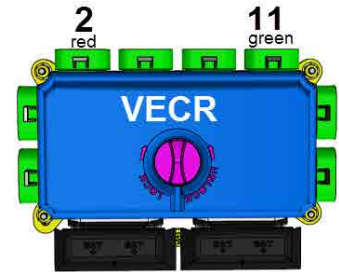
FIGURE 10 : VECR

1. Inside rear electrical compartment (rear junction box), locate VECR module (FIGURE 10).

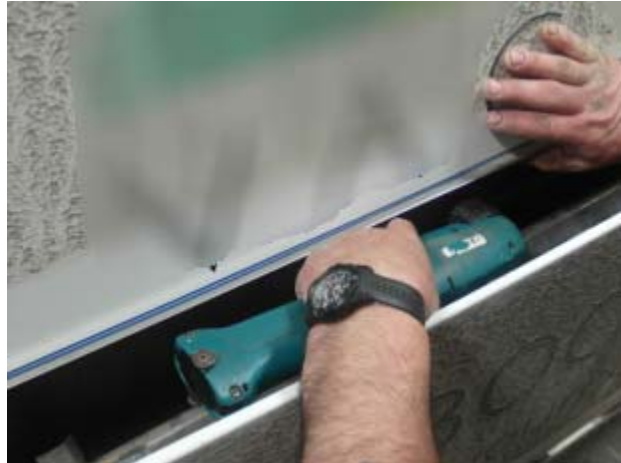
Drill using a 9/64 bit. FIGURE 34 shows how to drill holes with the access hatch in place using a right angle drill.

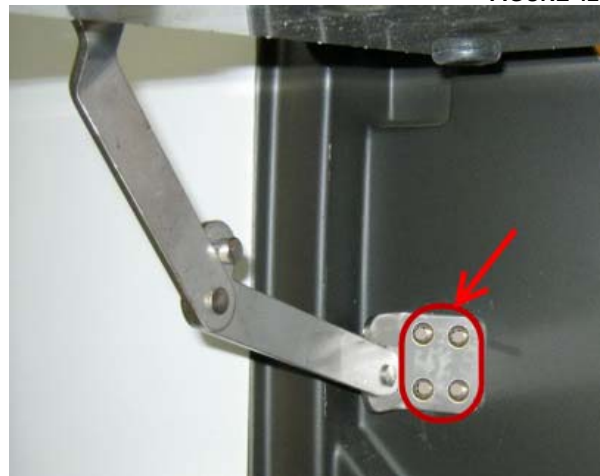
- a) To do so, drill through the folding arm rivets (4 rivets) shown on FIGURE 43
- b) Disconnect the “high mounted stop lights” cable harness.
- c) Unscrew the hinges mounting bolts (2 bolts per hinge). Spacers may be found behind the hinges. Make sure you identify the spacers in order to reinstall the access hatch using the proper spacer at the correct location (FIGURE 44).

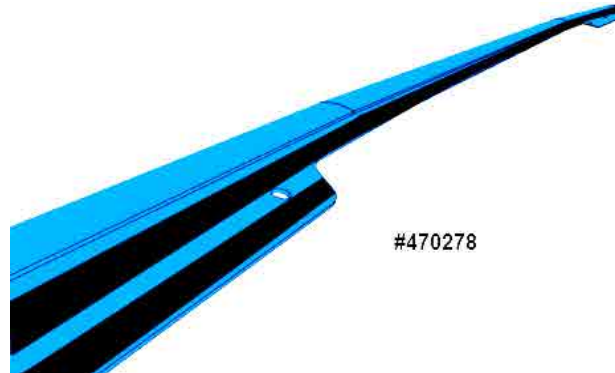
FIGURE 45

6. Apply two strips of double face self-adhesive tape, one to each side of the drilled holes (except in the middle where only one strip can be applied) along drip edge #470278 as shown on FIGURE 45.

IMPORTANT NOTE: The foam tape must be stuck on the drip edges. **The drip edges must not be stuck on the vehicle body.**

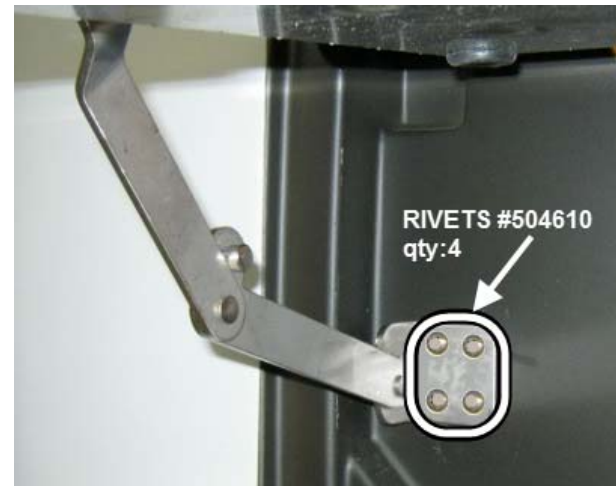
17. Reinstall the folding arm. Secure the folding arm as shown on FIGURE 54 using four 1/4" x 5/8 stainless steel rivets #504610.

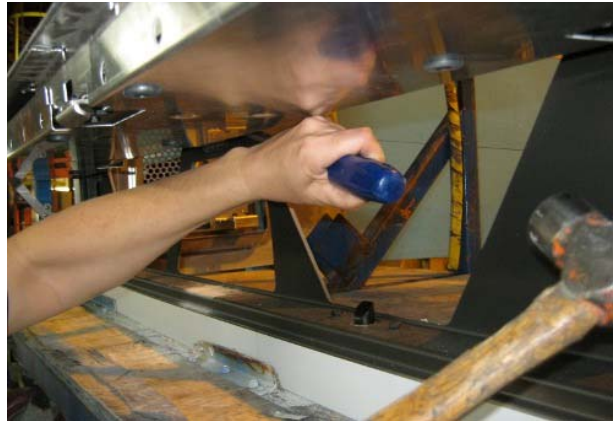
FIGURE 56

19. Check the upper part of the access hatch for rubbings against the rivets when opening and closing the hatch. If this is the case, the hatch has to be moved downward.
20. Loosen the hinge mounting bolts (4 bolts) slightly.
21. Use a screwdriver and hammer, tap slightly on the hinges to move the door for proper fit (FIGURE 56).
