Service Information

Number: ATE-16-03

**Subject: T10542/2 – Threaded Stud from High Voltage
Adapter Set – **Special Notice****

Date: March 1, 2016

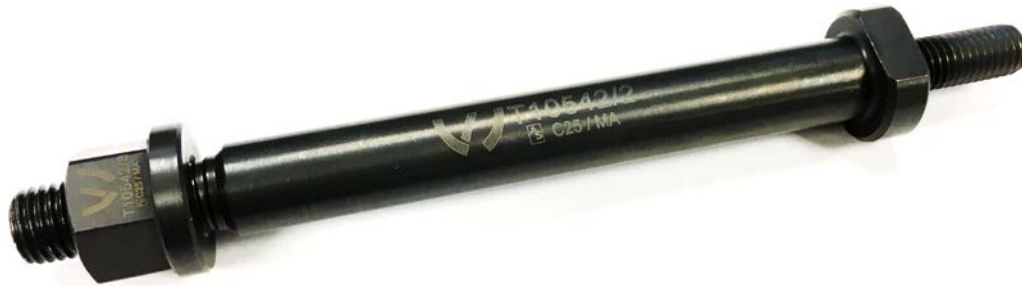
The T10542/2 Threaded Studs included in the T10542 adapter set sold by Matra do not meet the specified design. There are two T10542/2 Threaded Studs in each T10542 Adapter set.

We would like to explicitly state that using the non-replaced version entails a risk of injury that may lead to bodily harm. For this reason, the affected T10542/2 Threaded Studs may not be used under any circumstances!

The procedure for High-Voltage Battery, Lifting in ElsaPro has been updated to no longer require the use of T10542/2 – Threaded Studs and T10542/3 - Nuts from the T10542 – High-Voltage Adapter Set. These two components of T10542 need to be disposed of immediately.

There has been a change to the items supplied with kit T10542 due to a modified repair procedure for removing and installing the High-Voltage battery in the Audi A3 e-tron®. The T10542-ERG Kit updates the T10542 to the T10542A level. Follow the updated procedure in ElsaPro for proper usage of the T10542A Tool Kit.
