# TECHNICAL SERVICE BULLETIN

TSB#: 16-013

Inspect the battery disconnect switch to confirm it is working properly.  
Correct wiring to battery disconnect switch when required.

2016 Eagle Fifth Wheels

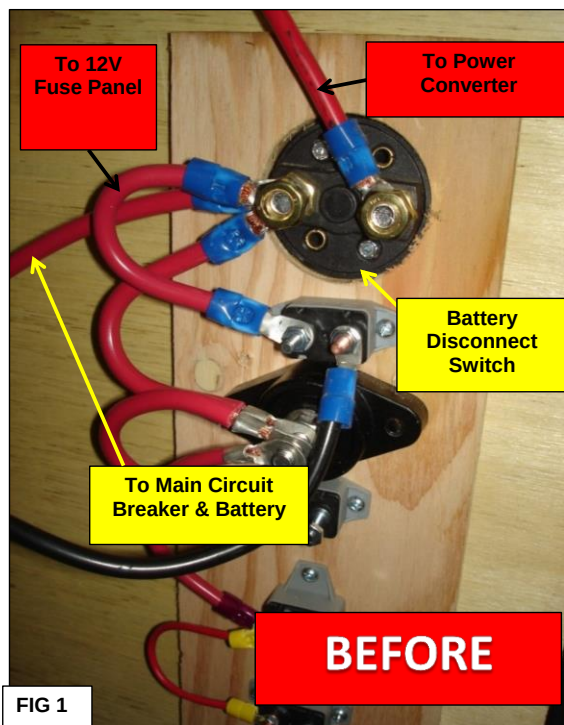
If the light **stays ON**, proceed to correct the wiring of the switch.

- Fig 1:** Remove nuts from the terminals of the battery disconnect switch and wire for the Power Converter and wire for the 12V Fuse Panel.
- Fig 2:** Reverse the Power Converter wire and the 12V Fuse Panel wire on the battery disconnect switch - tighten with nuts.

Jayco has determined that certain Model Year 2016 Eagle Fifth Wheels require inspection of the battery disconnect switch to ensure it is working properly. If not, the power converter wire and the 12V fuse panel wire on the switch are reversed and must be corrected.

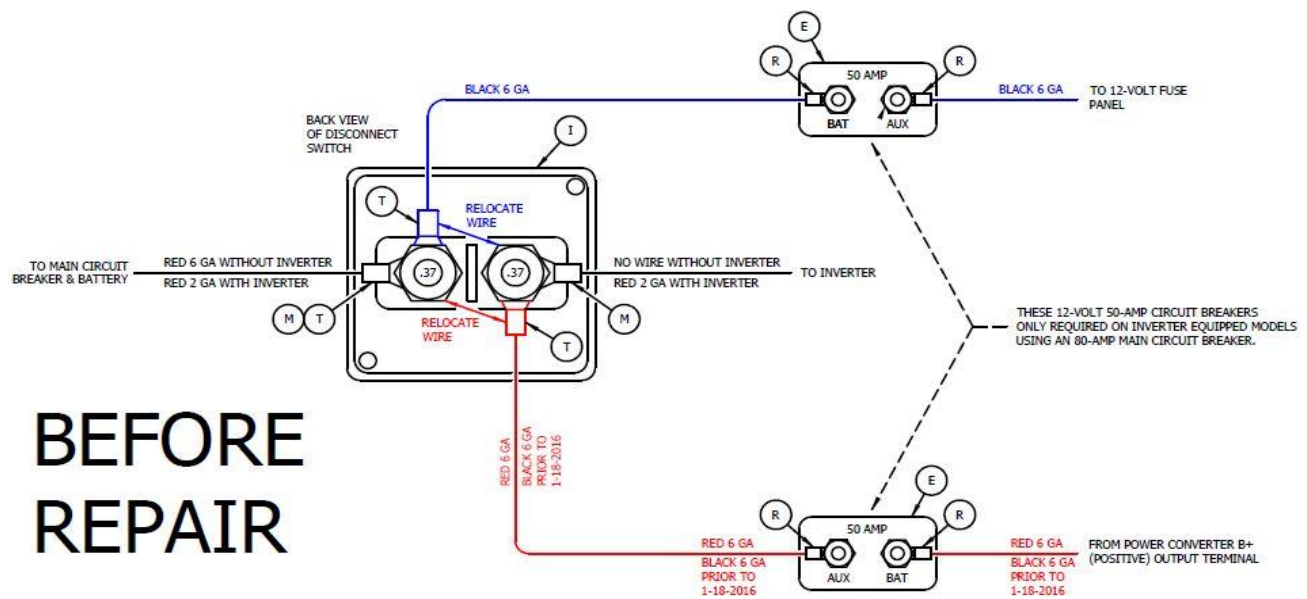
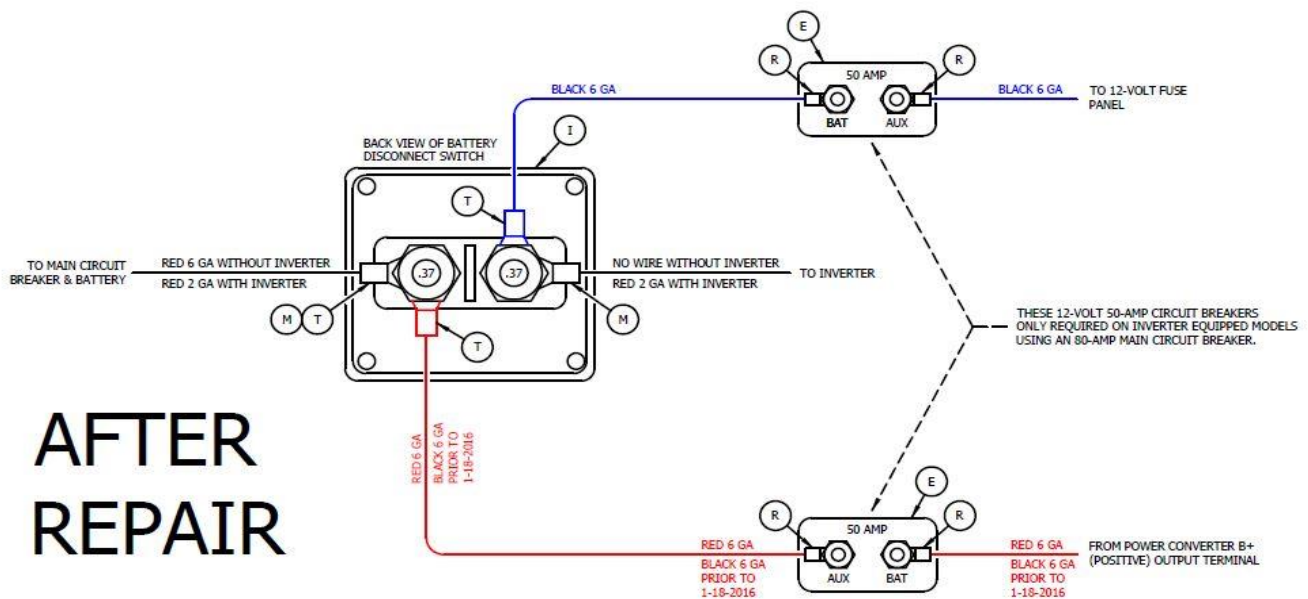
(Refer to the schematics on Page 2)
