# Customer Satisfaction Program

## 16056 Missing USB Port

Reference Number: N16205788

<b>Condition</b>	Certain 2016 model year Chevrolet Express and GMC Savana vehicles ordered with a base radio with optional USB port (RPO U0H), may have been built without the port installed.
<b>Correction</b>	Replace Monroney label on stock vehicles with corrected label. Customer option to install the USB outlet assembly, or receive a \$100 USD/\$135 CDN reimbursement.

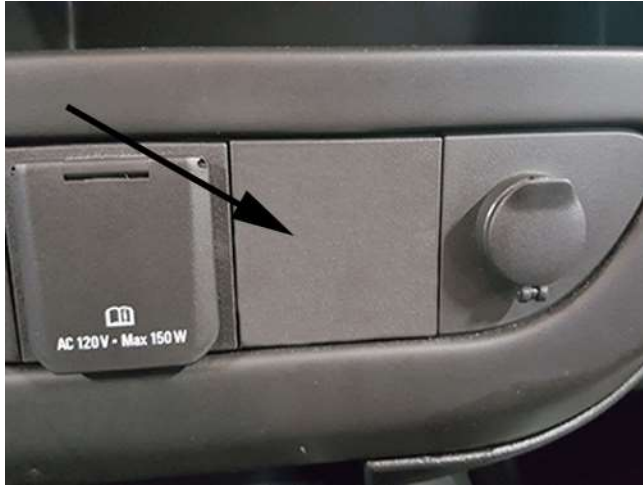
4602245

1. Remove the trim plate.

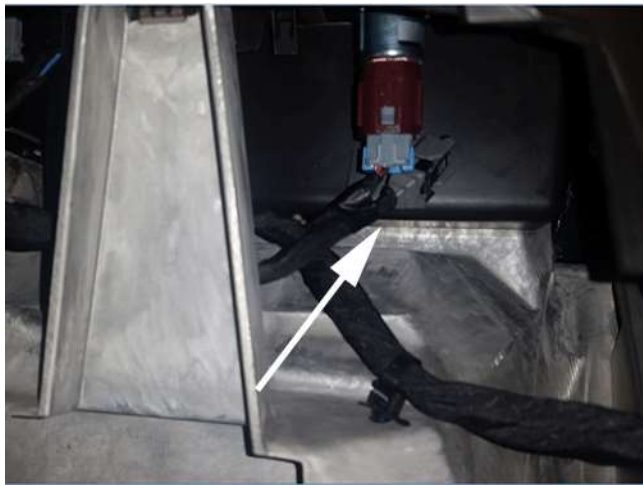
4602248

2. Remove the USB harness from the power outlet receptacle harness.

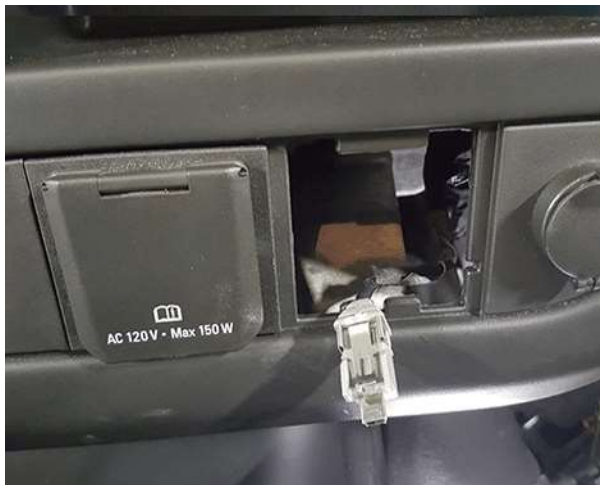
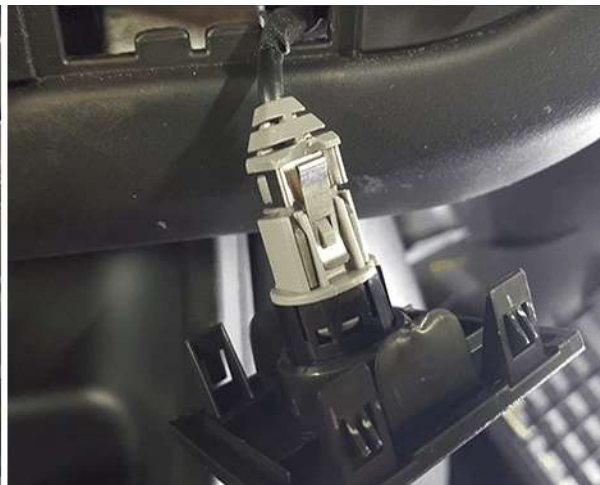
4602254

3. Connect the USB harness to the USB receptacle.

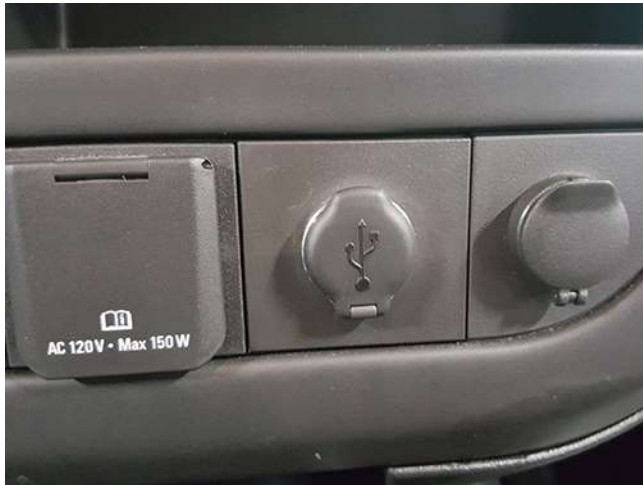
4602257

4. Install the USB receptacle to the instrument panel.
