Technical Bulletin

64 16 02 October 13, 2016 **2040673** Supersedes Technical Bulletin V641502 dated November 9, 2015 to include model year 2017 Beetle, Beetle Convertible and CC applicability.

Door(s) May be Difficult to Open or Close from the Outside in Freezing Temperatures

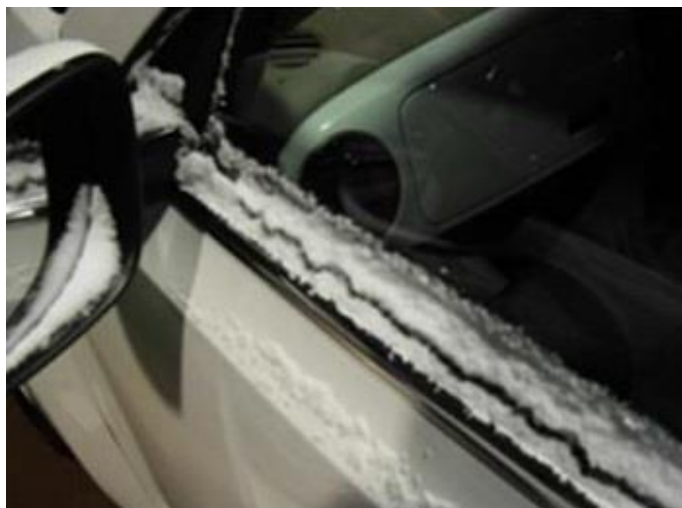
Figure 1

During high humidity/snow conditions with outside temperatures below freezing (below 32°F/0°C) the outer window slot seal can freeze to the door window glass (figure 1). This prevents proper operation of the door window “short drop” function which may cause the door to be difficult to open/close.

Replacement of the window slot seal will not resolve the concern. Follow the steps outlined below to apply a lubricant and hydrophobic coating to help prevent the seal from freezing to the window glass.

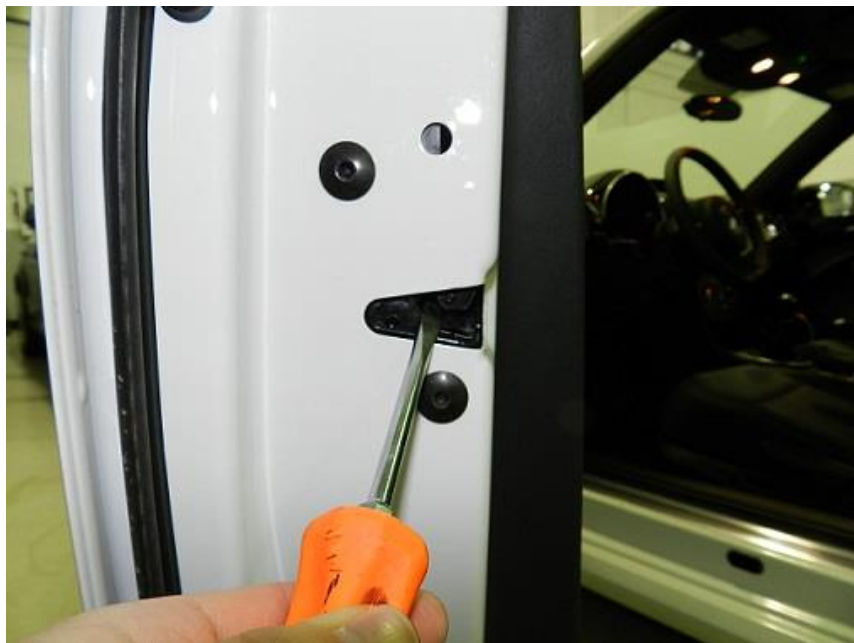
Figure 4 (Manually close the catch in the door latch)

- With the door open and the window in the closed position, deactivate the short drop function of the window by manually closing the catch in the door latch (figure 4).

The short drop function must be deactivated to completely coat the window with the sealant.

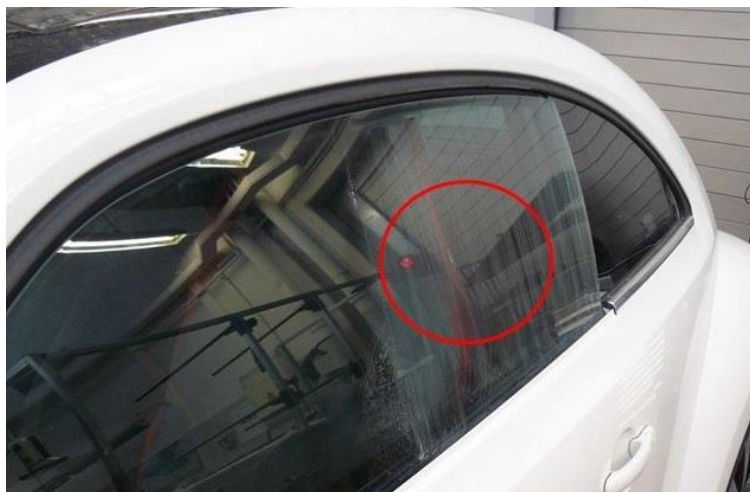
Figure 5 (sufficient treatment of the window with cleaning cloth)

- Thoroughly rub the outside of the window with the cleaning cloth that is included in the sealant kit (part number D 096 330 A2) (figure 5).

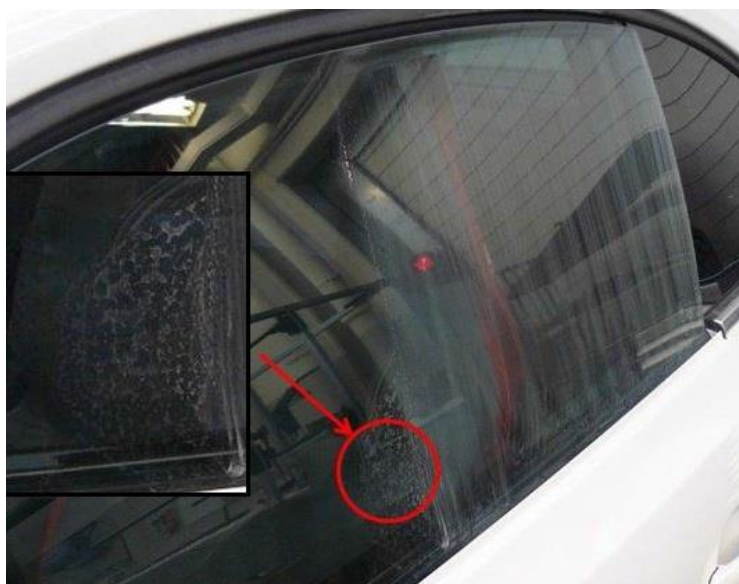
The red circle in figure 6 illustrates an insufficient treatment of the window with the cleaning cloth.

Figure 6 (insufficient treatment of window with cleaning cloth)
