Tech Tips

TT 92-14-04

2015 A7 Golf-Rear Washer Jet Leaks - Drips After Use

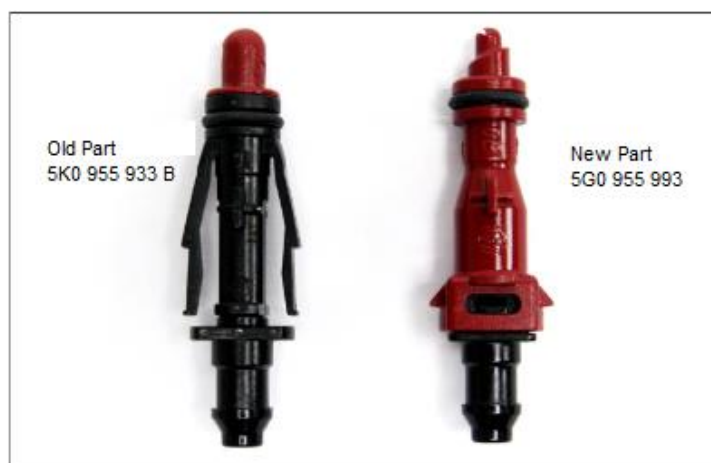
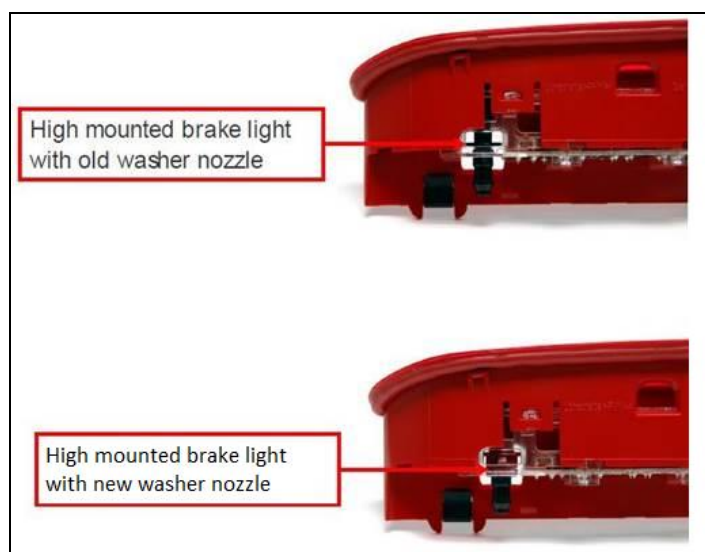
For the A7 Golf with a rear washer nozzle leaking after use (Installed in the high mount brake lamp housing). An updated washer nozzle is now available. Replace with 5G0-955-993 or the latest ETKA supersession for this part number available.
