53 16 02 June 8, 2016 **2040536** Supersedes Technical Bulletin V531601 dated February 1, 2016 to update Claim Processing statement.

Rear Quarter Panel Corrosion (U.S. Only)

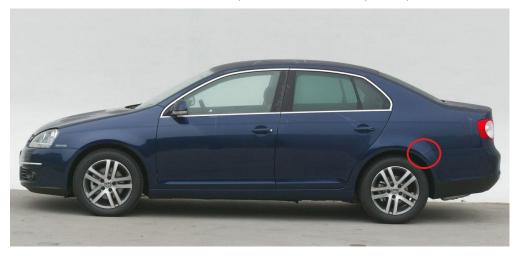
Figure 1

Corrosion is found where the rear bumper cover meets the quarter panel.

1a. Repair rear quarter panel.

1b. Replace rear quarter panel (Only if through-corrosion is present or if the repair cost is 80% or more of the replacement cost).

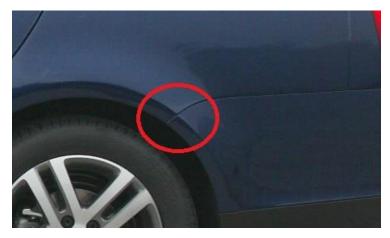
Figure 2

A Speed nut is used to assemble the rear bumper cover to the rear quarter panel. Relative movement between this metal speed nut and the quarter panel scratches away the paint and/or the corrosion protection (Figure 2).

- 2. Replace the speed nut (N 906 988 03) on the bumper cover (both sides).
- 3. Apply the paint protection film (AKL 448 300 04) to the contact area of the quarter panel as shown in Figure 3 (both sides).
