Service Information Bulletin

SUBJECT	DATE
SPN 2791 (MCM) (GHG14) and SPN 2791 (MCM) (GHG17)	March 2016

2 SPN 2791/FMI 11 - GHG14

Smart Remote Actuator 3 (EGR), Common Error

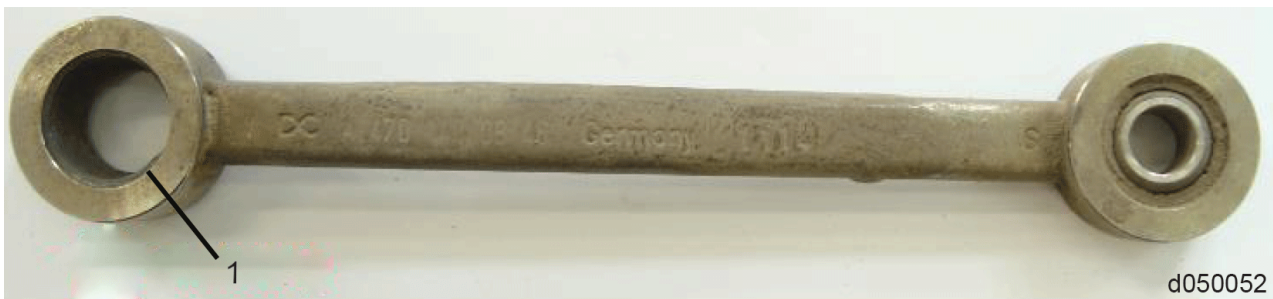
10. Check the Motor Control Module (MCM) software level. Is the MCM software level 4.7.0.00 ZGS 002 or higher?
 - a. Yes; Go to step 11.
 - b. No; update the MCM software using the latest server information. Perform the repair verification. If the fault returns, Go to step 11.
11. Turn the ignition off.
12. Disconnect and inspect the pull rod from the EGR actuator and the EGR valve. Are the bearings or inserts (1) in the pull rod missing ?

- a. Yes; replace the pull rod. Verify repair.
 - b. No; Go to step 13.
13. Rotate the bearings in the pull rod in the normal direction of movement when installed. Do the bearings move?
