**TECHNICAL INSTRUCTIONS
FOR
LIMITED SERVICE CAMPAIGN CLB
EXHAUST GAS CONTROL ACTUATOR REPLACEMENT
CERTAIN 2011 – 2012 MODEL YEAR CT200h**

UPDATED JULY 23, 2012

CLB Expired on May 31, 2015

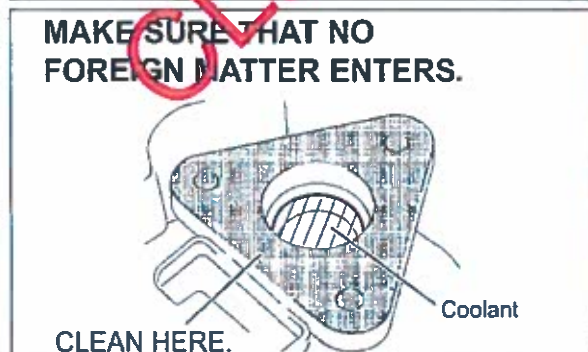
1. CLEAN THE AREA AROUND THE EXHAUST GAS CONTROL ACTUATOR SUB-ASSEMBLY

- a) Clean the area shaded in the illustration to prevent foreign material from entering the cooling system.

2. REMOVE THE EXHAUST GAS CONTROL ACTUATOR SUB-ASSEMBLY

- a) Remove the 5 bolts then the actuator and bypass pipe.

3. REMOVE THE HEAT INSULATOR

- a) If an old-style heat insulator is present, remove and discard this part.

4. CLEAN THE ACTUATOR CONTACT SURFACE

- a) Use a shop cloth to clean the contact surface.

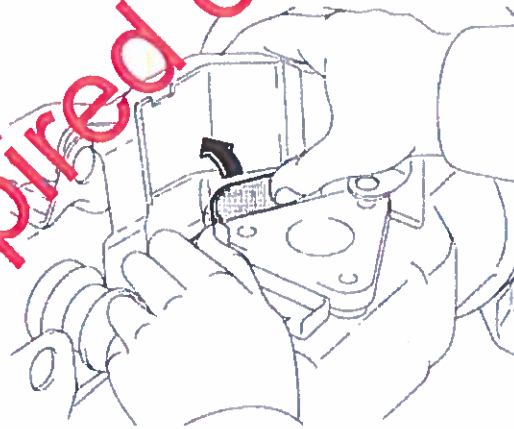
e) RETURN THE SMALL INSULATOR TO A POSITION IN WHICH IT WILL NOT CONTACT THE ACTUATOR.

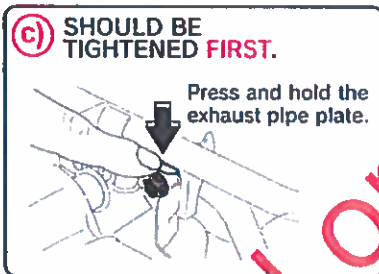
- Insert the **NEW** exhaust pipe plate between the bypass pipe bracket and exhaust bracket that is positioned towards the front of the vehicle.

Confirm the plate is installed in the correct direction, with the tab facing upward.

- Loosely install 2 **NEW** black bolts.

- While pressing down on the newly installed exhaust pipe plate tighten the bolt.
- While pressing down on the newly installed No.2 insulator tighten the bolt
Torque: 75in.lbf (8.5N·m)

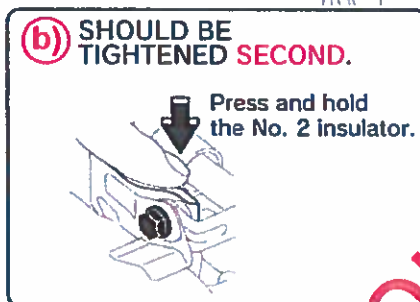
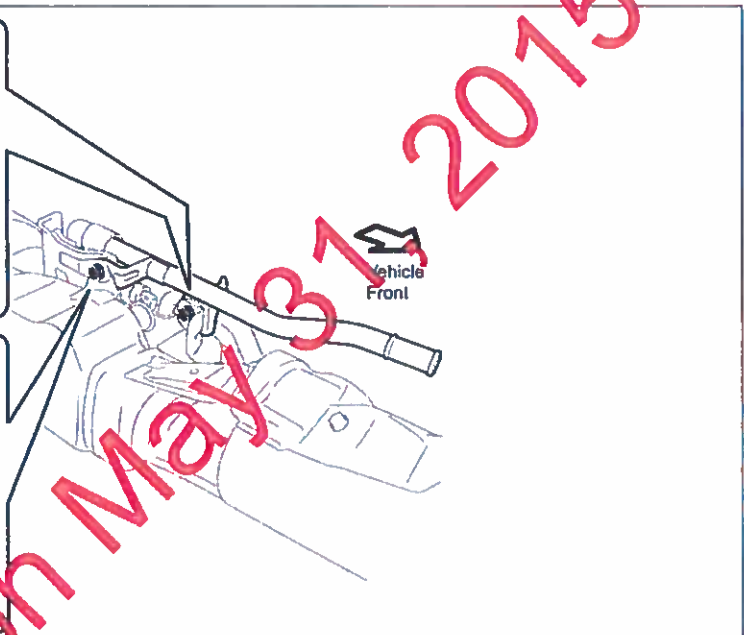
- **DO NOT** press down on the bypass pipe when tightening the bolts, this may cause a coolant leak.
- It is critical that step a) be performed before b), if these steps are completed in the incorrect order a coolant leak may develop.

a) While pressing down on the newly installed exhaust pipe plate tighten the bolt.

b) While pressing down on the newly installed No.2 insulator tighten the bolt.

Torque: 75in.lbf (8.5N·m)

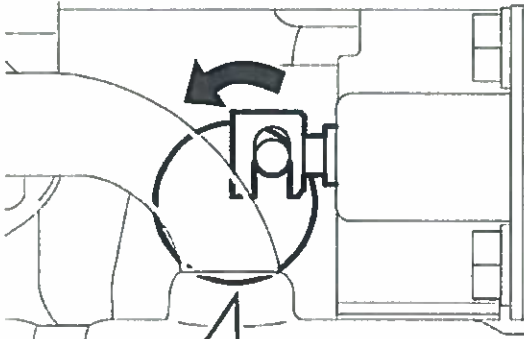
With cold engine:

- a) Place the vehicle in 'Inspection Mode' and warm the engine to normal operating temperature.
b) Confirm the hook of the actuator is fully extended.

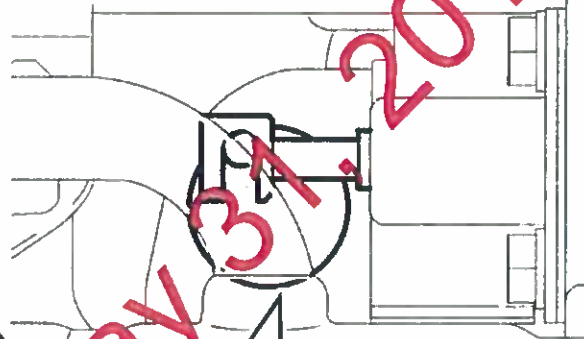
With warm engine:

CONFIRM THAT THE HOOK IS EXTENDED.
