Customer Satisfaction Program

45250 Shift Knob Not Fully Seated

Reference Number: N162045250
 GWM Number: 2045250

Release Date: July 2016
 Revision: 00

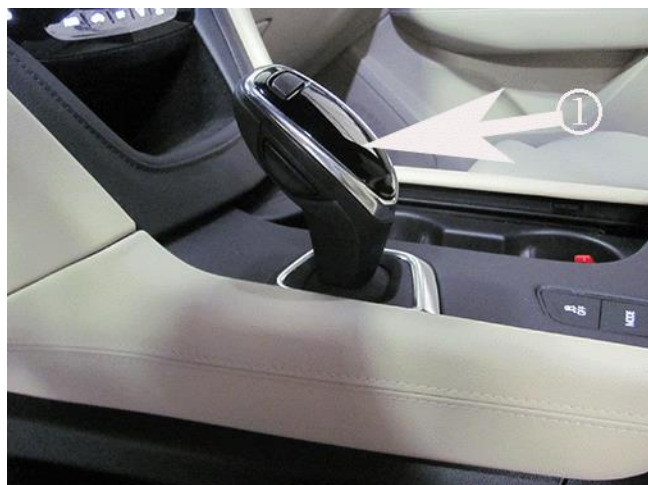
1. Press downward on the shifter knob assembly (1) firmly with both hands. An audible click may be heard if the shifter was not fully seated.

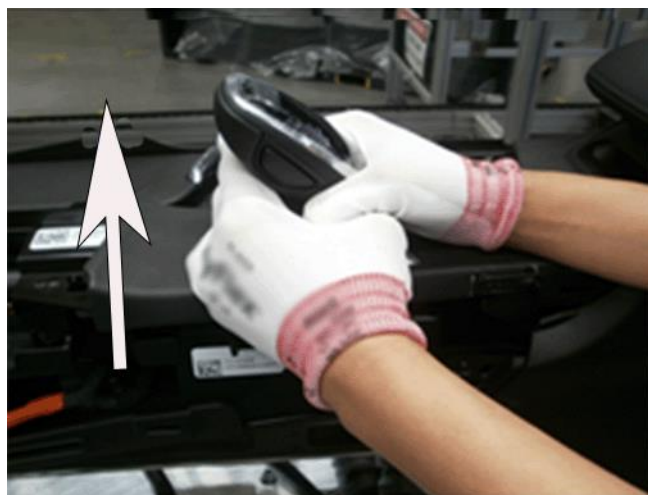
2. Cradle the shifter knob with both hands as shown. Pull straight up on the shifter to verify the shifter is fully seated.
3. Clear any related DTC's from the body control module (including, but not limited to: P07B4, P07BA, U156D P17A4, P17A8 and P17A9).
