## Cracking noise during throttle lift-off or engine lateral acceleration from engine compartment

| Topic number | LI09.10-P-063980 |
| Design group | 09.10 Air cleaner |
| Validity | Model series 213 with engine 274 up to production date 04/ 01/2016 |

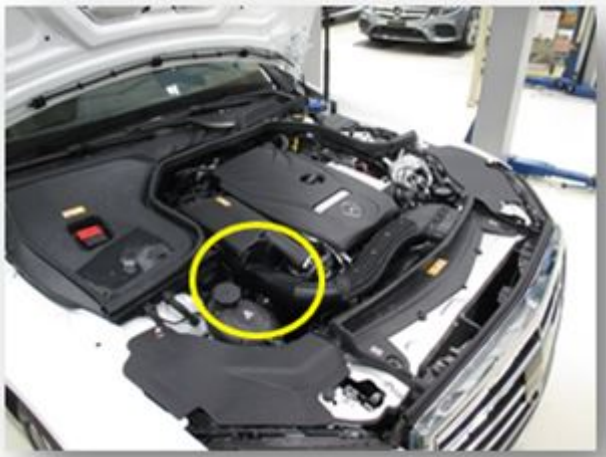
Bild\_01.JPG:

The engine air intake duct upstream of the air filter housing may slip in and out of its respective latching point on the air filter housing during a throttle lift-off or engine lateral acceleration. The engine air intake duct slipping in and out of its latching point, causes an audible cracking noise that can also be induced by fully turning the wheels to the left while driving, as during a full steering wheel turn to the left, the engine inclines to the right.

Remove engine air intake duct upstream of air filter and remove side catch tab from engine air intake duct using a suitable tool.
