## Rear seat belts roll up with difficulty

| Topic number | LI91.40-P-059554 |
| Design group | 91.40 Seat belts, emergency tensioning retractors |
| Validity | Model series 222 (With SA Code 223 and without SA Code 306) |

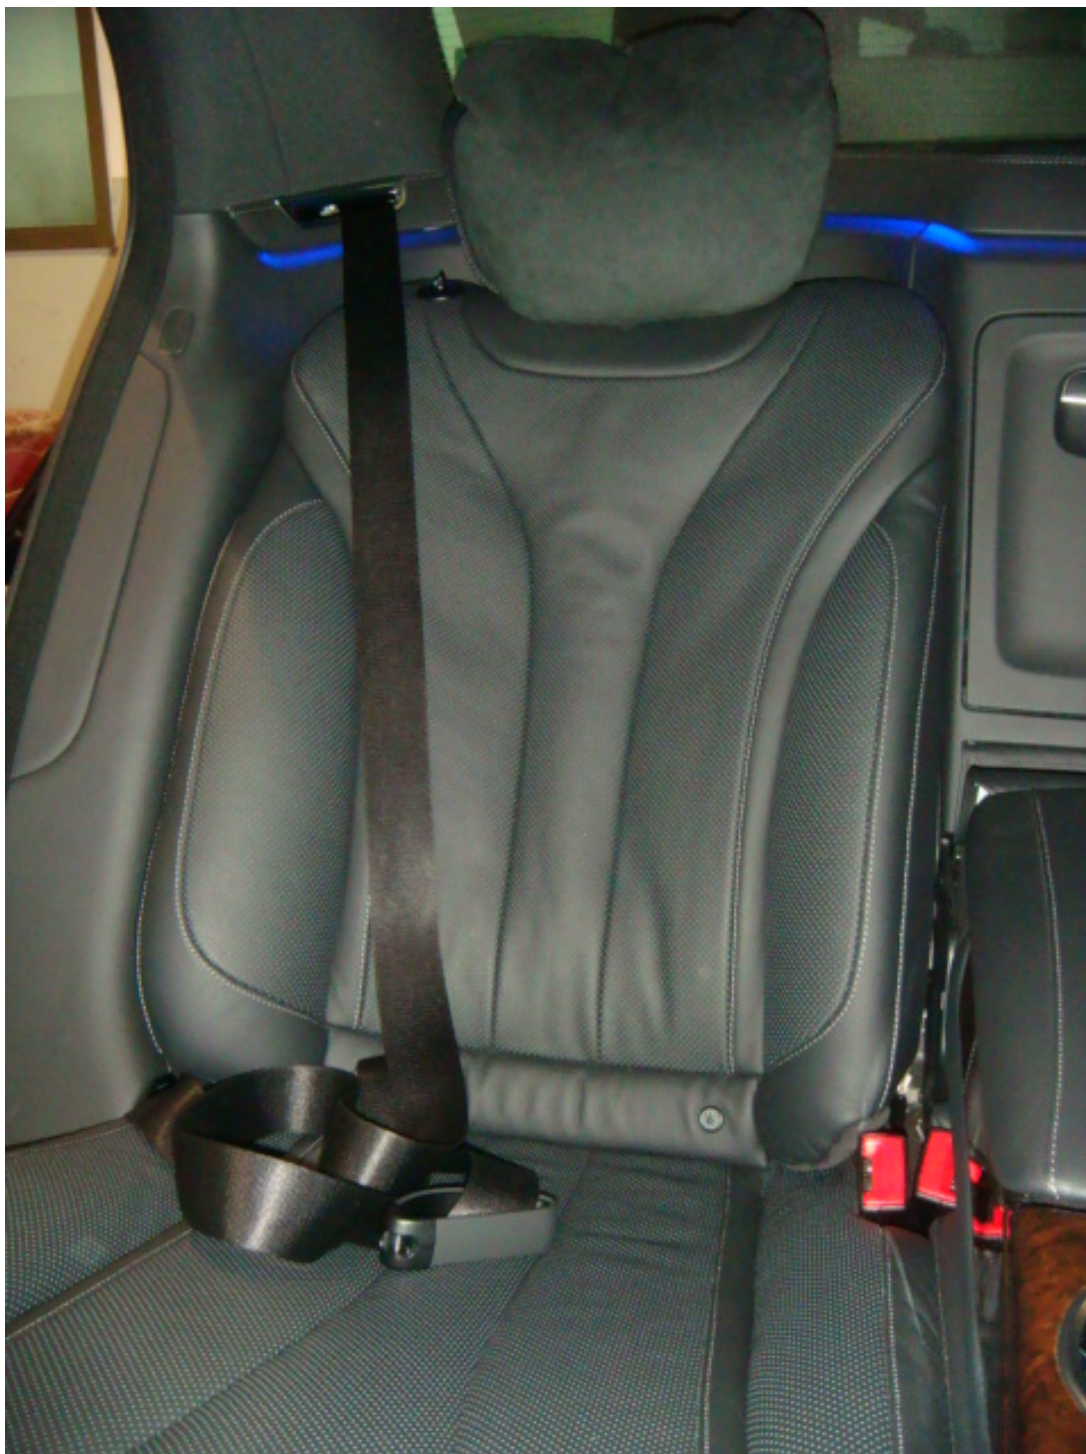
Photo\_1.JPG:

The left or right rear seat belt does not roll up correctly.

| Attachments | |
|---|---|
| Photo_1.JPG | Fault profile |

The seat belt is damaged, causing the retractor housing to collide with the reel flange causing increased friction. This obstructs the retraction of the belt.

In the event of complaints, the damaged rear seat belt (right or left) must be replaced.

Optimized rear seat belts will be available in series production in November/2015.

These are marked with a colored dot.
