## 2016 Legacy / Outback Stop Sale Information, WTD-65

This Service Procedure provides an inspection method for identification of affected vehicles and if determined necessary, additional steps for replacing the steering column assembly.

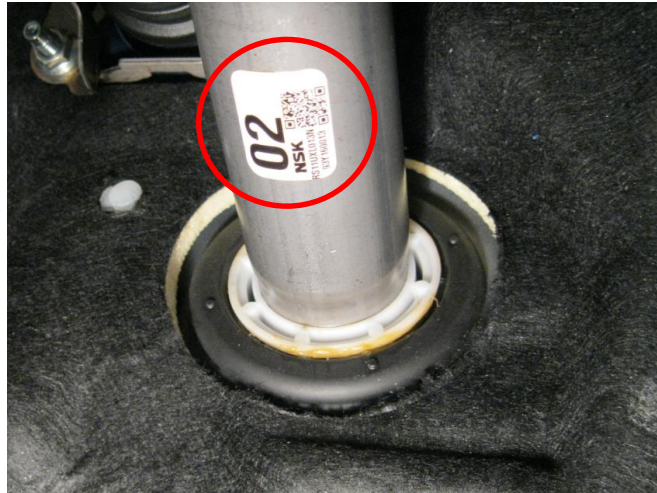
- Confirm the vehicle is within the provided VIN range.
- Locate the lot number label at the base of the steering column located just above the toe board grommet as shown in the photo below.
