SERVICE BULLETIN

APPLICABILITY: 2013-2016MY BRZ

NUMBER: 07-109-16

SUBJECT: Hard Starting

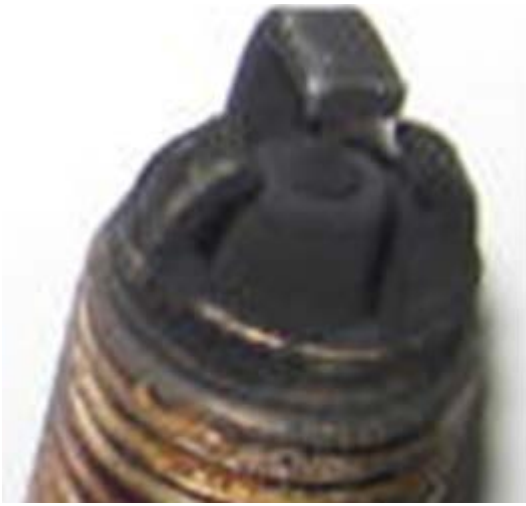
Before

This procedure should effectively “clean” the spark plugs and alleviate the hard start condition. “Before” and “After” photos of the spark plugs are shown below.

1. Crank the engine over for 30 seconds with the accelerator pedal fully depressed / wide open throttle (WOT). NOTE: The ECM shuts the injectors off when cranking the engine over at WOT. This will allow fresh air to pass through the engine and effectively “dry” the spark plugs.
2. Try to start the engine again as you would normally. When the engine starts, allow it to come up to operating temperature (cooling fan cycles).
3. Raise the engine RPM to 4500 and hold it at a steady 4500 RPM for 25 seconds.
4. Allow the engine to return to idle.
5. Repeat steps 3 and 4 four (4) more times.
6. When complete, allow the engine to cool down by idling for 30 seconds.
7. Repeat steps 3 through 6 two (2) more times to complete the procedure.
