Paint Stains Under Rapgard

Service Category Vehicle Exterior

Section Paint/Coatings

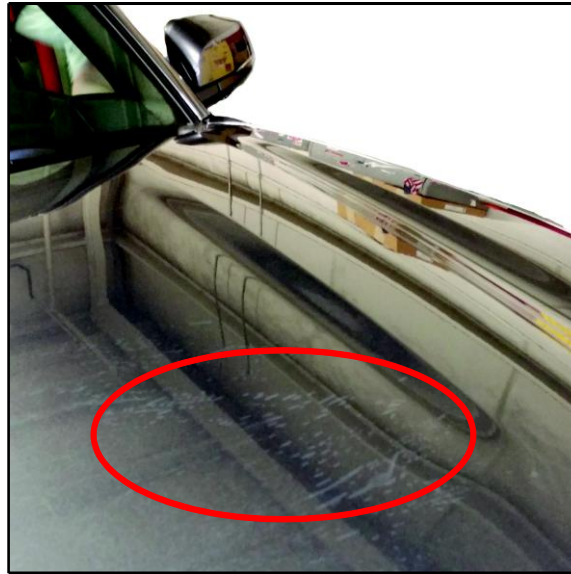
Figure 1.

On some vehicles, when Rapgard™ is removed, the paint may have a stained appearance. These stains appear to be under the clear coat (repainting this area is not necessary). The stain patterns are usually under wrinkles in the Rapgard™. These wrinkles sometimes trap water and cause the paint to stain from the trapped moisture, especially on horizontal surfaces, such as the hood, roof, and trunk. Stains can be removed by heating the stained surface to remove the trapped moisture.

1. Use the aluminum foil or damp cloth to cover plastic/rubber parts that are near the stain.
2. Apply heat to the stain using an infrared lamp or heat gun.

Apply heat for 5 – 10 minutes at 158°F – 176°F (70°C – 80°C). Do NOT allow the surface to become hotter than 176°F (80°C). Measure the temperature with a thermometer.

3. After applying heat for 5 minutes, examine the area to determine if the stain has been removed. If the stain still exists, continue to apply heat and re-examine the stain 5 minutes later.
