SI B11 20 16
I3 REX - W20 ENGINE OIL SERVICE PROCEDURE Technical Service

i01 (i3 REX)

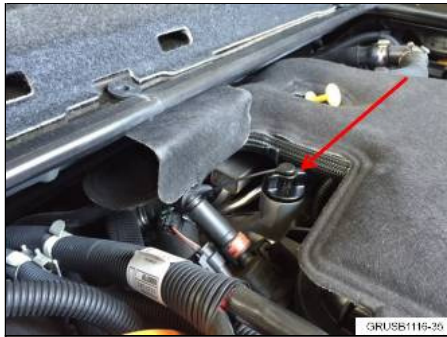
<p>GRUSB1116-23</p>	<p>The service flap of the engine sound insulation covers the oil filler neck and the filler cap.</p> <p>It may interfere with the oil refilling process, causing oil spills.</p>
<p>GRUSB1116-24</p>	<p>It is recommended that prior to removal of the oil cap, the service flap be folded behind the edge of the engine compartment (as shown on the picture) to provide unobstructed access to the oil filler neck.</p>
	<p>After oil service is completed, install the tethered oil filler cap and bring the service flap back to its original flat position.</p>
