SI B51 34 16
Body Equipment

RAISING OF WIND DEFLECTOR AT A HIGH SPEED

F33 (428i Convertible)	F33 (428i xDrive Convertible)	F83 (M4 Convertible)
------------------------	-------------------------------	----------------------

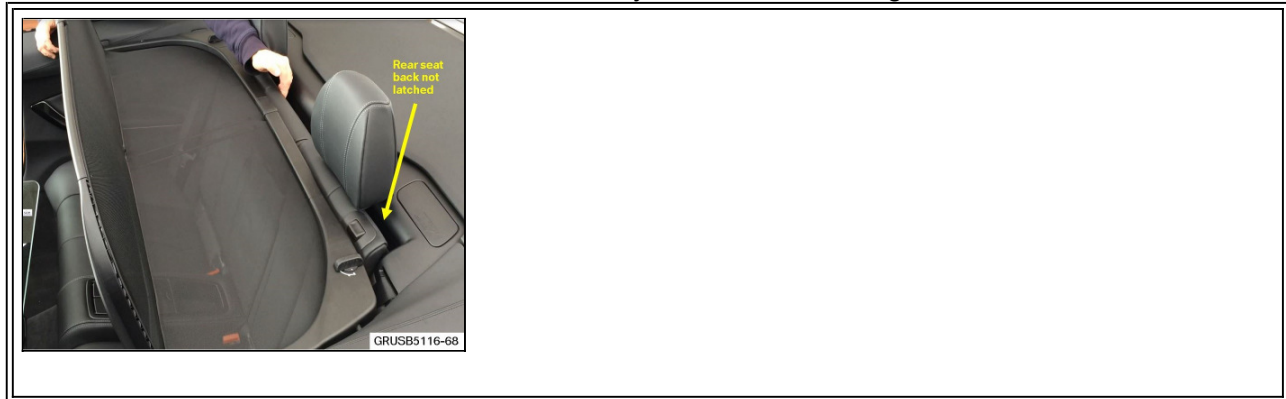
Unintentional lifting of the wind deflector occurs at a high speed and it is perceived that it may possibly detach.

Rear seat backrest not locked. This is not visually detectable at first glance.

Make the customer aware of the proper rear seat engagement.

Demonstrate to the customer how to properly latch the rear seat mechanism.

Inform them that this latch must be fully engaged to prevent the wind deflector from raising up while driving.

Explain that the wind deflector is firmly anchored by the front bolt therefore there is no danger of loss of the wind deflector at speed.
