INCORRECT TIRE AND LOADING INFORMATION LABEL

F15 (X5 xDrive35i)

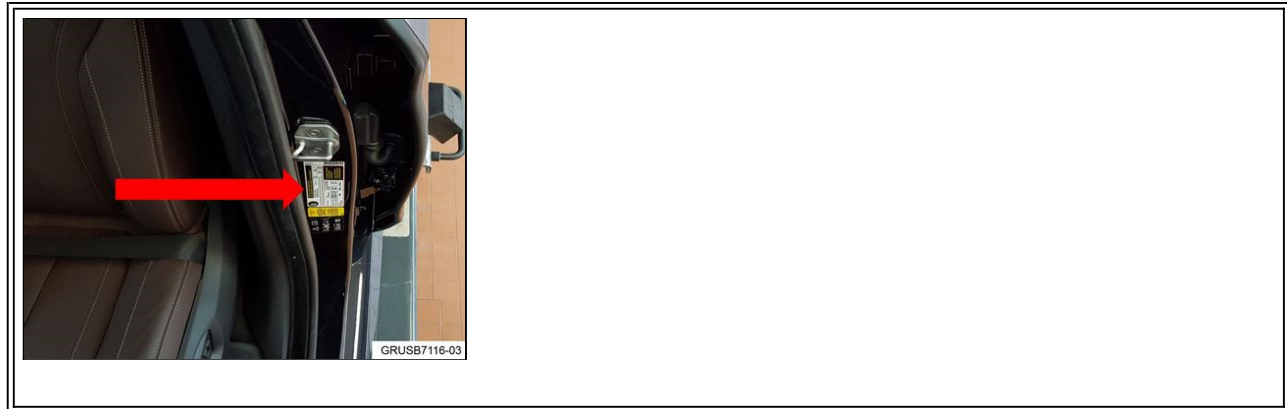
Open the driver's door and locate the white Tire and Loading Information label on the B-pillar that is shown below.

The correct Tire and Loading Information label will have the “Cold Tire Pressure” specifications listed below:

TIRE / PNEU	SIZE DIMENSIONS	COLD TIRE PRESSURE PRESSION DES PNEUS A FROID
FRONT / AVANT	###/## R ## (TR)	240 KPA, 35 PSI
REAR / ARRIERE	###/## R ## (TR)	290 KPA, 43 PSI
SPARE DE SECOURS	NONE	NONE KPA, NONE PSI

If necessary, install the correct Tire and Loading Information label on the vehicle:

- Wipe and clean the existing label with a clean dry cloth.
- Fold back a corner of the sheet containing the new label and peel off the label.
- Carefully place the new label directly over the existing label and press firmly into place.
