SI B66 15 16 Distance Systems, Cruise Control, Remote Control July 2016 Technical Service

### THE SMART OPENING/CLOSING TAILGATE FUNCTION IS INOPERATIVE.

F48 (X1) Vehicles with option code 322 (comfort access) Vehicles produced to July 6, 2016

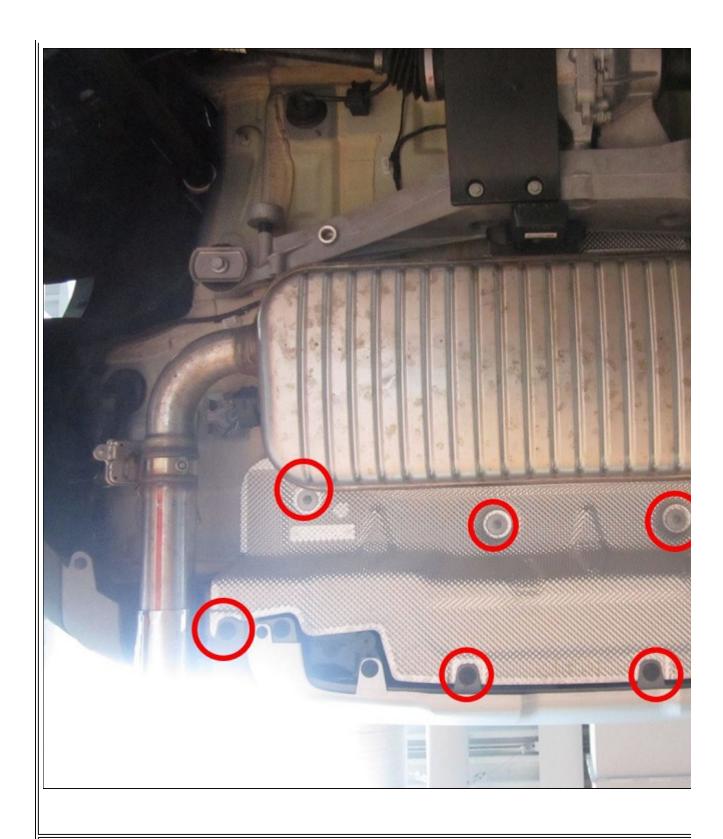
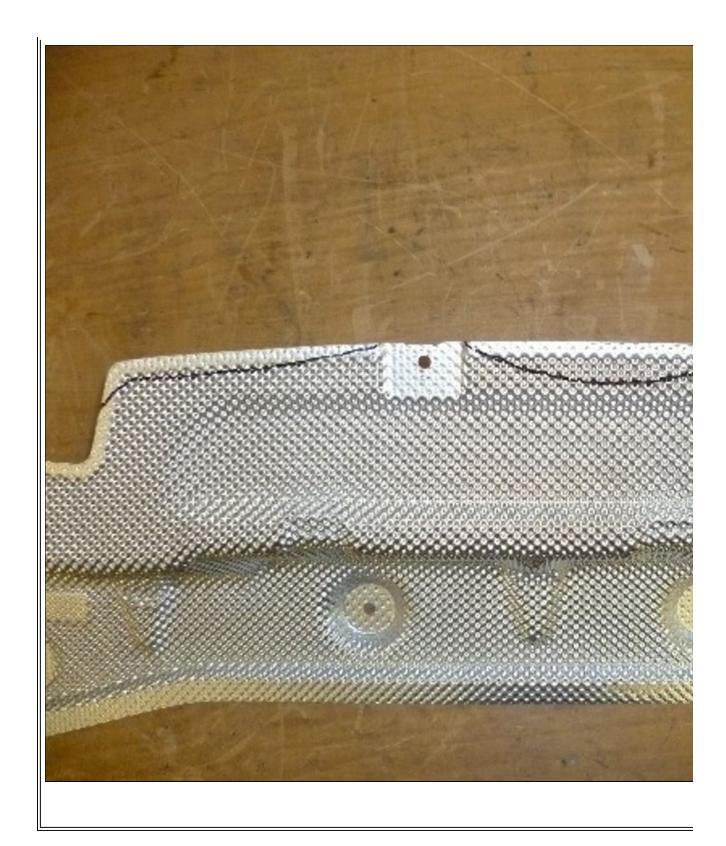
Vehicles with comfort access and **without** rear trailer tow hitch; the contactless tailgate smart opening/closing function using foot motion is INOPERATIVE.

The heat insulation on the rear bumper partially blocks the top and/or bottom sensor signal, which prevents foot movement detection

# Remove the heat insulation shield and cut the areas as shown in the picture below. **PROCEDURE**
