SI B64 02 16
Heating and Air Conditioning

Humming/Buzzing Noise from Passenger Side Dashboard

F15 PHEV (X5 xDrive40e)

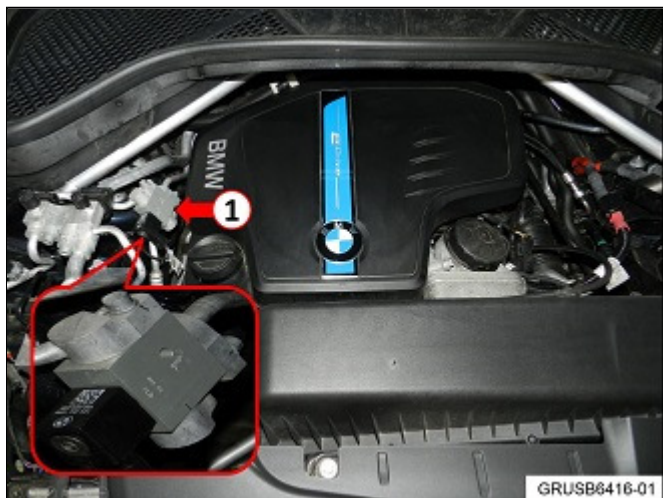
<ol style="list-style-type: none">1. Verify the noise is coming from the A/C shut off valve which is located on the passenger side of the engine compartment near the right front strut tower (1).
---	--

2. Replace the A/C shutoff valve as per REP “64 51 750 - Replace refrigerant shutoff valve for vehicle interior” and verify repair.

Note: The 3 “O” rings for the A/C lines that connect to the shutoff valve will also need to be replaced.
