### N51, N52, N52K and N52T Engines: Various Eccentric Shaft Sensor Faults stored in the DME – Diagnostic Hints

This Service Information bulletin and attachment supersedes SI B11 06 16 dated April 2016.

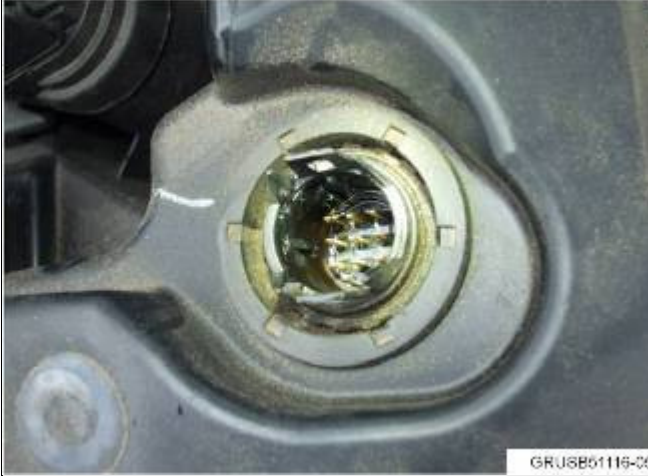
<p>VVT sensor connector located in in the center of the cylinder head cover.</p>

1. Connect a battery charger and perform a vehicle test.
2. If any of the listed above fault codes are stored, unplug the VVT eccentric shaft sensor connector (X60253) and inspect for engine oil contamination.

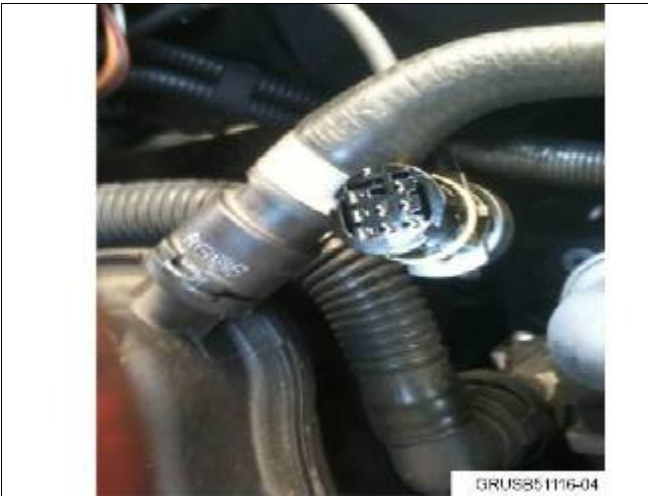
<p>VVT sensor engine harness connectors (X60253)</p>

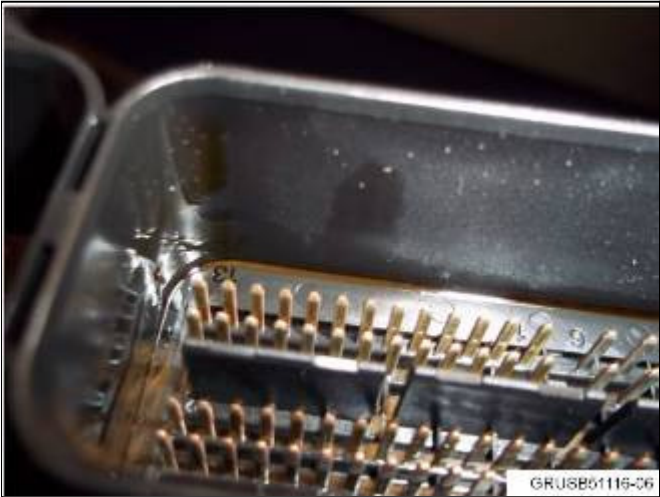
<p>DME Connector (Module 7, X60007, 26 pins)</p>

3. Inspect the DME and DME electrical harness connector.

- DME
- Engine electrical harness
- VVT Sensor
- Cylinder head cover gasket

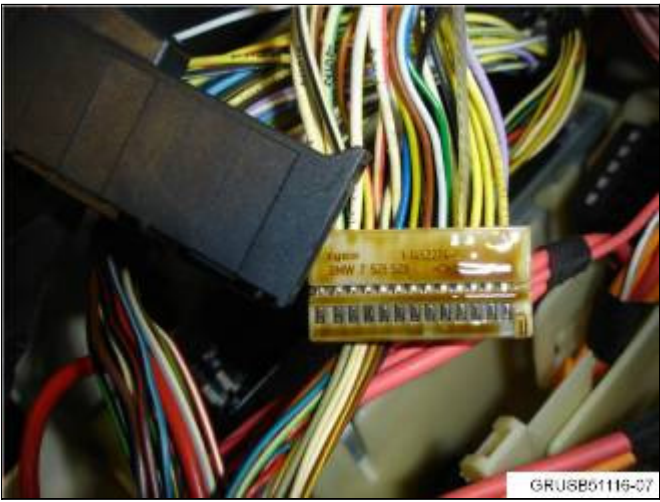
<p>DME engine harness connector.</p>
