SIL 5-EP-16  
January, 2016  
Page 1 of 16

**SUBJECT:** Replacing the DC Busbar Assembly and DC Terminal Block Inside the Dual Power Inverter Module 2 (DPIM2)

**MODELS AFFECTED:** H 40/50 EP System™ Equipped With DPIM2

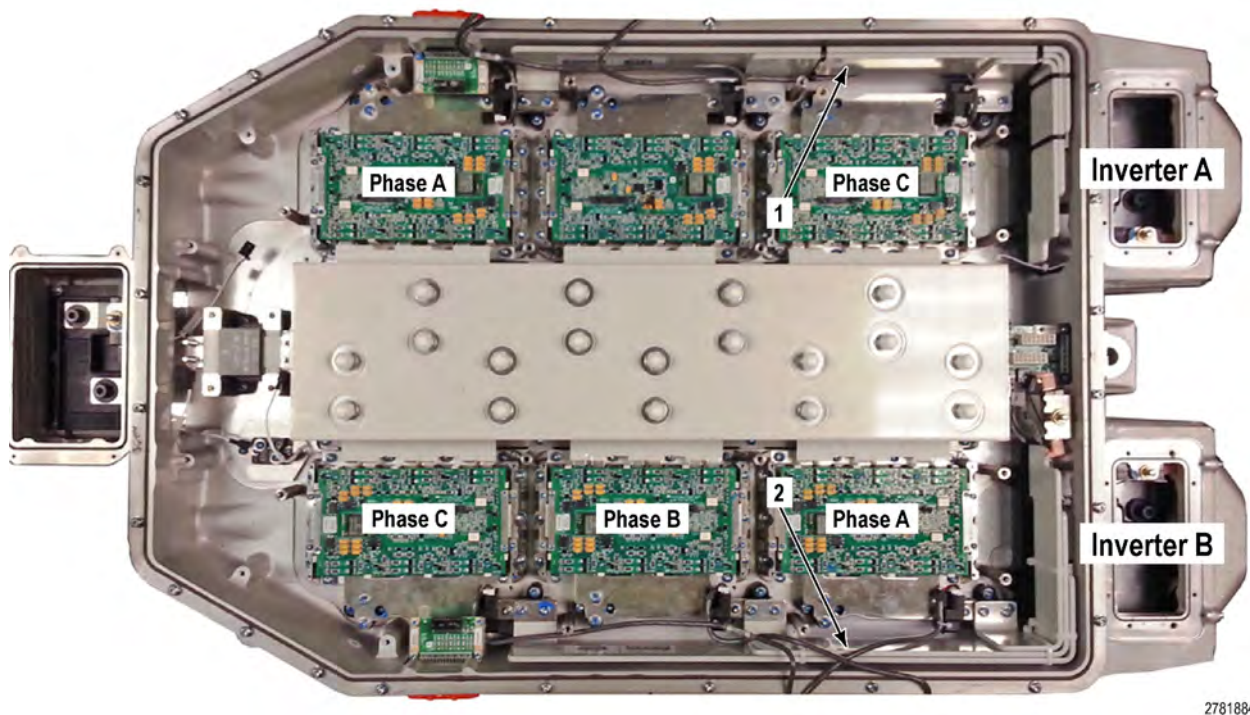
**Figure 1. DPIM2 Busbar Locations**

Refer to [Figure 1](#) for locations of the DC busbars, DC terminal block and related components. Refer to [Table 1](#) for list of Service Parts.

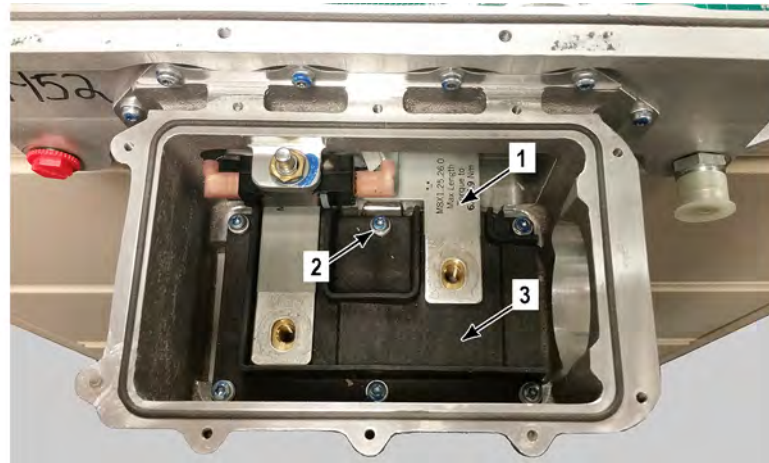
**Figure 2. Service Parts**

**Table 1. Service Parts (refer to [Figure 2](#))**

| Item Number | Part Name | Part Number |
|---|---|---|
| 1 | Busbar – DC | 29546732 |
| 2 | Screw – M4x16mm | 29540624 |
| 3 | DC Terminal Block | 29540604 |

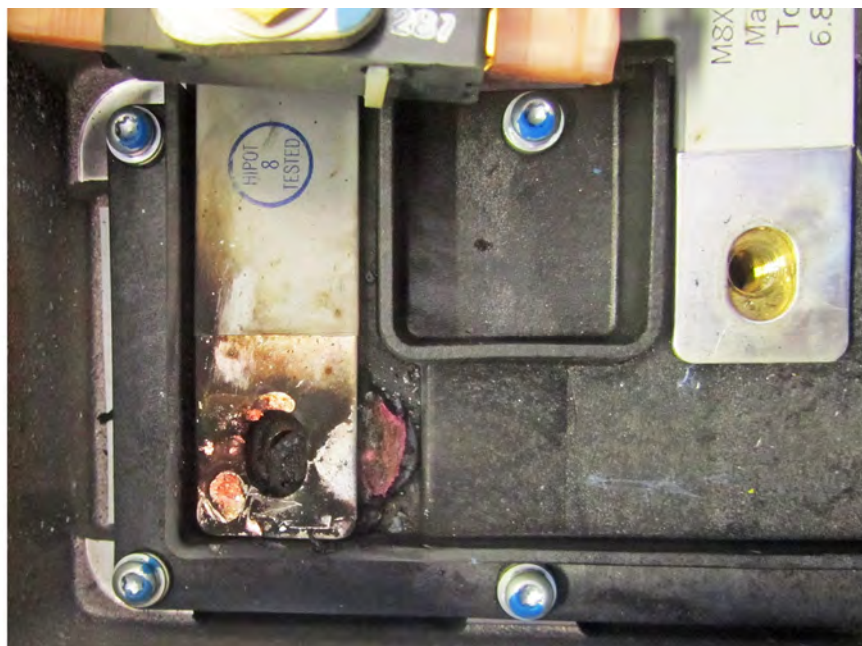
**Figure 3. Damage to Busbar and Terminal Block Caused by Electrical Arcing**

The DC busbar assembly and DC terminal block may need to be replaced if the HV lug bolt has become loose and components are damaged by electrical arcing. Refer to [Figure 3](#).

This Service Information Letter (SIL) announces the availability of the DC (Direct Current) busbar, DC terminal block, and related components and includes the procedure to replace the DC busbar and DC terminal block. The availability of this part eliminates the need for a complete DPIM replacement under certain failure conditions.

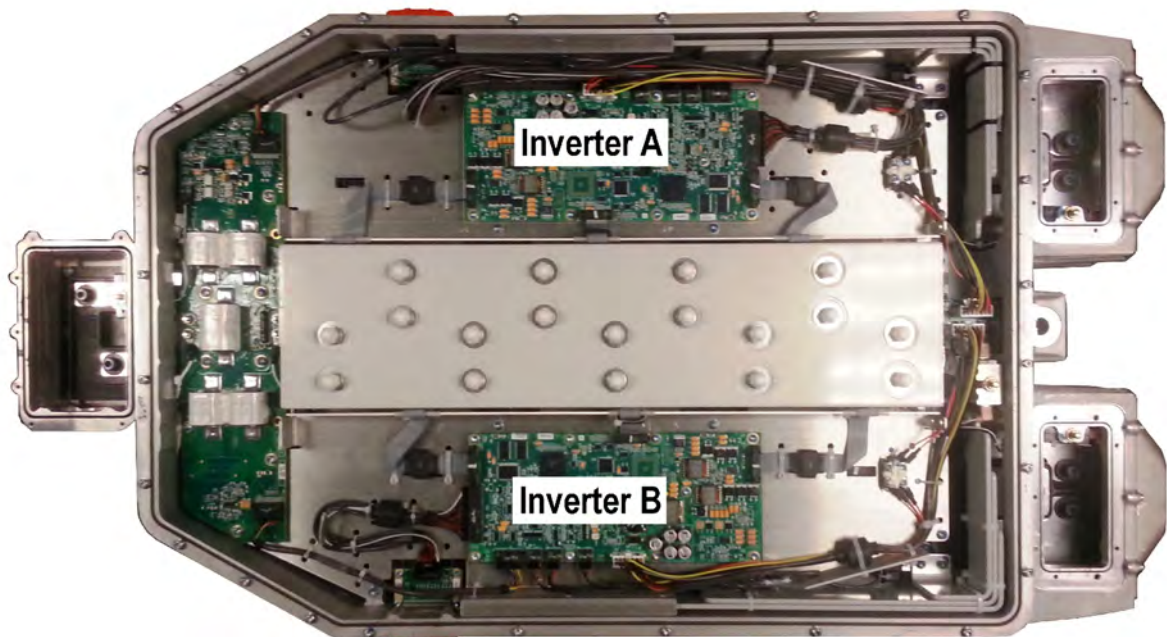
**Figure 4. DPIM2 (Main Cover and Lug Box Covers Removed)**

**NOTE:** Complete the DPIM Check List prior to replacing the DC busbar assembly and DC terminal block to ensure additional components have not been damaged. All cables (AC and DC) must be removed from the DPIM prior to taking measurements shown on the DPIM Check List. For additional information, refer to H 40/50 EP System™ Troubleshooting Manual (TS5812EN).

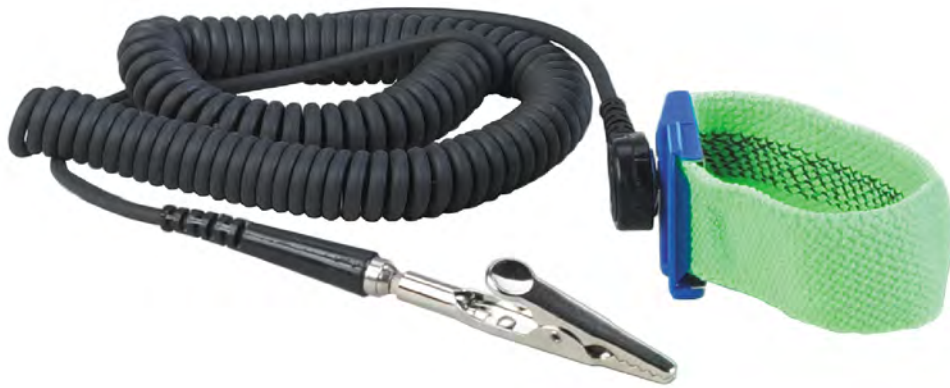
**Figure 5. Electrostatic Discharge Wrist Strap (Tool Number 7744 Shown)**

**NOTE:** All circuit cards in the DPIM2 are sensitive to electrostatic discharge (ESD). ESD damage can be caused by voltage levels that cannot be felt by humans. When working on the DPIM2, ALWAYS wear an ESD wrist strap to ground any possible electrostatic charge. The strap should be worn around the wrist with the alligator clip securely attached to the DPIM chassis. Refer to [Figure 5](#).

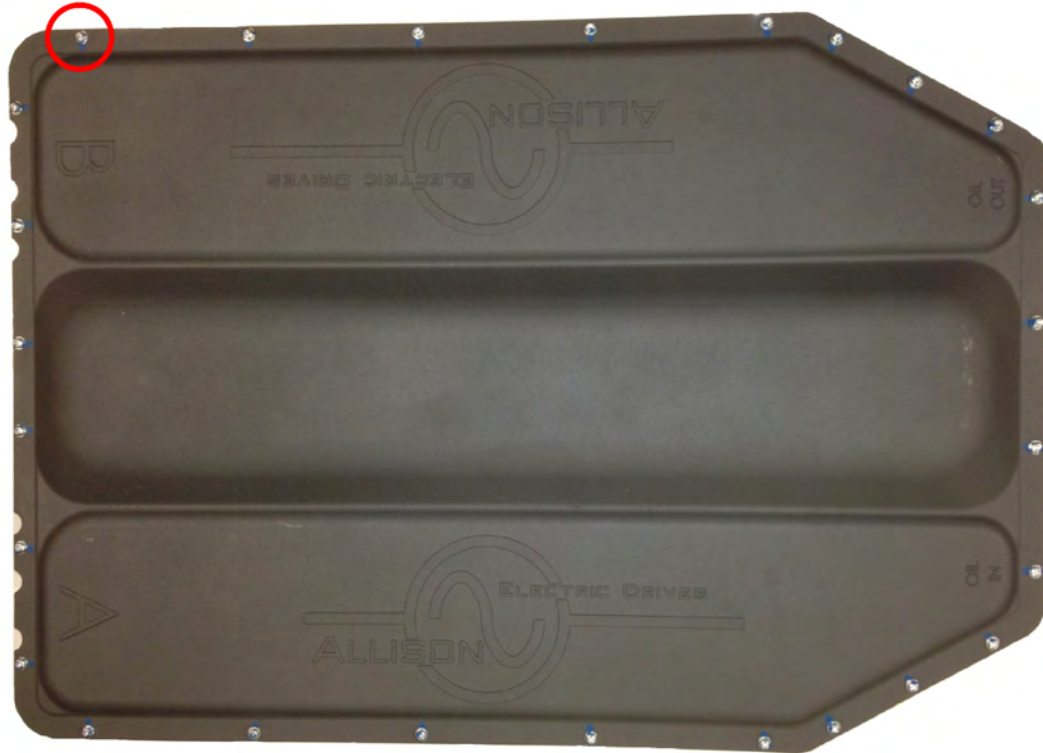
**Figure 6. DPIM Main Cover**

1. Using a Torx Plus™ T25 bit, remove twenty-six (26) M5x18mm machine screws that secure the Main Cover to the DPIM Housing (refer to [Figure 6](#)). Set the screws aside for reassembly. Remove the Main Cover. Discard the cover gasket.

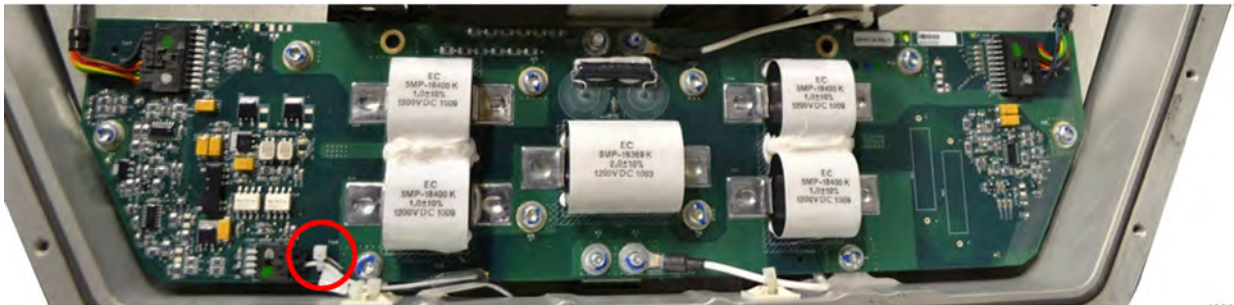
**Figure 7. HVIL Circuit Card – Wire Tie Location**

2. Exercising care, cut one (1) wire tie at location shown in [Figure 7](#). Do NOT remove any wire ties that pass through the HVIL Circuit Card. Leaving the severed wire ties in place will provide a visual aid for wire tie locations during installation of the replacement circuit card.

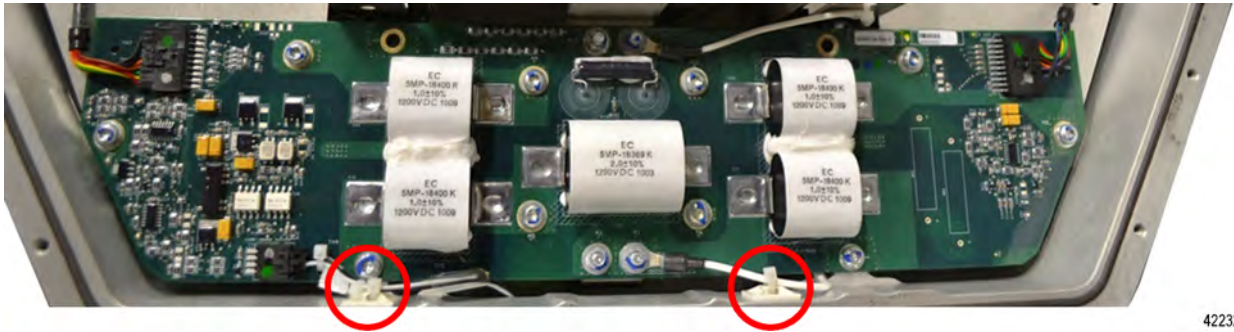
**Figure 8. HVIL Circuit Card – Two (2) Wire Tie Locations**

3. Cut the two (2) wire ties at locations shown in [Figure 8](#) and remove them from the mounts. The wire tie mounts do NOT have to be removed from the DPIM Housing unless they interfere with the removal or installation of the HVIL circuit card.

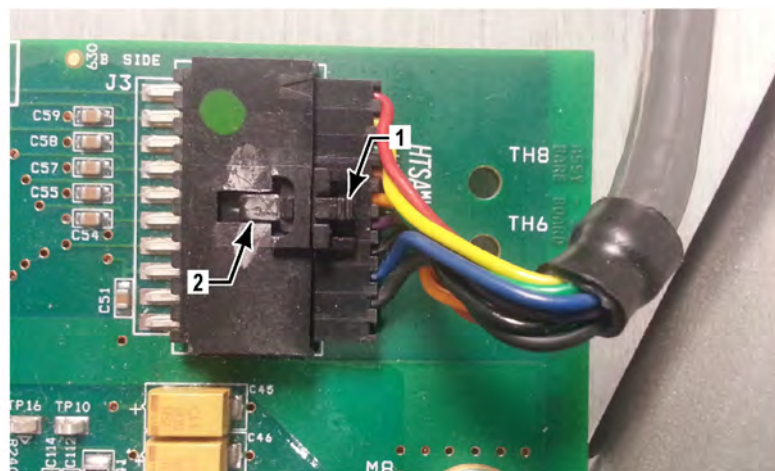
**Figure 9. HVIL Circuit Card Connector Removal**

4. When removing connectors, push down on the tab at Location 1 and push the harness out of the connector at Location 2 with a Pick or Small Flat Blade Screwdriver (refer to [Figure 9](#)).

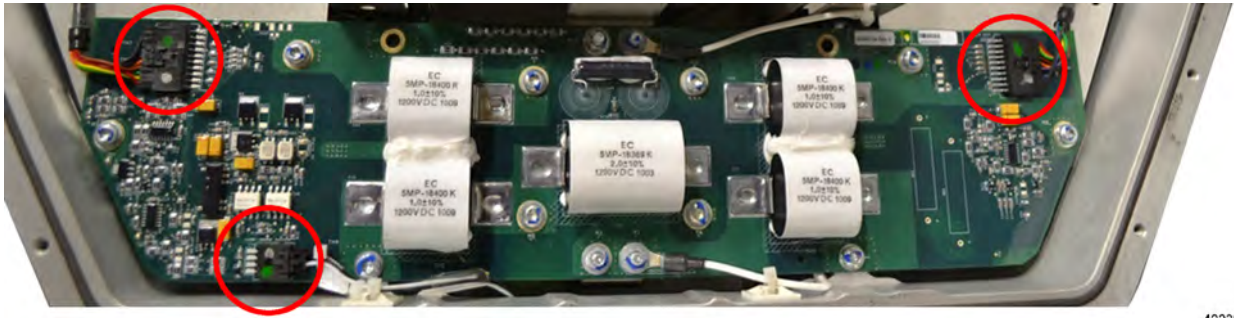
**Figure 10. HVIL Circuit Card – Three (3) Harness Connector Locations**

5. Remove three (3) wire harness connectors from HVIL Circuit Card surface mount connectors by gently depressing the retaining tab with a pick or small flat blade screwdriver. Refer to [Figure 10](#).

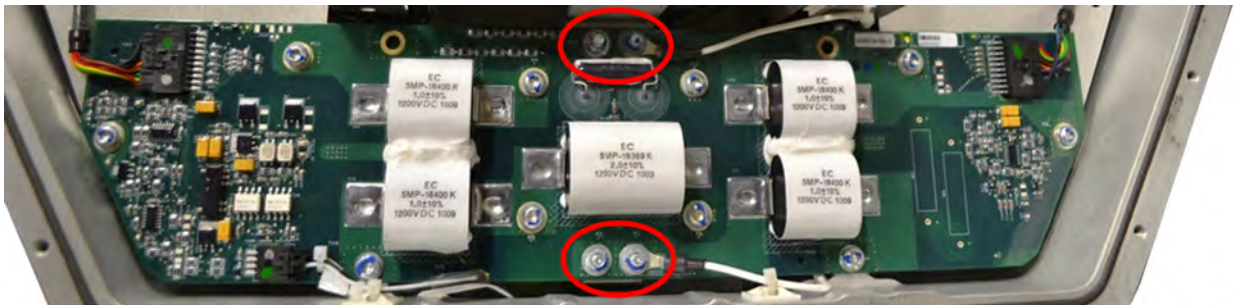
**Figure 11. HVIL Circuit Card – Four (4) Mounting Nut/Washer Locations (M5)**

6. Using an 8mm hex socket, remove the four (4) M5 nut/washer assemblies as shown in [Figure 11](#). Disconnect the two (2) wire ring terminals from the studs.

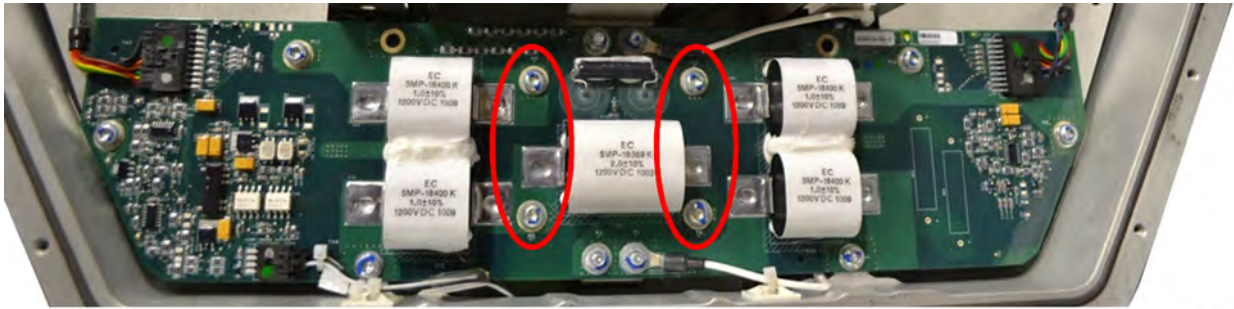
**Figure 12. HVIL Circuit Card – Four (4) Mounting Screw Locations (M5x30mm)**

7. Using a Torx Plus™ T25 bit, remove the four (4) M5x30mm screws securing the HVIL Circuit Card as shown in [Figure 12](#).

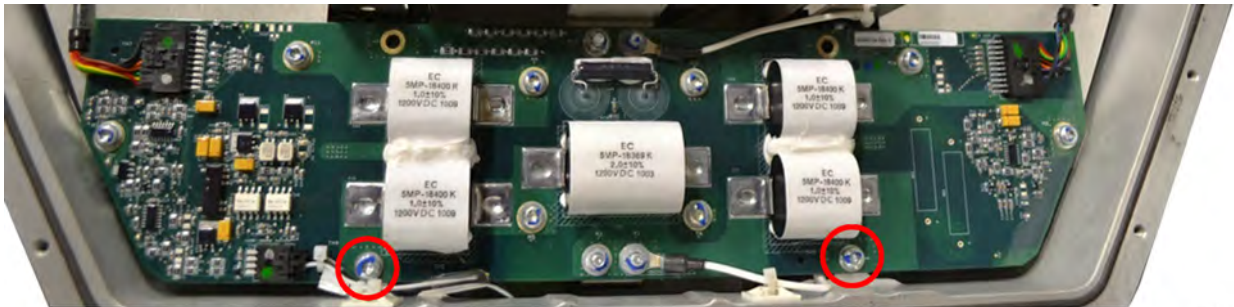
**Figure 13. HVIL Circuit Card – Two (2) Mounting Screw Locations (M5x14mm)**

8. Using a Torx Plus™ T25 bit, remove the two (2) M5x14mm screws securing the HVIL Circuit Card as shown in [Figure 13](#).

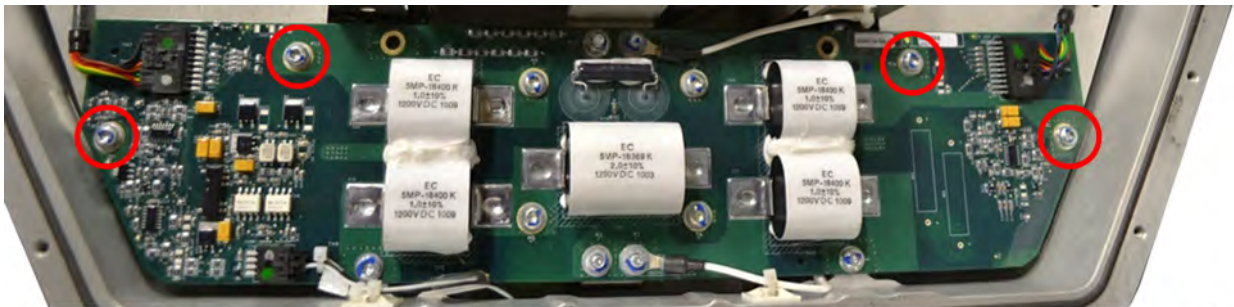
**Figure 14. HVIL Circuit Card – Four (4) Mounting Screw Locations (M5x22mm)**

9. Using a Torx Plus™ T25 bit, remove the four (4) M5x22mm screws securing the HVIL Circuit Card as shown in [Figure 14](#).

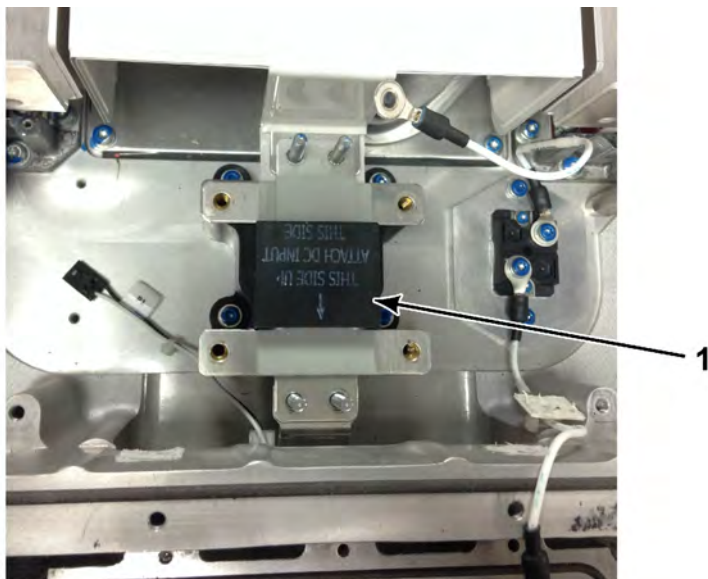
**Figure 15. DC Choke Location**

10. Lift the HVIL Circuit Card straight up and remove it from the DPIM Housing.
11. Remove the DC Choke (refer to [Figure 15](#)).

(1) – Choke

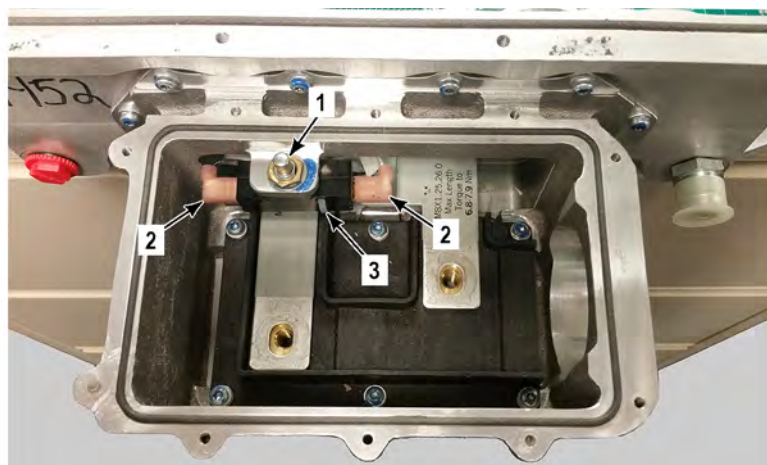
**Figure 16. DC Lug Box Components**

1. Using a 13mm socket, remove the nut and washer that secure the HVIL switch to the DC lug box housing. Unplug the two (2) wiring terminals from the ends of the HVIL switch. Remove the wire tie. Remove the HVIL switch (refer to [Figure 16](#)). Make note of the wiring terminal and wire tie orientation for reinstallation.

(1) – HVIL Switch Nut

(2) – Wiring

(3) – Wire Tie

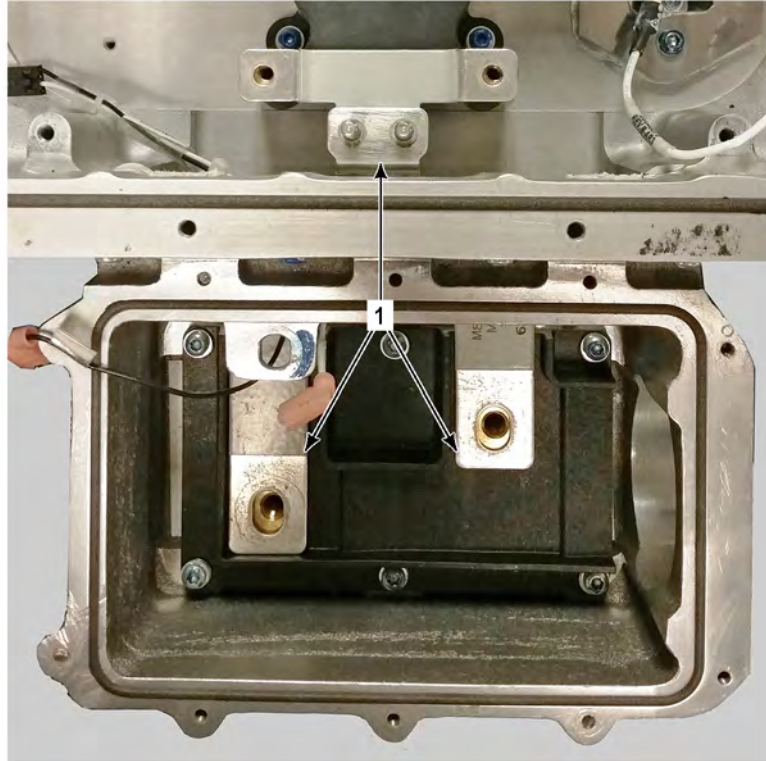
**Figure 17. DC Busbar Location**

2. Remove and discard the DC busbar through the main cover opening (refer to [Figure 17](#)).

- (1) – DC Busbar

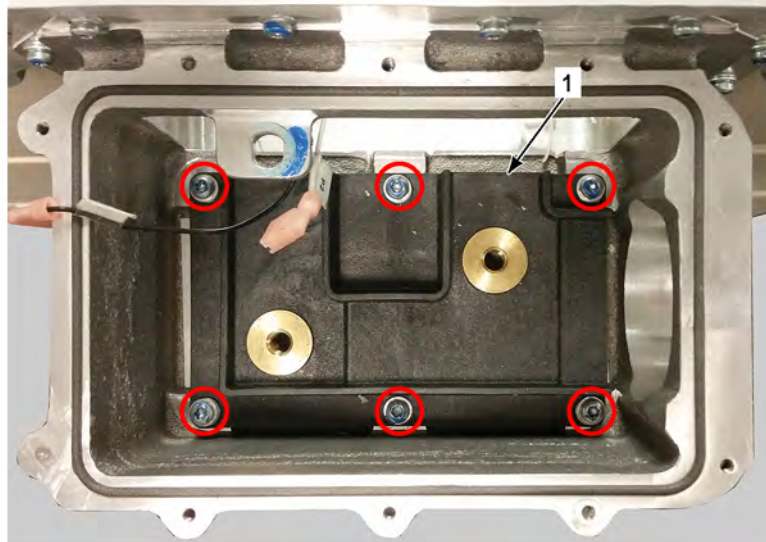
**Figure 18. DC Terminal Block and Fastener Locations**

3. Using a Torx Plus™ T20 bit, remove the six (6) M4x16mm screws that secure the DC terminal block to the DC lug box (refer to [Figure 18](#)). Remove and discard the DC terminal block from the DC lug box.

(1) – DC Terminal Block

4. Place the DC terminal block into the DC lug box. Apply one drop of Loctite® 425 (or equivalent) to the external threads of the six (6) M4x16mm screws. Using a Torx Plus™ T20 bit, install the six (6) M4x16mm screws that secure the DC terminal block to the DC lug box (refer to [Figure 18](#)) and torque to 1.24-1.47 N·m (10.97-13.01 lb in).
5. Insert the new DC busbar into the DC Lug Box through the main cover opening (refer to [Figure 18](#)).
6. Place the HVIL switch in the DC lug box. Connect the two (2) wiring terminals to the ends of the HVIL switch (refer to [Figure 19](#)). Apply one drop of Loctite® 425 (or equivalent) to the external threads. Using a 13mm socket, install the nut and washer that secure the HVIL switch to the DC lug box. Torque the nut to 1.9-2.2 N·m (16.8-19.5 lb in). Install wire tie to secure the black wire to the HVIL switch and cut to length.

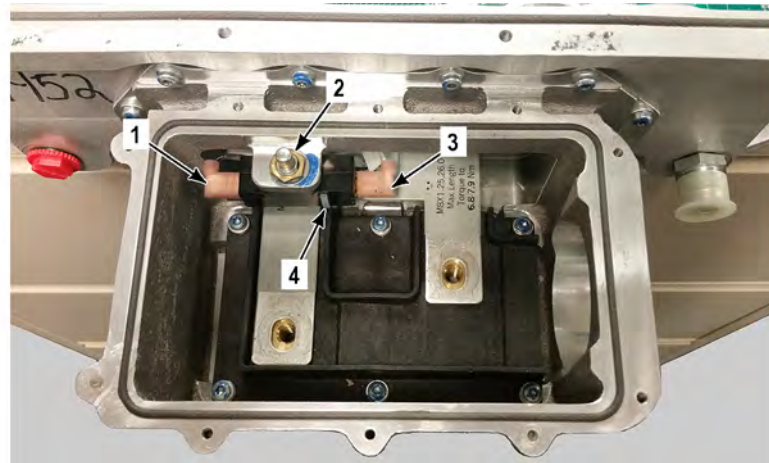
**Figure 19. DC Lug Box Components**

| (1) - Black Terminal | (3) - White Terminal |
| (2) - HVIL Switch Nut and Washer | (4) - Wire Tie |

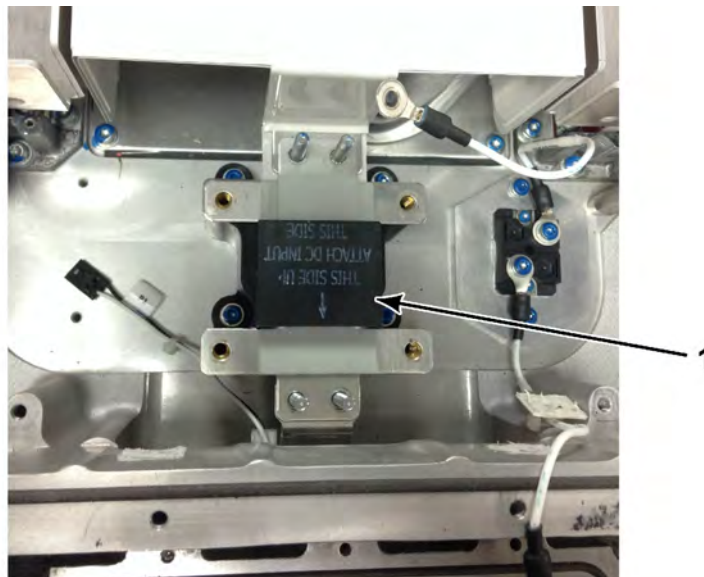
**Figure 20. DC Choke Location**

1. Install the DC Choke, ensuring that the arrow is pointing towards the DC lug box (refer to [Figure 20](#)).

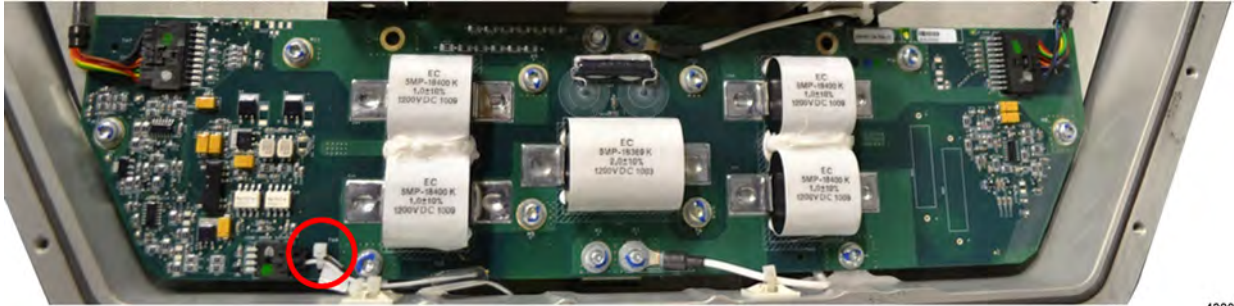
**Figure 21. HVIL Circuit Card – Wire Tie Location**

2. Insert one (1) new wire tie into the new HVIL Circuit Card at the same location as shown in [Figure 21](#).

**NOTE:** To ease assembly, the new wire tie must be inserted through the hole in the circuit card prior to installation in the DPIM Housing.

7. Secure wiring with new wire ties and clip excess length as required. Refer to [Figure 21](#) and [Figure 25](#) for wire tie locations.

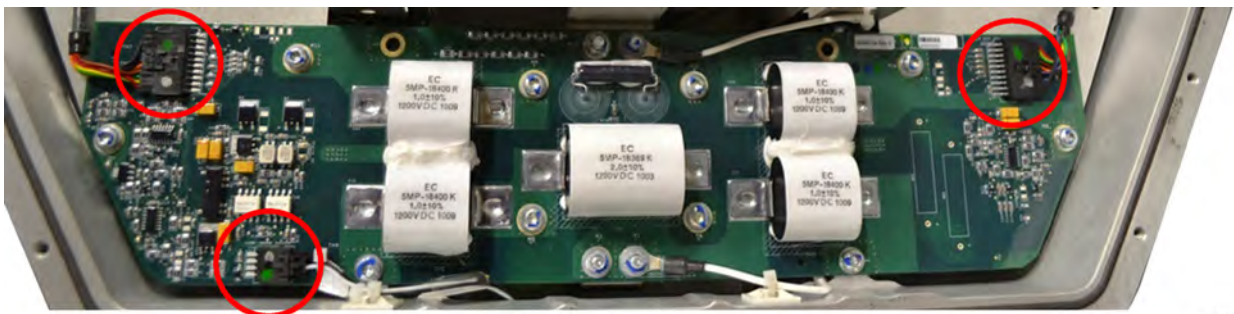
**Figure 22. HVIL Circuit Card – Three (3) Harness Connector Locations**

4. Connect the three (3) wiring harness connectors at locations shown in [Figure 22](#).

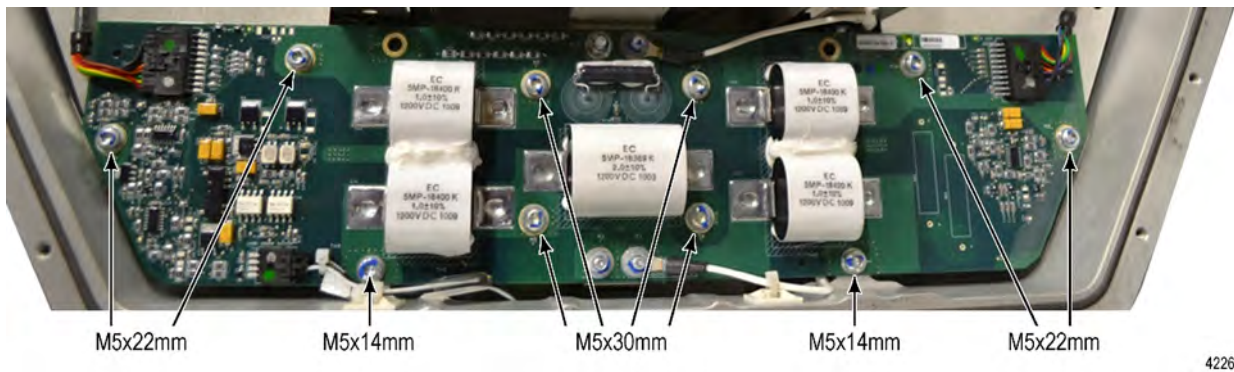
**Figure 23. HVIL Circuit Card – Fastener Sizes/Locations**

5. Using a Torx Plus™ T25 bit, install and finger tighten the ten (10) M5 screws that secure the HVIL Circuit Card to the DPIM Housing. Torque all M5 screws to 3.1-3.5 N·m (27-31 lb in). Refer to [Figure 23](#) for fastener sizes and locations.

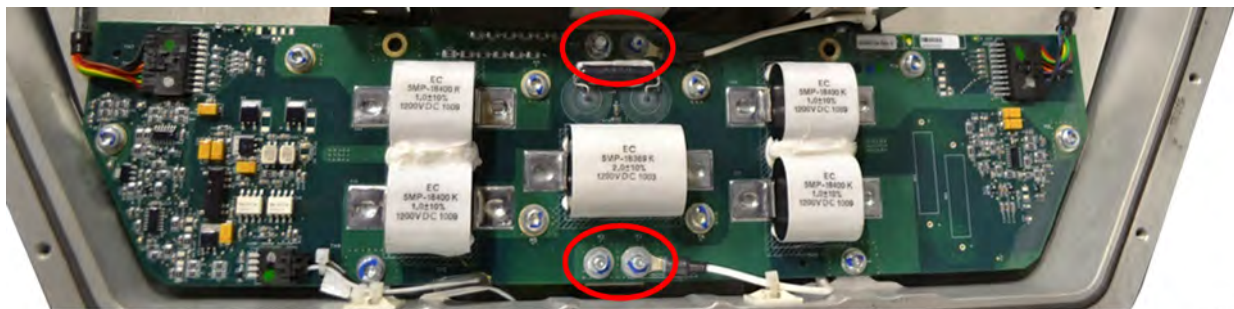
**Figure 24. HVIL Circuit Card – Four (4) Mounting Nut/Washer Locations (M5)**

6. Install the two (2) wire ring terminals onto the studs at locations shown in [Figure 24](#). Using an 8mm socket, install four (4) M5 nut/washer assemblies onto the studs as shown in the same figure. Torque the nuts to 3.1-3.5 N·m (27-31 lb in).

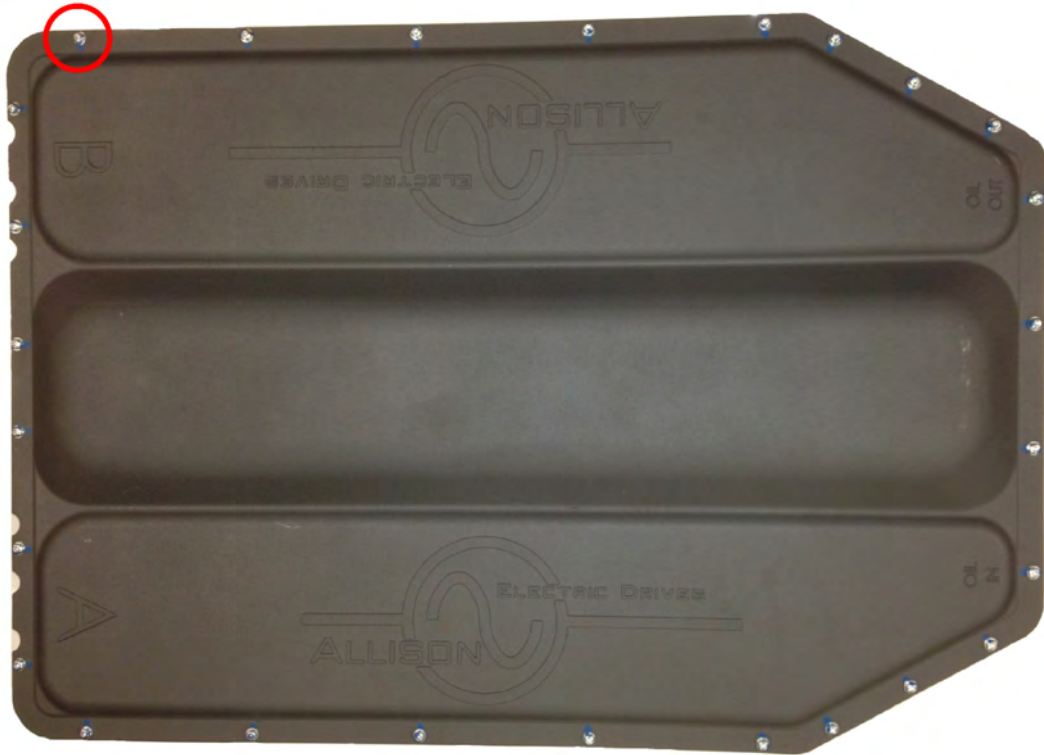
**Figure 26. DPIM Main Cover**

8. Install new Cover Gasket P/N 29540714. Using a Torx Plus™ T25 bit, install and finger tighten the twenty-six (26) M5x18mm machine screws that secure the Main Cover to the DPIM Housing as shown in [Figure 26](#). Torque the screws to 3.1-3.5 N·m (27-31 lb in).

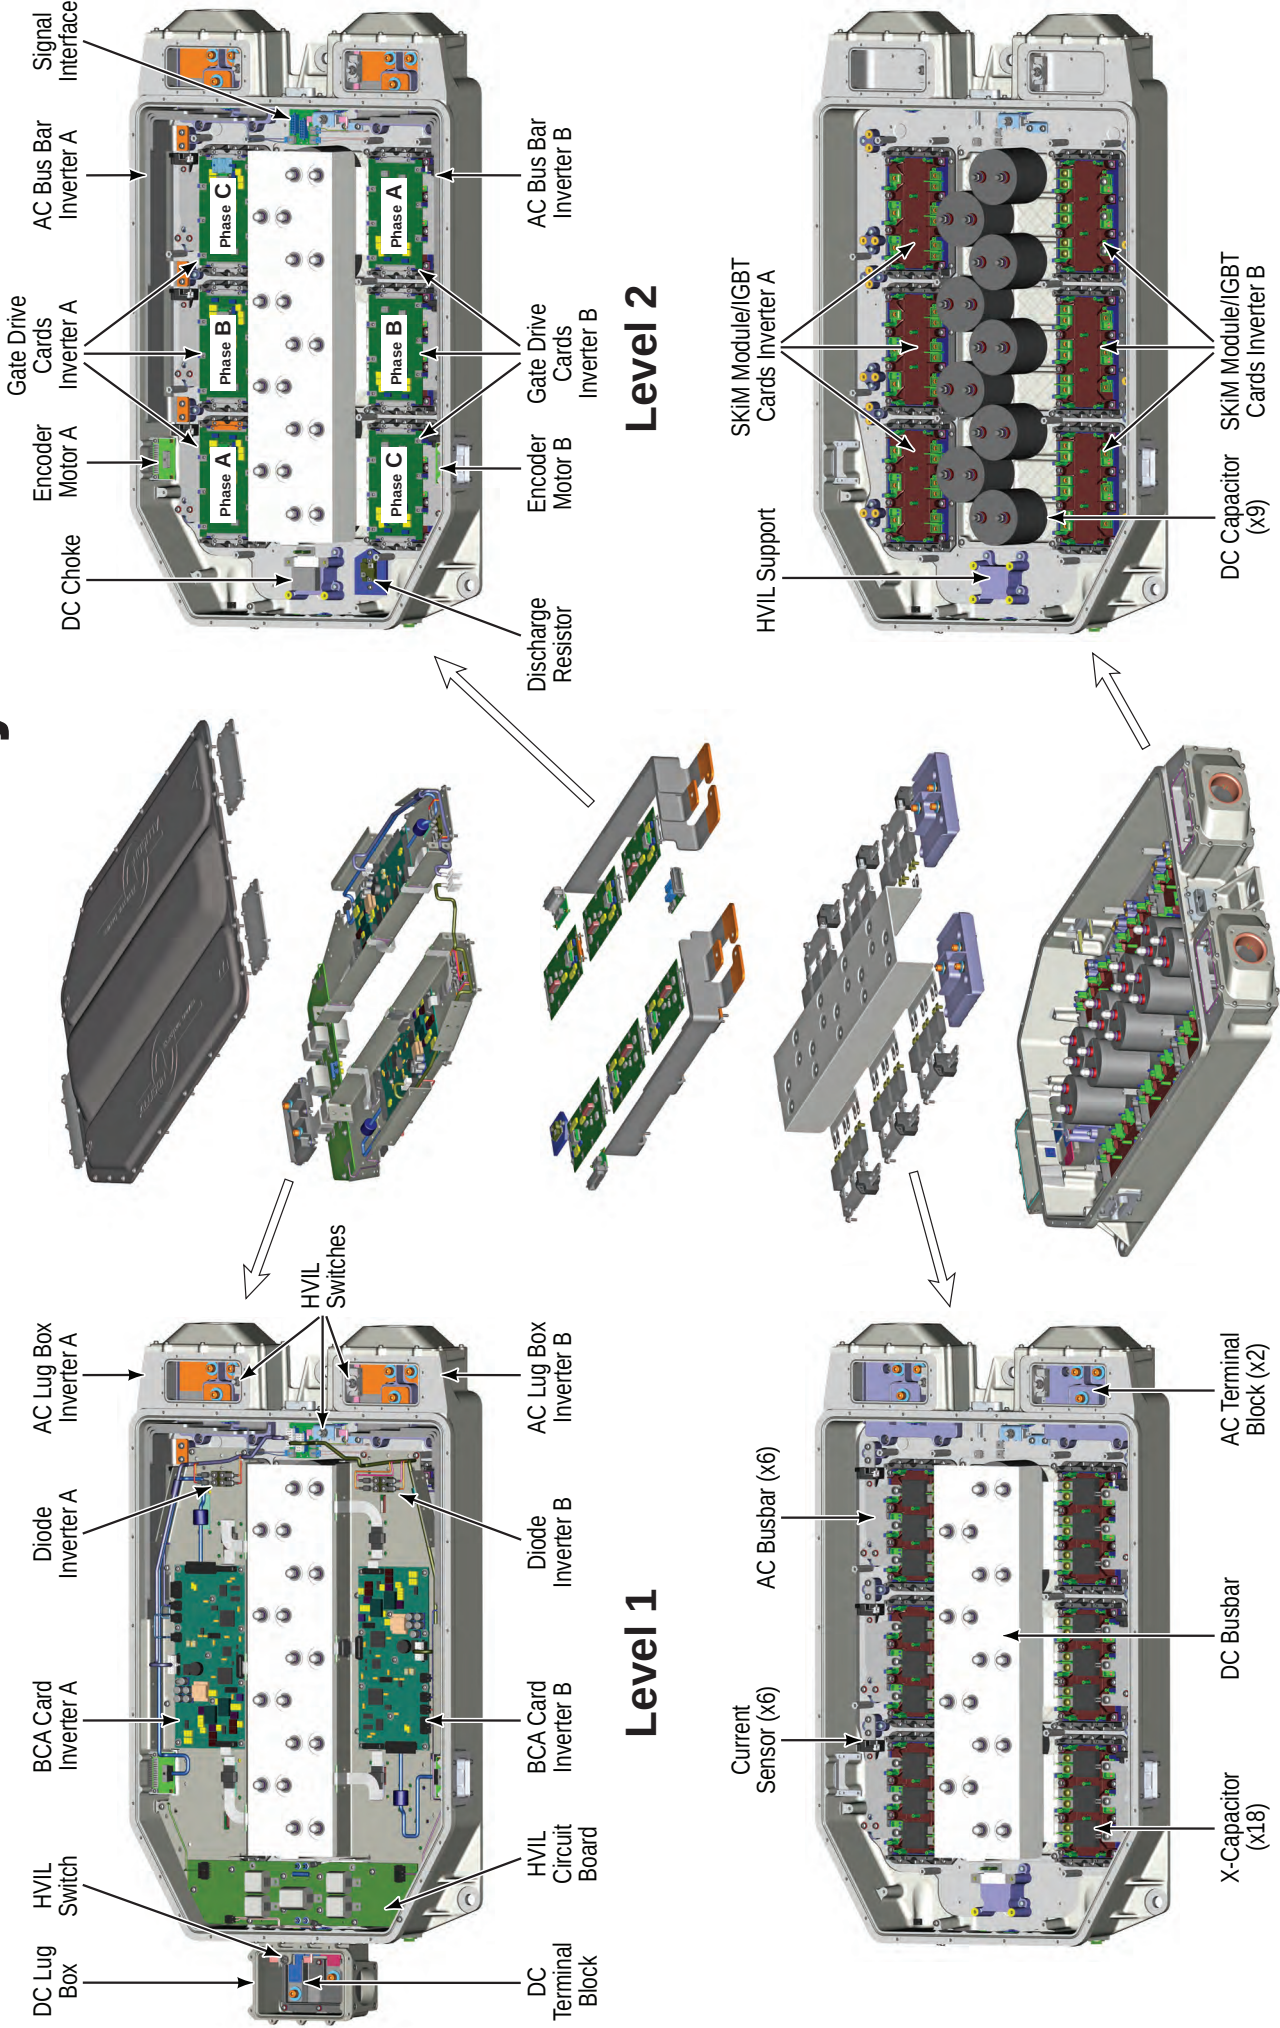
## Levels of Assembly

**NOTE:** This illustration is to be used for identifying the name and location of components within the Dual Power Inverter Module 2 (DPIM2). It is not intended to be used for disassembly and assembly procedures.

**NOTE:** Refer to the attachment at the end of this SIL for information regarding the name and location of components within the DPIM2.
