## Diagnostics for the SAF-HOLLAND APL (Auto-PosiLift™) September 2016

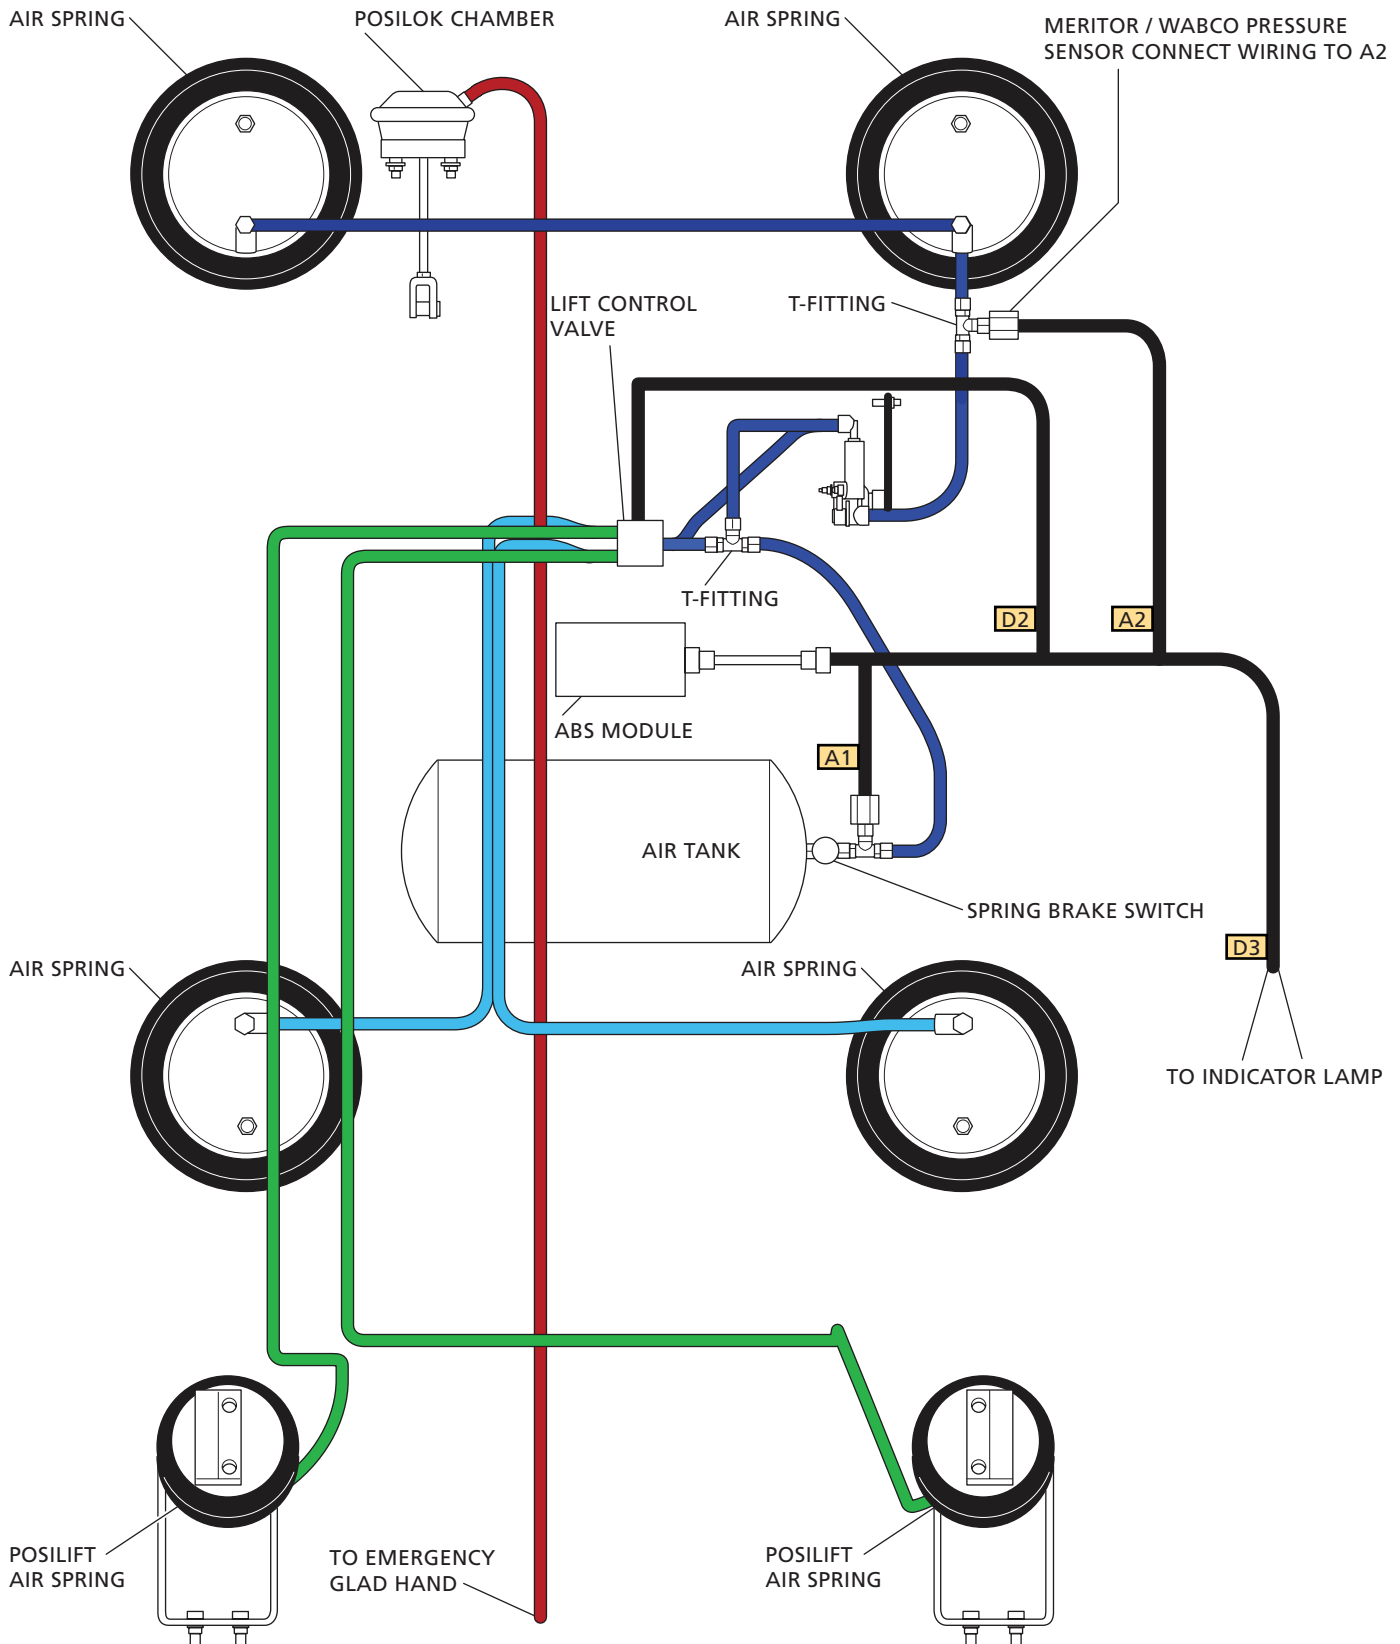
- A. Check connections D2 and D3 are connected correctly. If D2 is not plugged into the lift axle control valve, the lift will not work. Connections are marked (i.e. "D2") a few inches from the connection.

- B. Ensure connections A1 and A2 are connected correctly. If A2 is connected to the spring brake switch, which should be A1, then the lift will not work. Connections are marked (i.e. "A2") a few inches from the connection.

- C. Check the connections for the spring brake pressure switch and the air bag pressure transducer are coupled the correct way around. This is the other end of the A1 and A2 connectors. This should be traced from the marked A1 and A2 connectors and should be easily identifiable. The pressure transducer connects straight to the A2 cable, whereas the spring brake pressure switch connects via a short lead, then via a longer cable up to the A1 connector.

- D. This modulator cable is to control external modulators (i.e. Relay valves) where the modulators are not internally connected to the ABS ECU. This cable will be connected in 2S/1M systems and 6S/3M systems. 4S/2M (2 modulator systems) will not have this connector attached and it should be blocked off.

- E. Check the spring brake pressure switch is connected to a drop hose between the spring brake valve and the brake chamber. This should not be connected to the supply line between the spring brake valve and the glad hand.

- F. Check that the inputs in the lift axle control valve are not connected back to front. The port marked 1.1 should be connected to supply pressure from the air tank. The port marked 1.2 should be delivered from the air bags and should only have a low pressure in the airline.

- G. The ride height valve should not have a dump when run in conjunction with the lift axle. Some manufacturers still run a dump valve, but plumb supply pressure into the dump port effectively disables the dump feature. Ensure that the valve does not have a dump feature, or it is disabled as mentioned above.
