**SUBJECT:** Regional Program 15R02

Certain 2009-2010 Model Year Edge and MKX Vehicles Not Covered Under Safety

Recall 15S31

Fuel Tank Corrosion Inspection and Repair

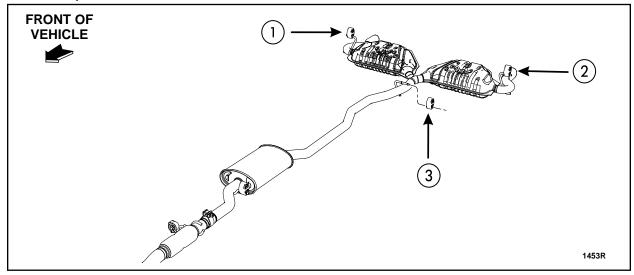
FIGURE 1

- a. Detach the three (3) muffler and tailpipe assembly rear isolators. See Figure 1.
- b. Position the rear of the exhaust system down approximately 305 mm (12 in) and support using a jack stand.

8. Attach the three (3) muffler and tailpipe assembly isolators. See Figure 1.

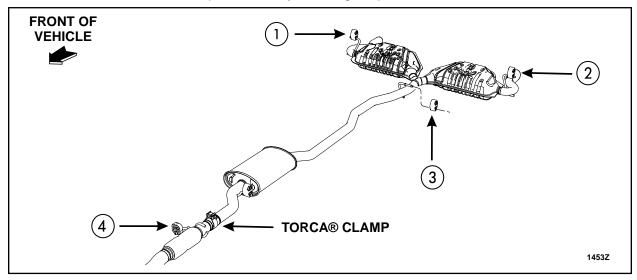
### FIGURE 2

- a. Detach the four (4) muffler and tailpipe assembly isolators. See Figure 2.
- b. Loosen the Torca® clamp and remove the exhaust system from the vehicle.

11. Install the muffler and tailpipe assembly and attach the four (4) isolators. See Figure 2.

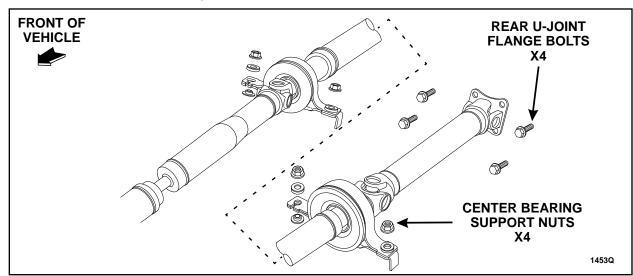
FIGURE 3

- 6. With the help of an assistant, detach and position the rear of the driveshaft aside as follows: See Figure 3.
  - a. Remove and discard the four (4) rear u-joint flange bolts at the differential assembly.
  - b. Remove and discard the two (2) or four (4) center bearing support nuts. Position and secure the driveshaft up and to the left side of the vehicle.

- 9. Position the driveshaft and install the two (2) or four (4) new center bearing support nuts. See Figure 3.
  - Tighten to 40 Nm (30 lb-ft).
- 10. Position the driveshaft and install the four (4) new rear u-joint flange bolts. See Figure 3.
  - Tighten to 70 Nm (52 lb-ft).

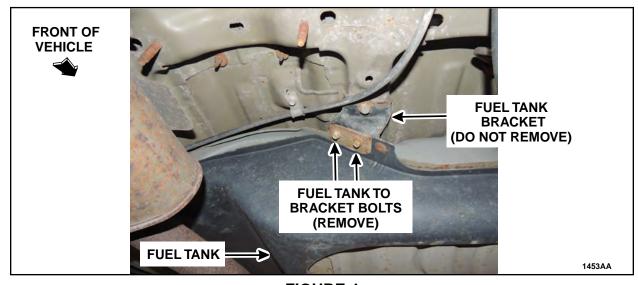
FIGURE 4

- 14. Remove the fuel tank bolts as follows:
  - a. Remove and discard two (2) bolts attaching the fuel tank to the fuel tank brackets at both the front center and rear center of the tank (four (4) bolts total). Leave the brackets attached to the vehicle. See Figure 4.
  - b. Remove and discard the four (4) bolts (one at each corner) attaching the fuel tank to the body.

**NOTE:** Two (2) rear center fuel tank to bracket bolts shown, two (2) front center fuel tank to bracket bolts similar.

- 3. Install the four (4) new fuel tank to bracket bolts. See Figure 4.
  - Tighten to 25 Nm (18 lb-ft).
- 4. Position the parking brake cables and install the two (2) parking brake cable bracket bolts.
  - Tighten to 23 Nm (17 lb-ft).
- 5. Connect the fuel tank jumper tube-to-fuel tank quick connect coupling. Please follow WSM procedures in Section 310-00.
- 6. Connect the fuel tank pressure sensor.
- 7. Connect the fuel tank wiring harness connector.

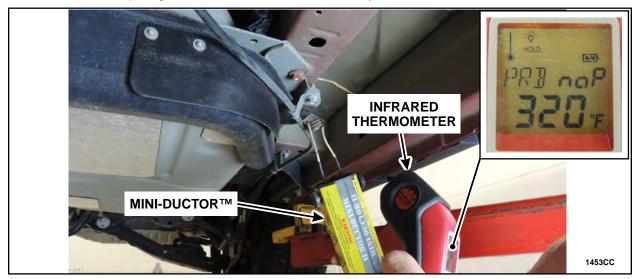
FIGURE 5

- a. Using a Mini-Ductor™ or equivalent and infrared thermometer, heat the corner attaching bolts one at a time to approximately 160°C (320°F). See Figure 5.
- b. Use an air impact gun to remove each bolt immediately after it is heated.

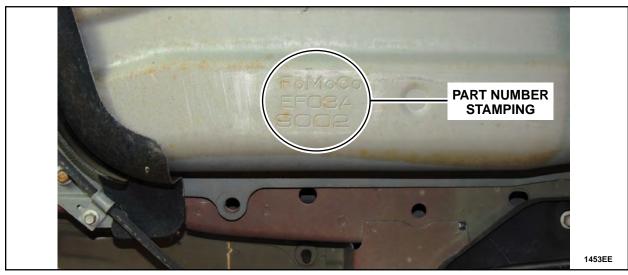
FIGURE 6

- 1. Inspect the bottom side of the fuel tank for a "FoMoCo" part number stamping. See Figure 6.
  - If the fuel tank has a "FoMoCo" part number stamping, proceed to Step 2.
  - If the fuel tank does not have a "FoMoCo" part number stamping, replace the fuel tank.

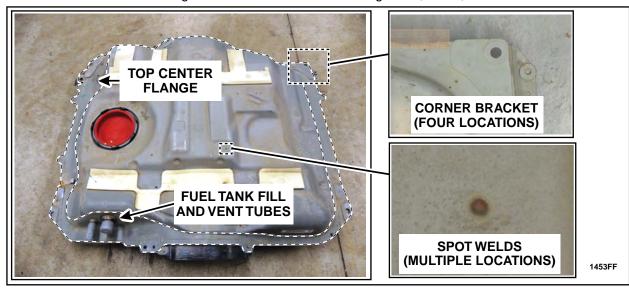
FIGURE 7

2. If necessary, use a stiff nylon brush and Motorcraft Metal Brake Parts Cleaner to clean any heavy deposits of dirt/debris from around the top center flange area of the fuel tank so the metal in the corner bracket areas can be inspected for rust/corrosion. See Figure 7.

3. Inspect the fuel tank corner bracket areas, fuel filler and vent tube attachment areas and other areas of the fuel tank for signs of leaks or corrosion. See Figures 7, 8a-8b, and 9a-9b.

- 10. Remove the aerosol tube and apply a heavy coat of anti-corrosion treatment over the following areas of the fuel tank: See Figures 7 and 12a-12d.
  - a. Around the fill and vent tubes.
  - b. All spot welds on top of the tank.
  - c. Corner bracket areas.
  - d. On the top center flange around the entire perimeter of the tank.

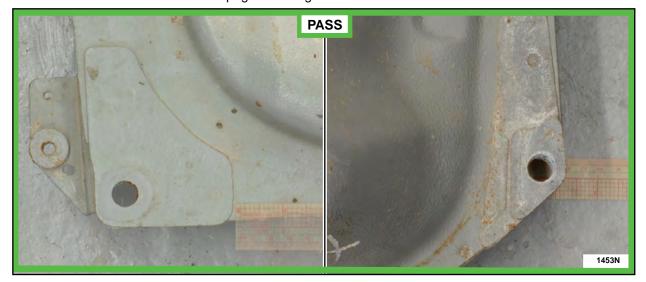
FIGURE 8a FIGURE 8b

A fuel tank **PASSES** the inspection procedure if there are no signs of leaks, soft/bubbling paint or corrosion at the edges of the corner brackets, fuel filler and vent tube attachment areas, or other areas of the fuel tank. If the fuel tank passes the inspection, continue to Fuel Tank Corrosion Treatment Procedure on the next page. See Figures 8a and 8b.

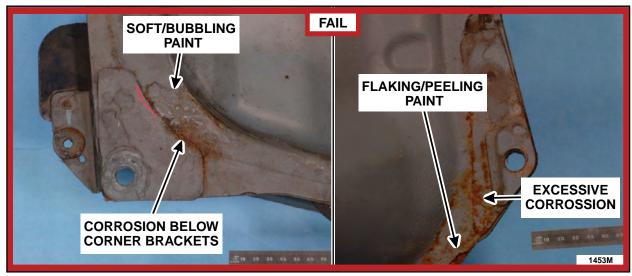
Conditions that indicate a fuel tank **FAILS** and must be replaced include:

- Any soft or bubbling paint that is easily scraped from the surface of the tank at ANY location.
- Any corrosion stemming from below the corner brackets that has compromised the surface of the metal.
- Excessive corrosion at the weld seam around the top center flange of the tank, at the base of the fuel inlet and vent ports, and on top of the tank at the baffle spot welds.

If the fuel tank fails the inspection, replace the tank and proceed to Fuel Tank Installation Procedure on Page 11. See Figures 9a and 9b.

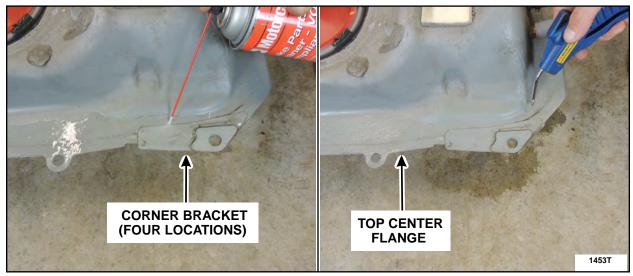
- 2. Clean the area around the fuel fill and vent tubes.
- 3. Clean the spot welds on top of the tank.
- 4. Wipe clean with shop towel.
- 5. Spray Motorcraft Metal Brake Parts Cleaner under each of the corner brackets using the supplied aerosol spray tube. See Figure 10a.
- 6. Use compressed air regulated to approximately 137 kpa (20 psi) to spray under the corner brackets to clean/dry the surfaces under them. See Figure 10b.

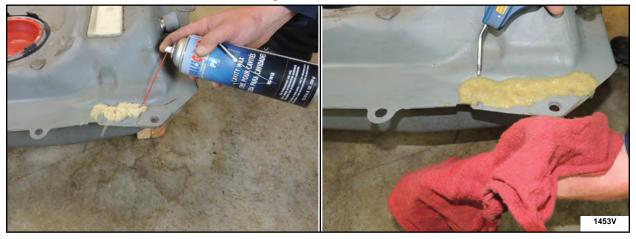
- 7. Spray anti-corrosion treatment under each corner bracket using the supplied aerosol spray tube. See Figure 11a.
- 8. Use compressed air regulated to approximately 137 kpa (20 psi) to force the anti-corrosion treatment under each of the corner brackets. See Figure 11b.

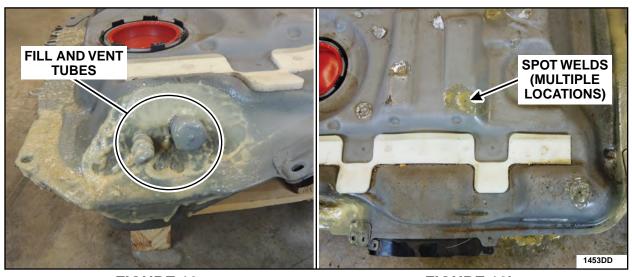
**NOTE**: Before applying anti-corrosion treatment to the fuel tank surface, cover the filler neck and vent tube with a suitable cover to keep these areas free of the treatment. See Figure 12a.
