Service Alert No: 001313

Title: 2016 CX-9 - 2ND ROW SEAT WALK-IN AND RECLINE LEVER USAGE

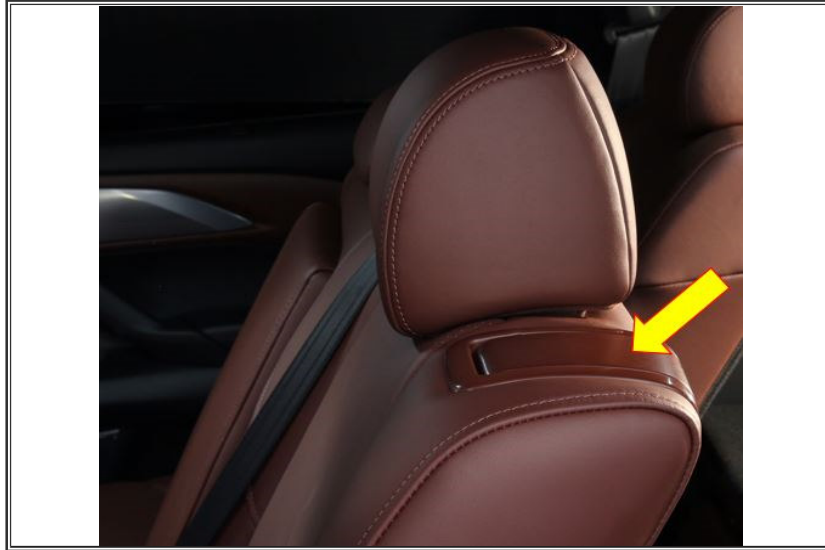
#### Walk-in Lever

**CAUTION: Do not operate the "Walk-in" lever AND the "Recline" lever at the same time.**

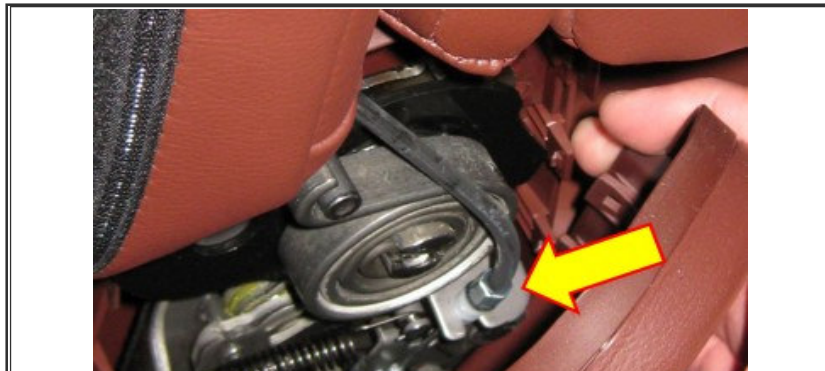
**Operating both at the same time will cause an excessive load on the walk-in lever bracket (shown below) at the release linkage. This can cause the bracket to bend downwards and reduce the operation of the walk-in lever.**
