SERVICE BULLETIN

Classification: EL15-035	Reference: NTB16-006	Date: January 6, 2016
-----------------------------	-------------------------	--------------------------

2013 - 2016 LEAF; CHARGE IS STOPPED BEFORE COMPLETE, EV WARNING LIGHT ON AND DTC STORED

APPLIED VEHICLE 2013 – 2016 LEAF (ZE0)

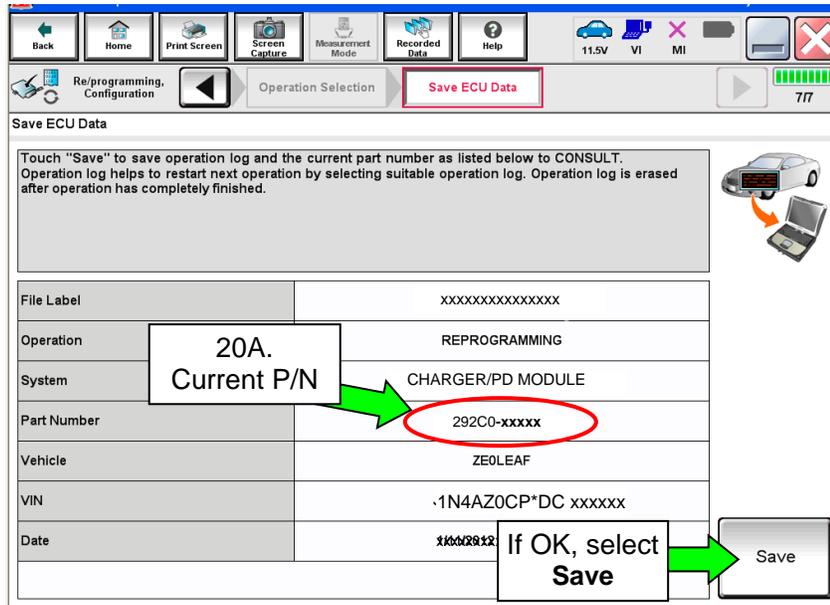
Figure 8

20. When you get to the screen shown in Figure 8, confirm this bulletin applies as follows.

A. Find the **CHARGER/PD MODULE Part Number** and write it on the repair order.

NOTE: This is the current CHARGER/PD MODULE Part Number (P/N).

B. Compare the P/N you wrote down to the numbers in the **Current CHARGER/PD MODULE Part Number** column in **Table A** below.

- If the CHARGER/PD MODULE part number **is** one of the Part Numbers listed in Table A, continue with reprogramming.
 - Select **Save**, and then go to the next step.
- If the CHARGER/PD MODULE part number **is not** listed in Table A, this bulletin does not apply. Refer to ASIST for further diagnostic and repair information.

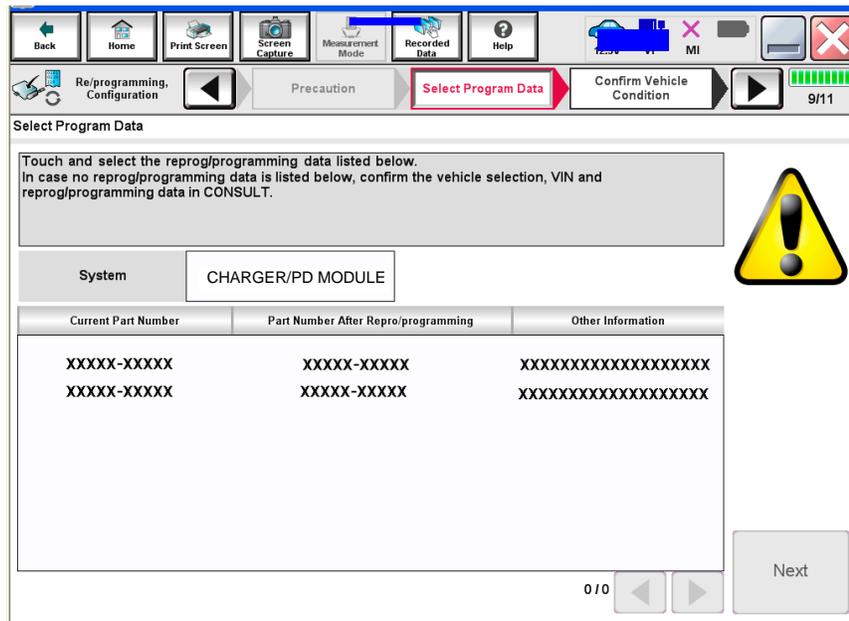
- In some cases, more than one new P/N for reprogramming is available.
 - If more than one P/N is available, the screen in Figure 11 will display. Select and use the reprogramming option that **does not** have the message “Caution! Use ONLY with NTBXX-XXX”.
- If you get this screen and it is blank (no reprogramming listed), it means there is no reprogramming available for this vehicle.

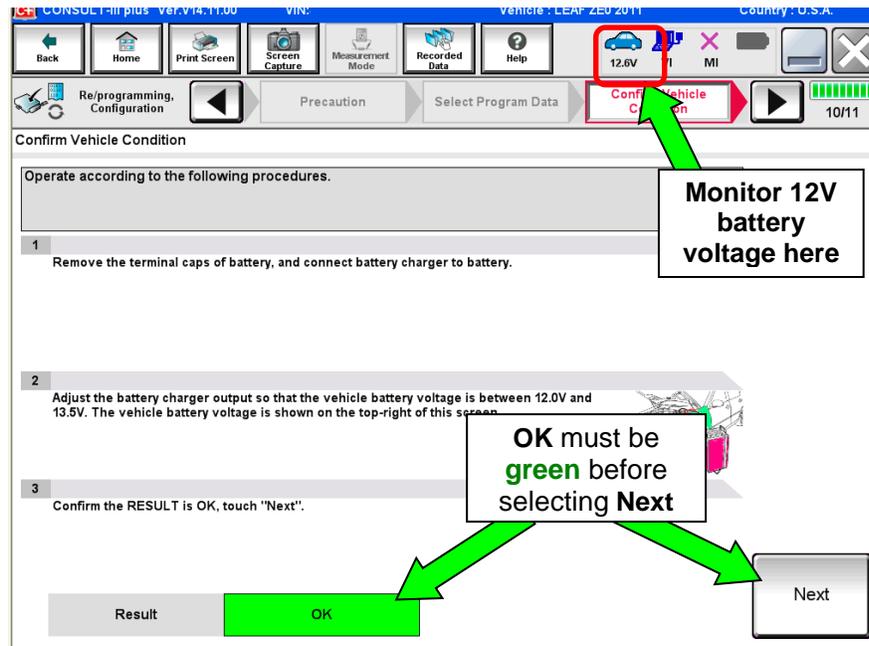
Figure 13

26. Confirm battery voltage is correct, and then select **Next**.

NOTE: Battery voltage must stay within specified range to make the indicator turn **green**.

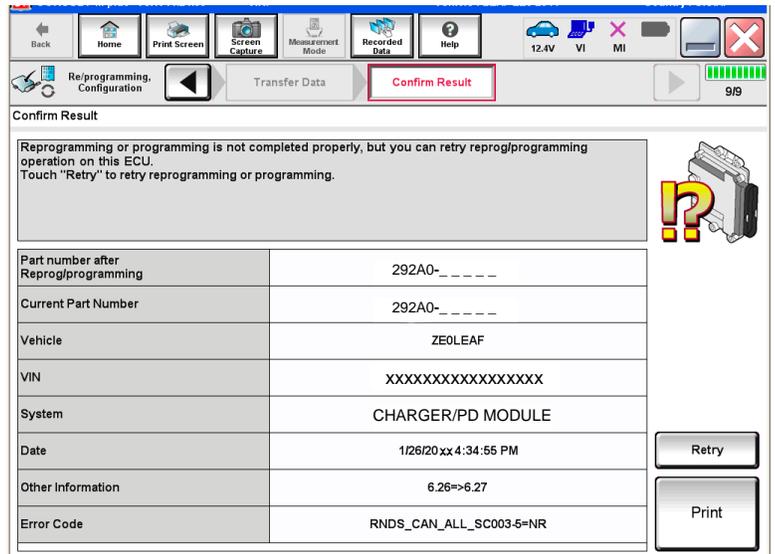
Figure 17

NOTE: If reprogramming does not complete and the **!?** displays as shown in Figure 17:

- Check battery voltage (12.0 - 13.5V).
- Ignition is ON, Ready Mode is OFF.
- External Bluetooth® devices are OFF.
- All electrical loads are OFF.
- **Select Retry and follow the on screen instructions.**
- Retry may not go through on the first attempt and can be selected more than once.

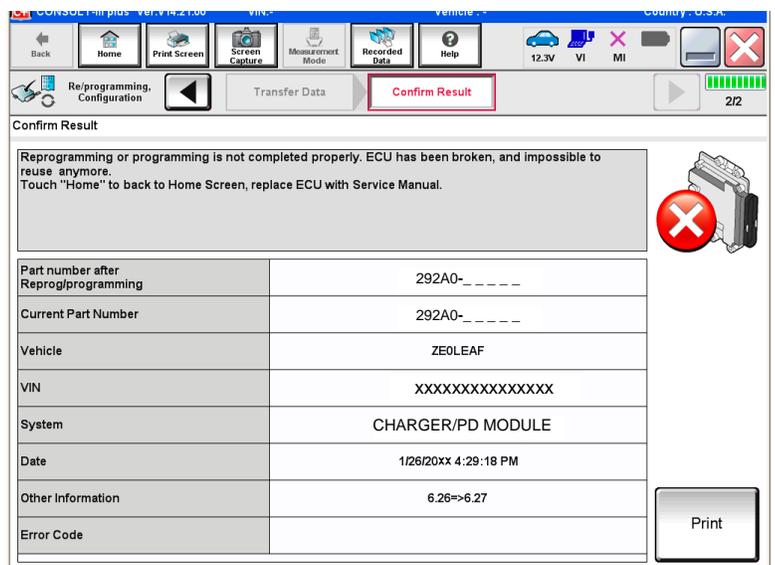
Figure 18

OR: If reprogramming does not complete and the **X** displays as shown in Figure 18:

Do not disconnect plus VI or shut down Consult III plus if reprogramming does not complete.

- Check battery voltage (12.0 - 13.5V).
- CONSULT A/C adapter is plugged in.
- Ignition is ON, Ready Mode is OFF.
- Transmission in Park.
- All C-III plus / plus VI cables are securely connected.
- All C-III plus updates are installed.
- **Select Home, and then restart the reprogram procedure from the beginning.**

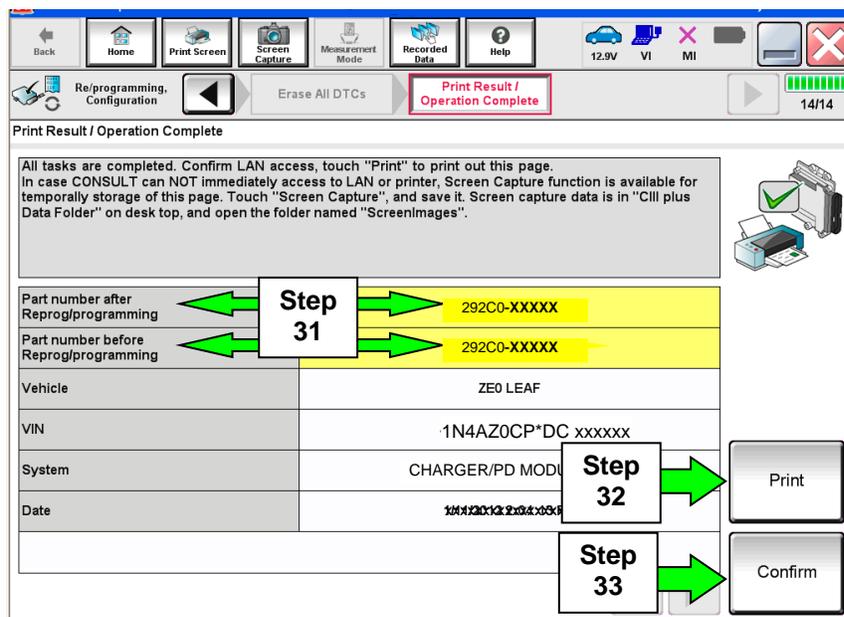
Figure 22

31. Verify the before and after part numbers are different.

32. Print a copy of this screen (Figure 22) and attach it to the repair order.
