EM13-007a

2013-2014 SENTRA; **ENGINE UPPER TORQUE ROD SERVICE INFORMATION**

NTB14-003a

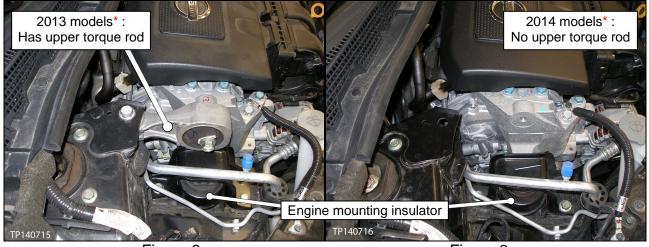
Figure 2

2013 Sentra: All models are equipped with an upper torque rod.

These vehicles have an engine mounting insulator that requires an upper torgue rod. •

- These vehicles have a redesigned engine mounting insulator that does not require an upper torque rod.
- * 2014 Sentra: S models built BEFORE 3N1AB7AP(*)EL 606447 and November 2, 2013 are equipped with an upper torque rod.
 - These vehicles have an engine mounting insulator that requires an upper torque rod.

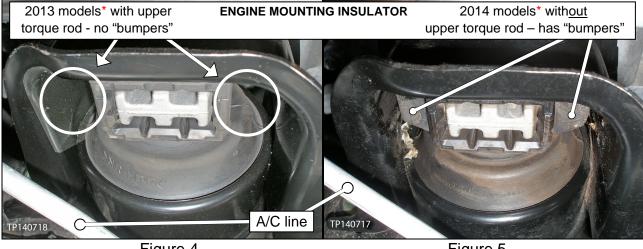
Figure 4

2014 Sentra: All SV, SL, and SR models DO NOT HAVE an upper torgue rod. DO NOT INSTALL an upper torque rod on these models for any reason.

2014 Sentra: S models built ON and AFTER 3N1AB7AP(*)EL 606447 and November 2, 2013 DO NOT HAVE an upper torque rod. DO NOT INSTALL an upper torque rod on these models for any reason.

These vehicles have a redesigned engine mounting insulator that does not require an upper torque rod.
