# SERVICE BULLETIN

Classification: EM16-001a	Reference: NTB16-007a	Date: March 22, 2016
------------------------------	--------------------------	-------------------------

## 2016 ALTIMA; VIBRATION FELT IN CENTER CONSOLE AND DRONING HEARD WHILE DRIVING

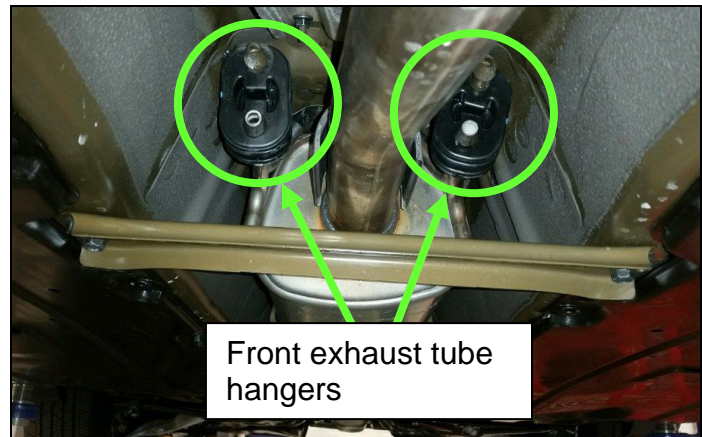
A vibration is felt in the center console armrest pad, seat base and steering wheel that is accompanied by a droning sound.

Remove two rubber “front exhaust tube hangers” shown in Figure 1 that support the rear of the center exhaust tube.

**IMPORTANT:** Vehicles built after the above Applied VIN and Date are no longer equipped with exhaust hangers installed in these locations.
